*More than three million households in South Africa still lack access to basic sanitation.*

***South Africa could be chasing a perpetual sanitation backlog if not more thought is given to the rollout as well as operation and maintenance of basic sanitation services, a Water Research Commission (WRC) study has found. Lani van Vuuren reports.***

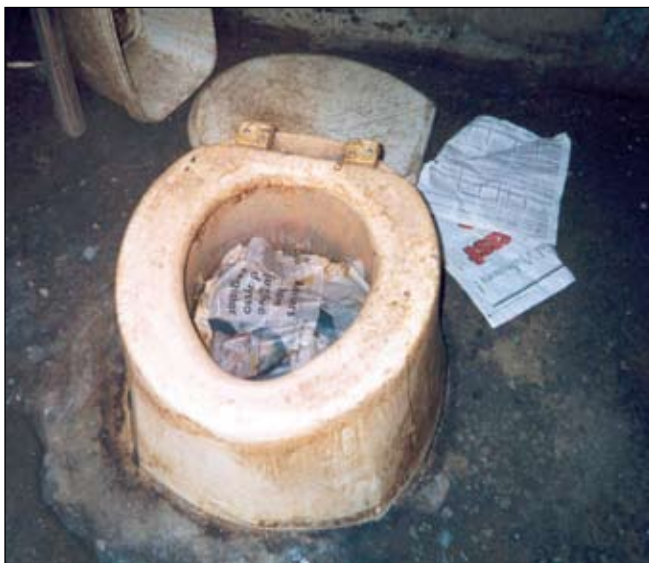
*A poorly maintained, overflowing pit latrine, filled with non-biodegradable material.*

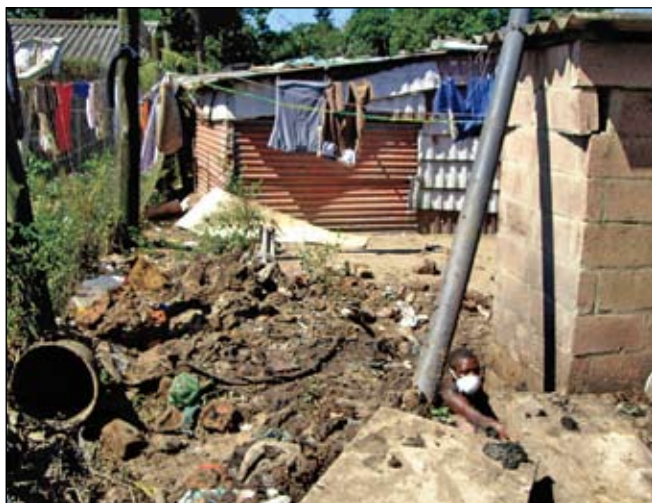
*Contents of pit latrines extracted during pit emptying near Tongaat, KwaZulu-Natal.*
