An Evaluation of the Enviro Loo Composting Latrine in an Informal Settlement Area in Greater Johannesburg

Report to the Water Research Commission
and
the Greater Johannesburg Metropolitan Council
by
Stewart Scott

WRC Report No KV 112/98

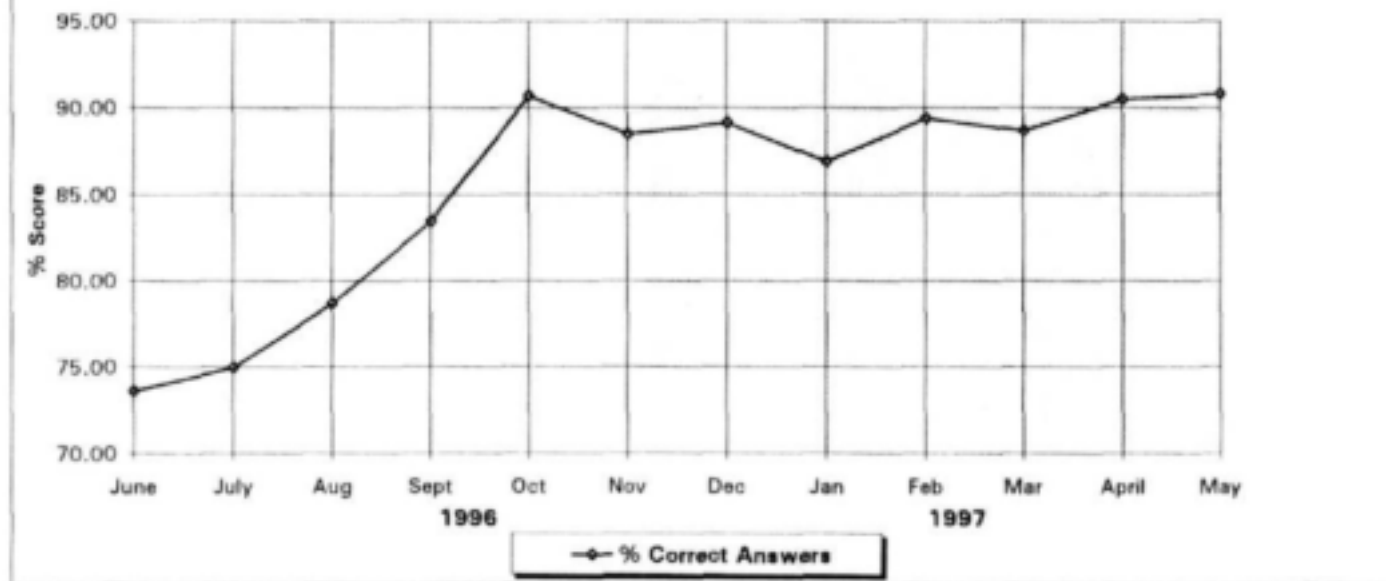
Figure 3: Specific Knowledge of Composting Latrines
(June 1996 - May 1997)

1996							1997				
Specific Knowledge:	June	July	Aug	Sept	Oct	Nov	Dec	Jan	Feb	Mar	April	May
% Correct Answers	73.60	74.95	78.68	83.45	90.70	88.50	89.15	86.90	89.40	88.70	90.50	90.80

- The routine questionnaire was used as a means to evaluate **knowledge** amongst the Study Group regarding the **correct usage of the Enviro Loo latrines** (see Figure 3). Such knowledge included the regular and proper application of organic toilet cleaner and compost. It was found that users generally showed a good understanding of how the Enviro Loo latrine should function. An improvement in knowledge was noted during the winter period of 1996, which was sustained throughout the summer period of 1996-97 with 85-90% of respondents on average correctly answering questions on these matters. The regular questioning of respondents on these issues together with the user education sessions held at the outset of the trial, and again after six months, contributed to this improved knowledge. It should be noted, however, that although the users displayed a good knowledge about the latrine, this was not always put into practice leading to the disposal of wastewater in some latrines (see below).

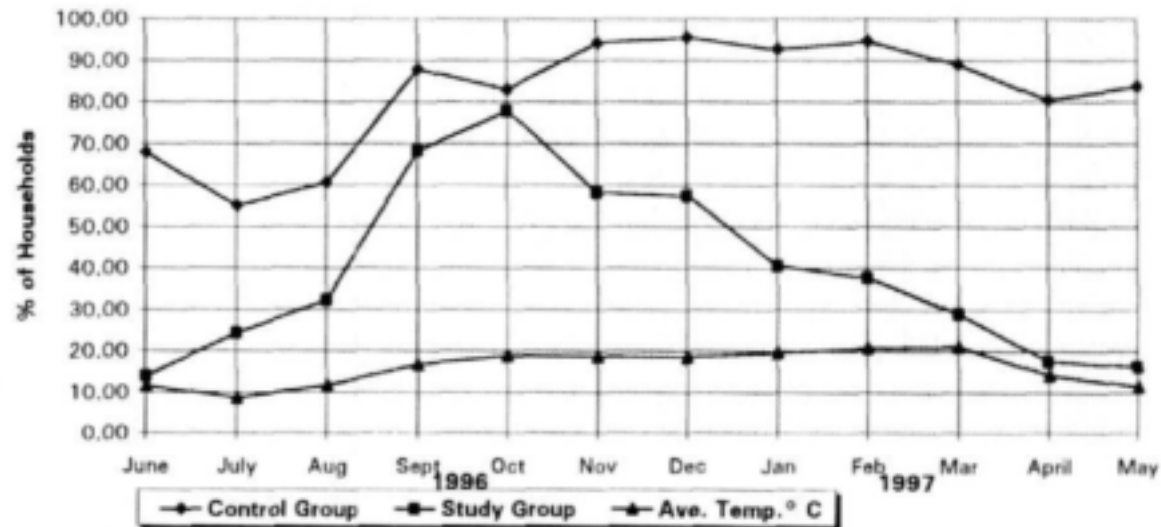
Figure 4: Complaints in Respect of Flies

1996							1997				
	June	July	Aug	Sept	Oct	Nov	Dec	Jan	Feb	Mar	April	May
Control Group	67.85	55.10	60.61	87.90	83.10	94.25	95.50	92.60	94.60	88.90	80.40	83.90
Study Group	13.93	24.29	32.26	68.27	78.00	58.20	57.50	40.70	37.80	28.90	17.60	16.40
Ave. Temp. ° C	11.60	8.70	11.70	16.80	18.90	18.80	18.50	19.60	20.80	21.10	14.30	11.50

- Complaints from respondents in the Study and Control Groups in respect of **flies and unpleasant smells** (Figures 4 and 5) were used by the project team as an indicator of the performance of the latrines, as well as an additional parameter for evaluating the health impacts on the respective latrine users. Once again, a direct comparison should not be drawn in terms of the number of complaints of flies and unpleasant smells recorded by respondents from the Study and Control Groups since the Enviro Loo latrines and the communal chemical latrines were operating under different conditions. The number of complaints in respect of flies increased for both the Study and Control Groups with the onset of the summer season, although the increase in the Study Group was more marked, since it came off a lower base. From November 1996 until the end of the study, complaints in respect of flies fell amongst the Study Group whilst remaining consistently high amongst the Control Group. The fall in the number of complaints amongst the Study Group is attributed to the retrofitting of the new agitator rod. A similar trend is discernible with regard to complaints of unpleasant smells, although in this case the fall in complaints from the Study Group after November 1996 was interrupted by an increase in January and February 1997. This anomaly is attributed to problems experienced with certain of the retrofitted agitator rods which were not functioning properly. It would be expected that the Enviro Loo latrines which are located on single stands would be more cared for and maintained by the individual owners than the communal chemical latrines used by a number of households. The results for the Study Group, however, show that completely fly and odour free operation was not attained during the trial period.

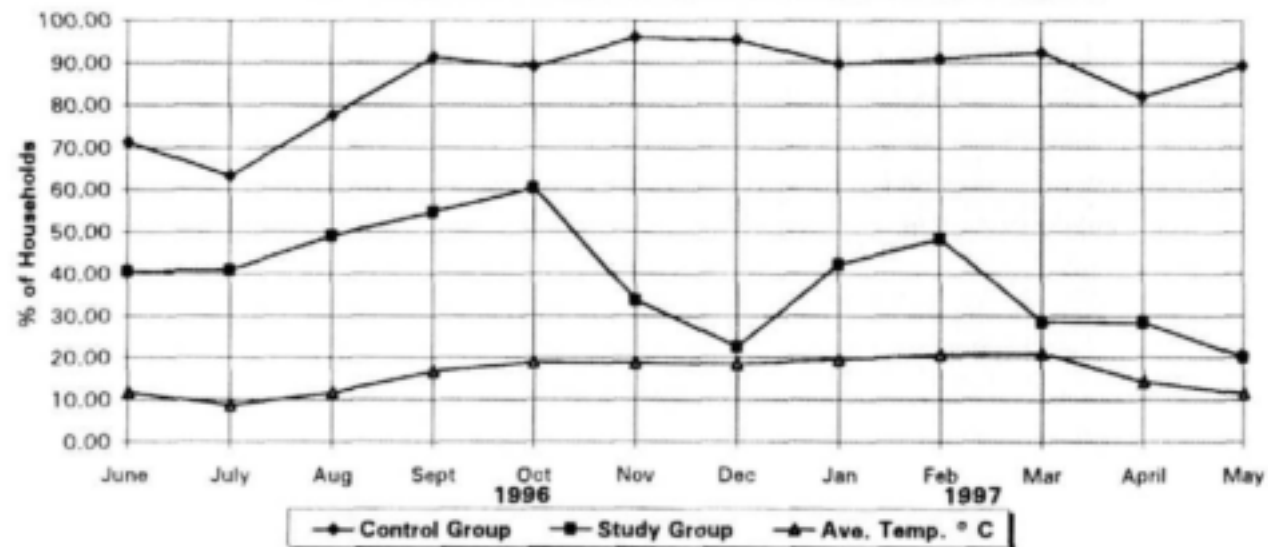
Figure 5: Complaints in Respect of Unpleasant Smell
(June 1996 - May 1997)

1996								1997				
	June	July	Aug	Sept	Oct	Nov	Dec	Jan	Feb	Mar	April	May	
Control Group	71.25	63.27	77.70	91.26	89.15	96.15	95.50	89.70	91.00	92.60	82.00	89.30	
Study Group	40.84	40.93	49.10	54.77	60.40	33.80	22.70	42.30	48.30	28.70	28.30	20.20	
Ave. Temp. °C	11.60	8.70	11.70	16.80	18.90	18.80	18.50	19.60	20.80	21.10	14.30	11.50

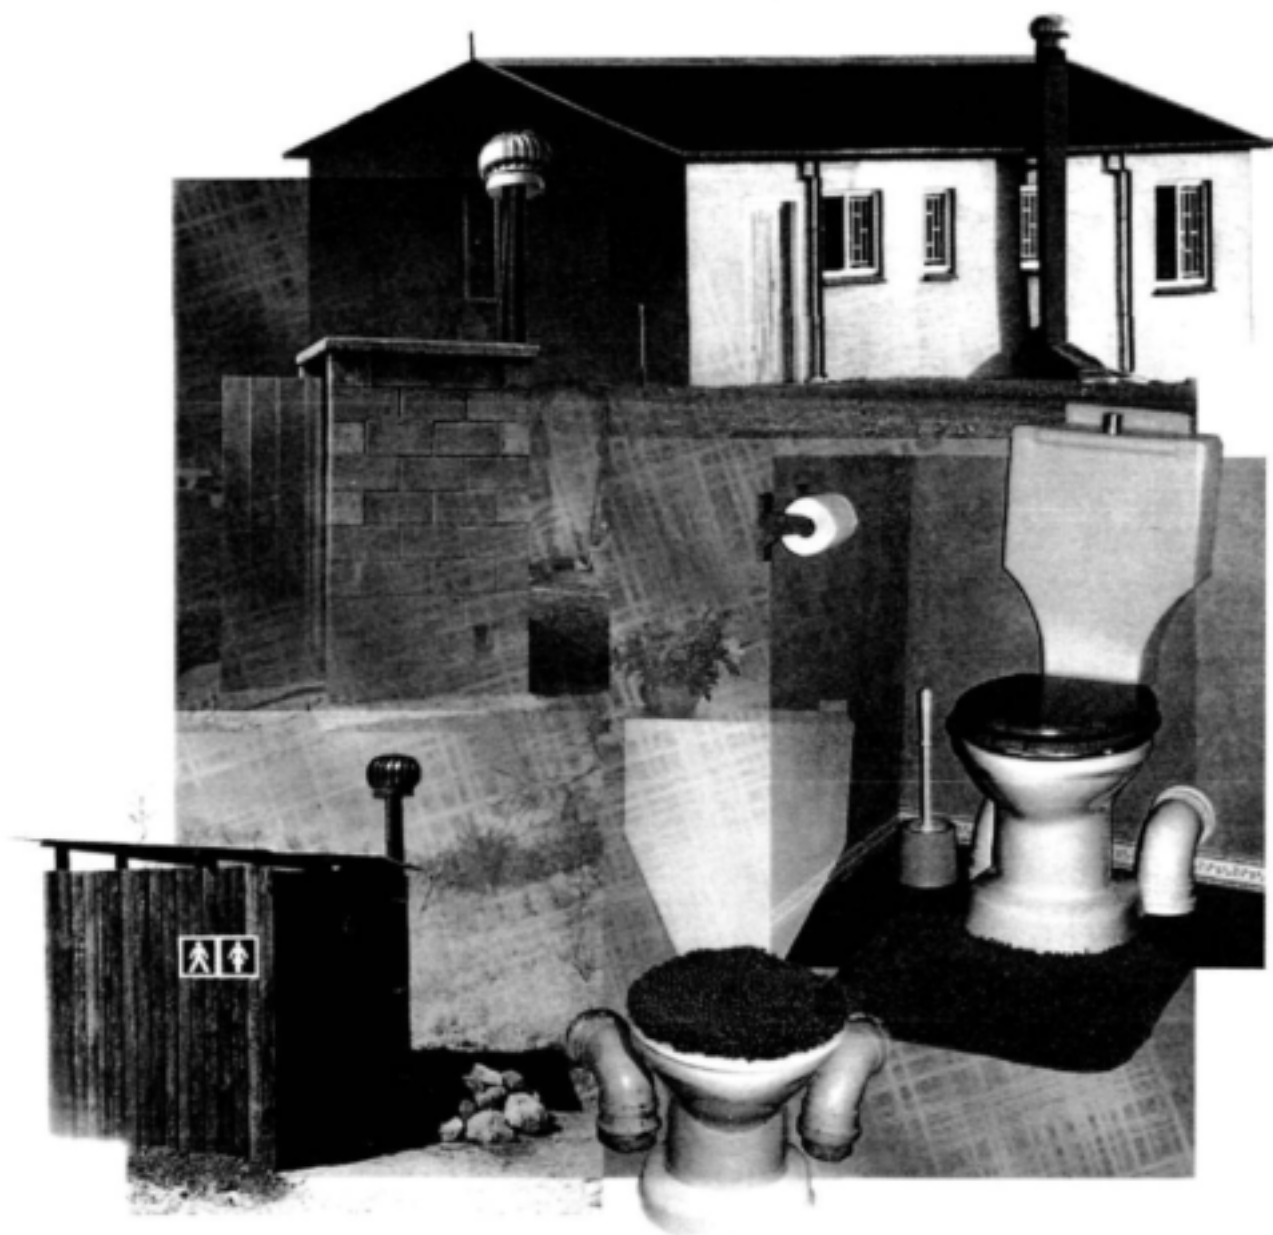
ENVIRO LOO

THE NON-FLUSH DRY SANITATION SYSTEM

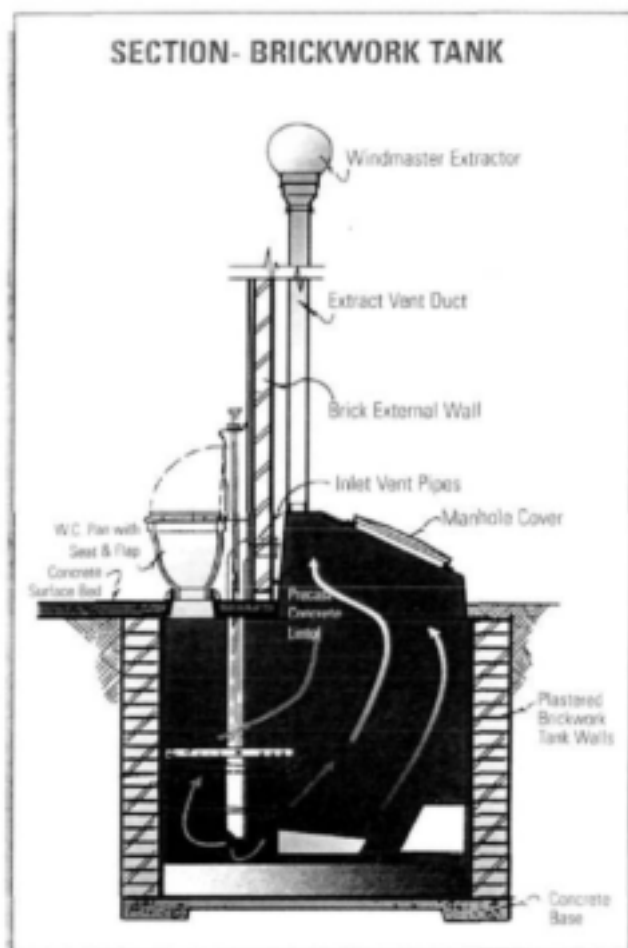
HOW IT WORKS

- The body waste falls onto a bed of organic matter on the grid. The aerator which has been designed for ease of operating, breaks up the solid waste to ensure proper aeration and drying.
- As the waste dries and decomposes, the dried matter falls from the grid onto the drying plates and in time travels down the plates towards the collection box.
- A uniquely designed ventilation system allows air to be drawn into the container and through the waste.
- Air is exhausted from the container with the assistance of the ventilation extraction system.
- A manhole is positioned above the collection box to ensure easy access for the periodic removal of the humus. (Dried waste.)

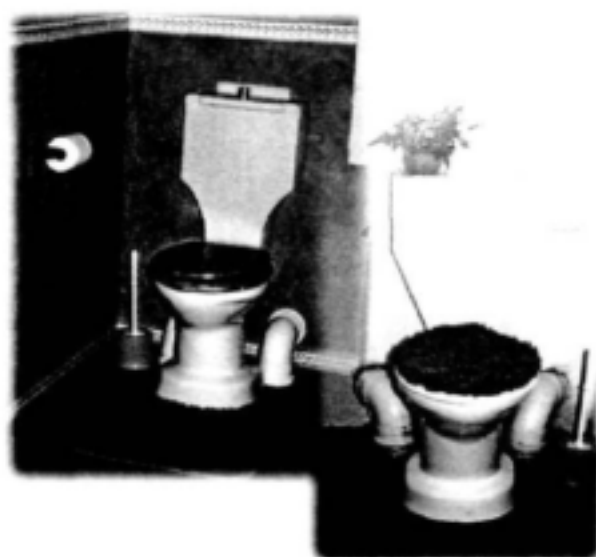
- Just as Nature recycles garden refuse into compost, the Enviro Loo composting toilet provides the right environment allowing human waste, toilet paper and organic material to break down through the natural composting process into an inoffensive compost like material. Oxygen, moisture, heat and organic material are required for the aerobic bacteria and microbes to recycle human waste into a good fertilising material.
- Radiant heat is absorbed and conducted through the U.V. protected black polyethylene plastic of the manhole cover and vent pipe.
- Through the designed ventilation system, adequate

oxygen is provided for the aerobic decomposition and deodorising process.

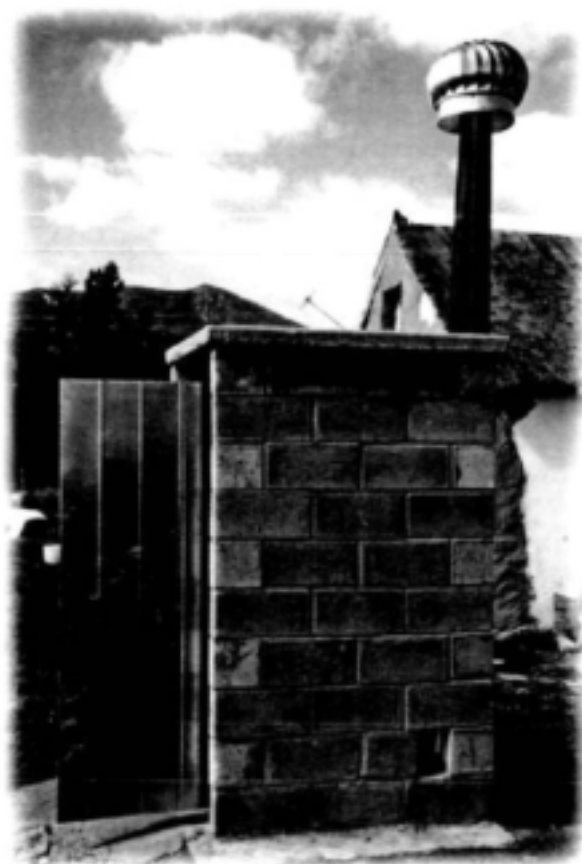
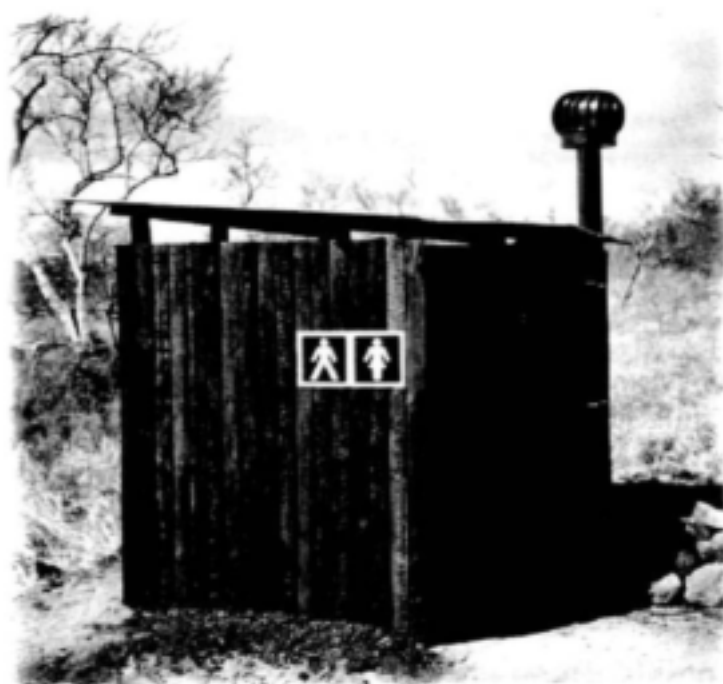
- Enviro Loo toilets require minimal regular maintenance. It is recommended that a handful of the prepared organic additive is added into the toilet through the toilet bowl after use.
- The waste on the grid needs to be mixed and aerated on a daily basis, this is simply operated through the handle on the toilet backrest.
- The Enviro Loo requires NO servicing for the first eighteen months to two years after installation.

Thereafter only the dried matter is removed on an annual basis depending on the number of users per day. Under lower usage conditions the maintenance required can extend to every two to three years. The dried matter is simply raked from the drying plates into the collection box and removed through the manhole.

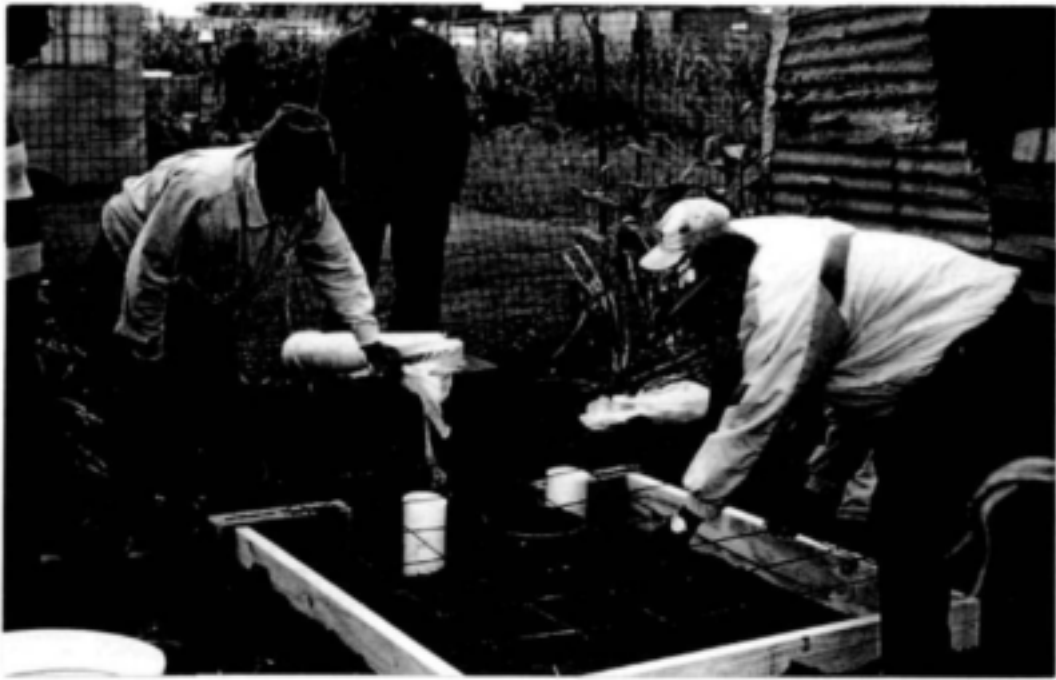
Photograph A :
Installation of Enviro Loo latrine in the ground prior to casting of floor slab

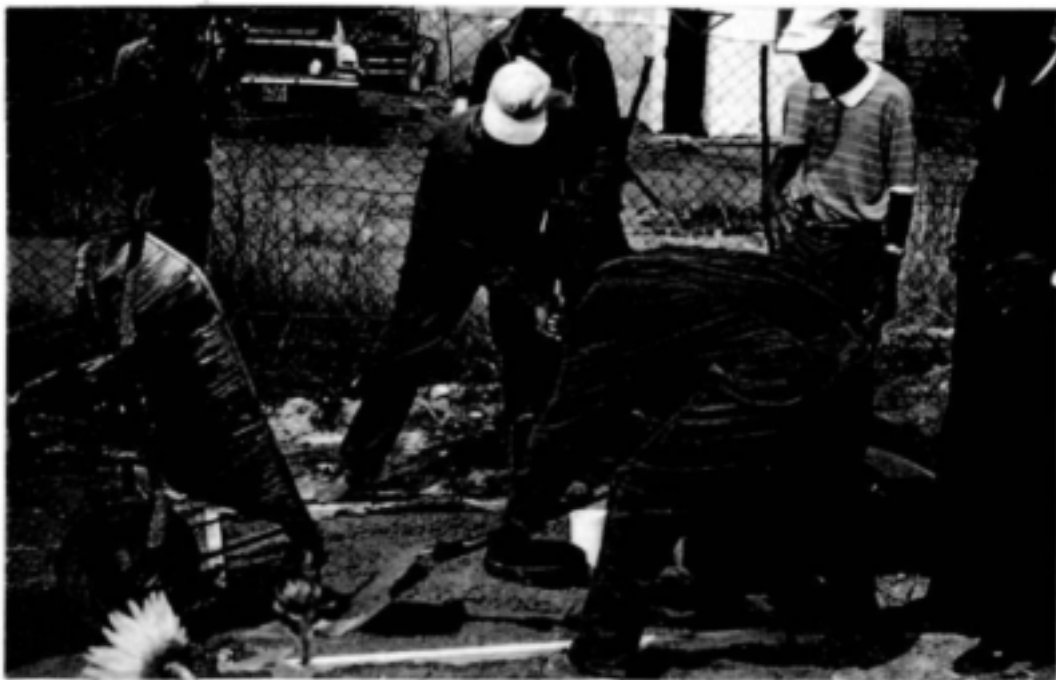
Photograph B : Casting of concrete floor slab

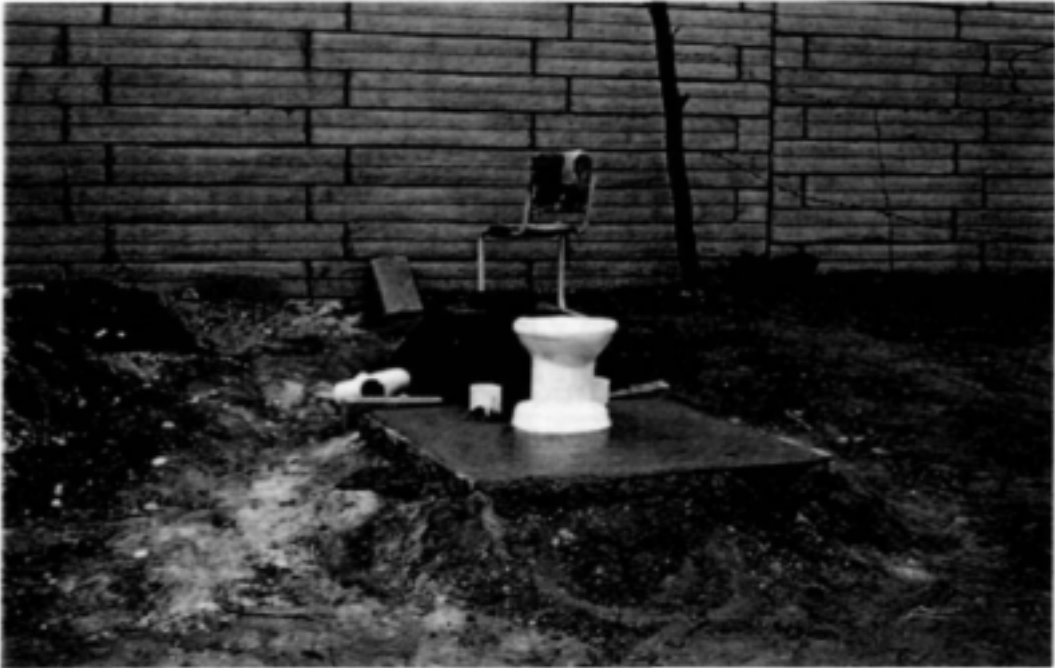
Photograph C : Freshly cast floor slab with toilet bowl in place

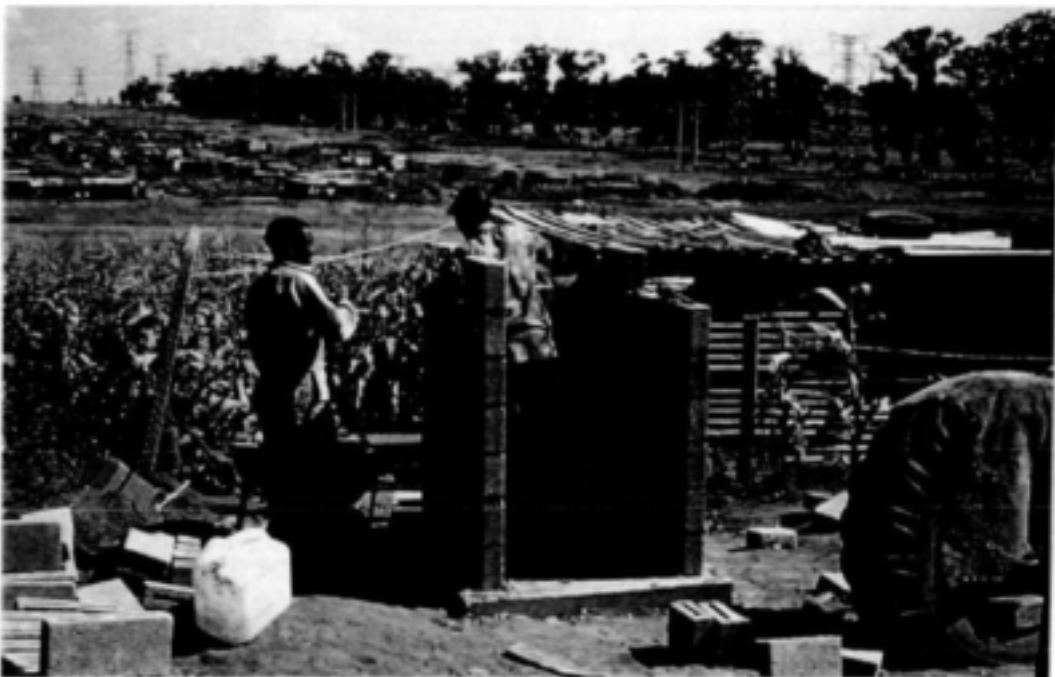
Photograph D : Construction of the walls of the superstructure

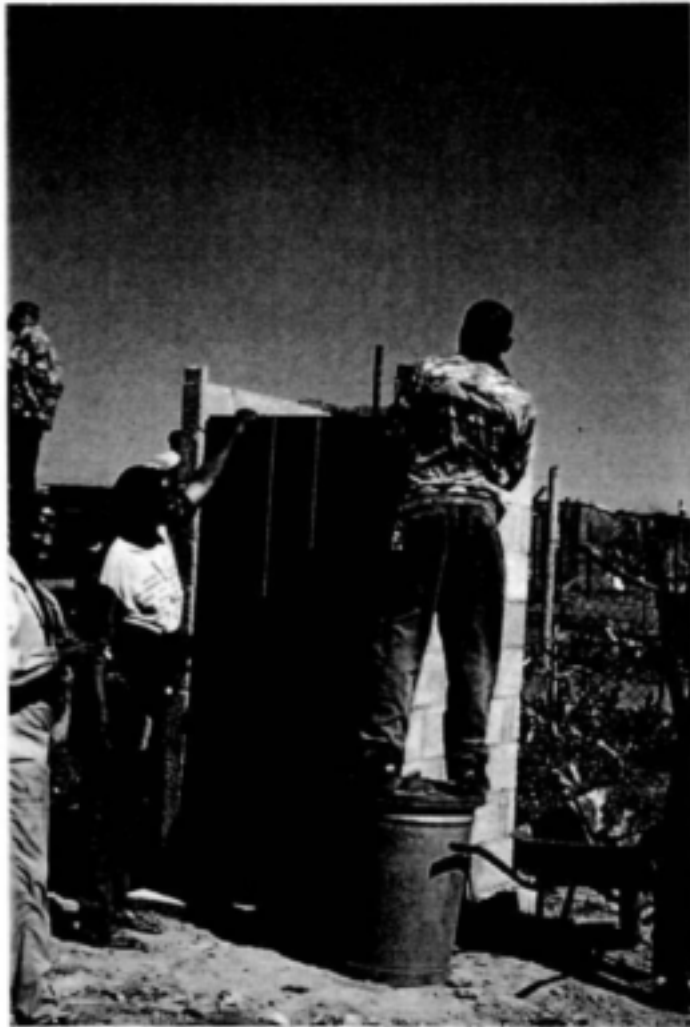
Photograph E : Installation of latrine door prior to positioning of roof slab

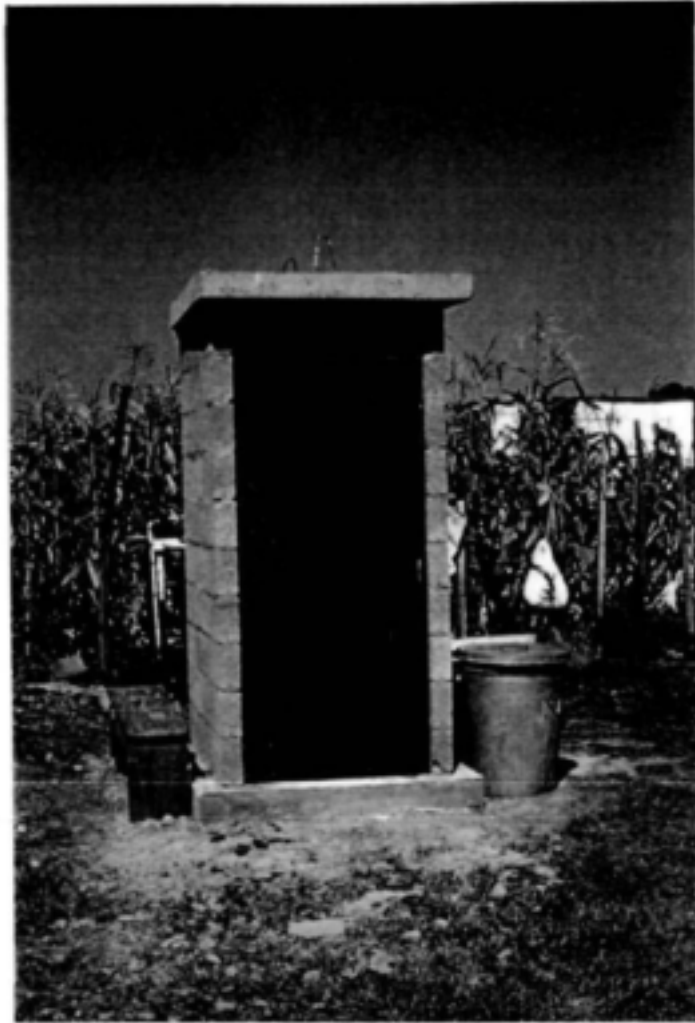
Photograph F : Completed superstructure prior to finishing

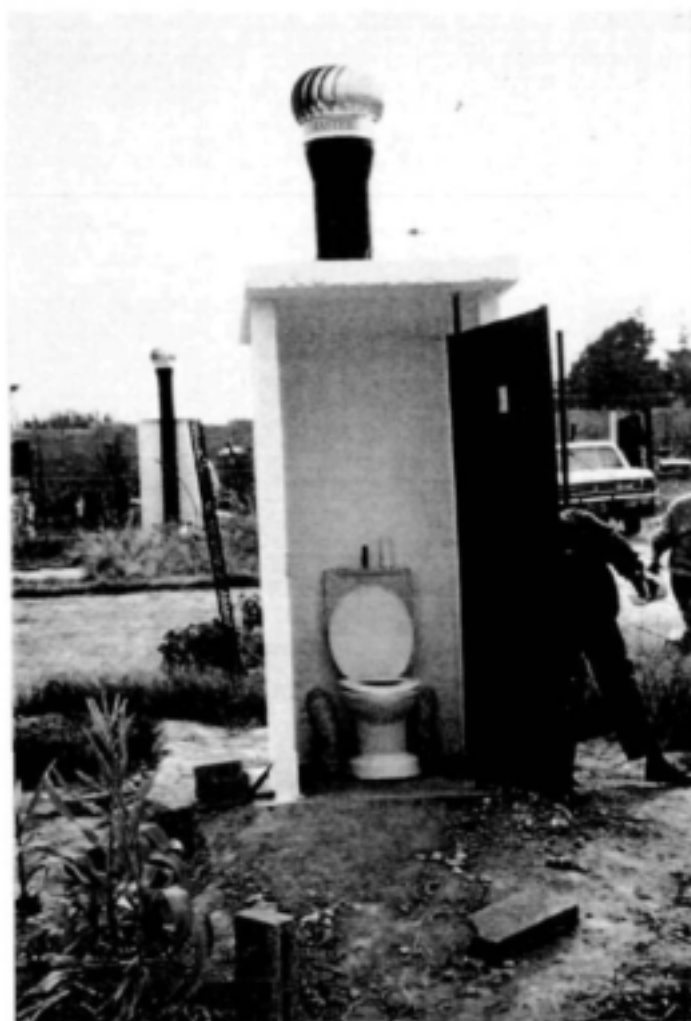
Photograph G : Final finishing of installed Enviro Loo latrine

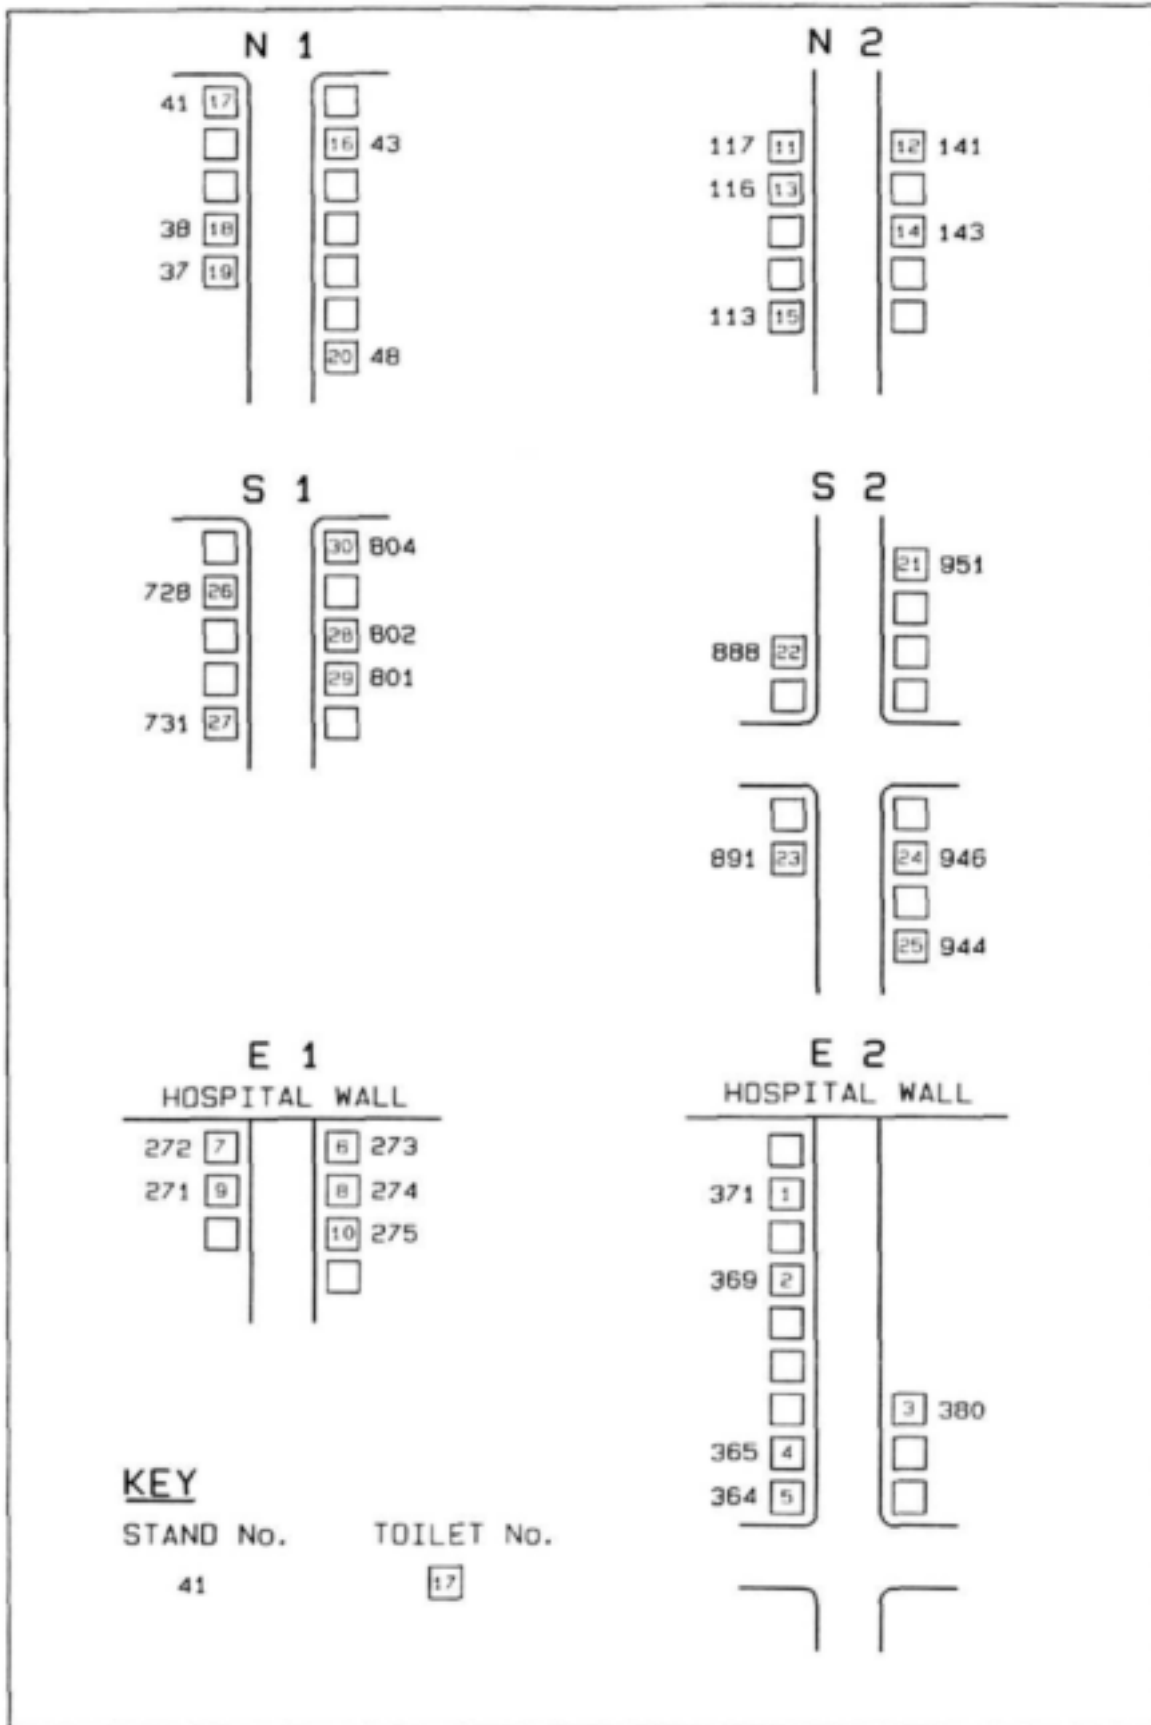
Schematic layout and location of stands on which Enviro Loo latrines are located

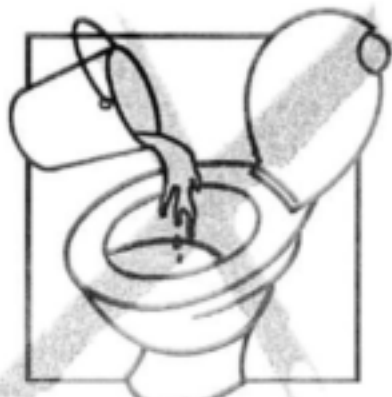
DO NOT
POUR WATER INTO THE
TOILET FOR CLEANING OR
ANY OTHER PURPOSE.

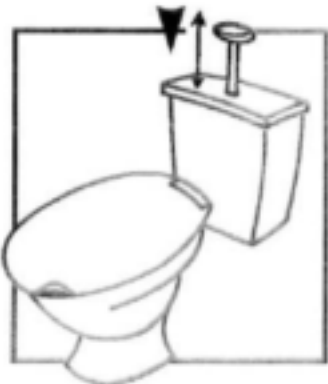
YOU SHOULD
LIFT AND PUSH DOWN
THE AERATOR HANDLE
AFTER USE

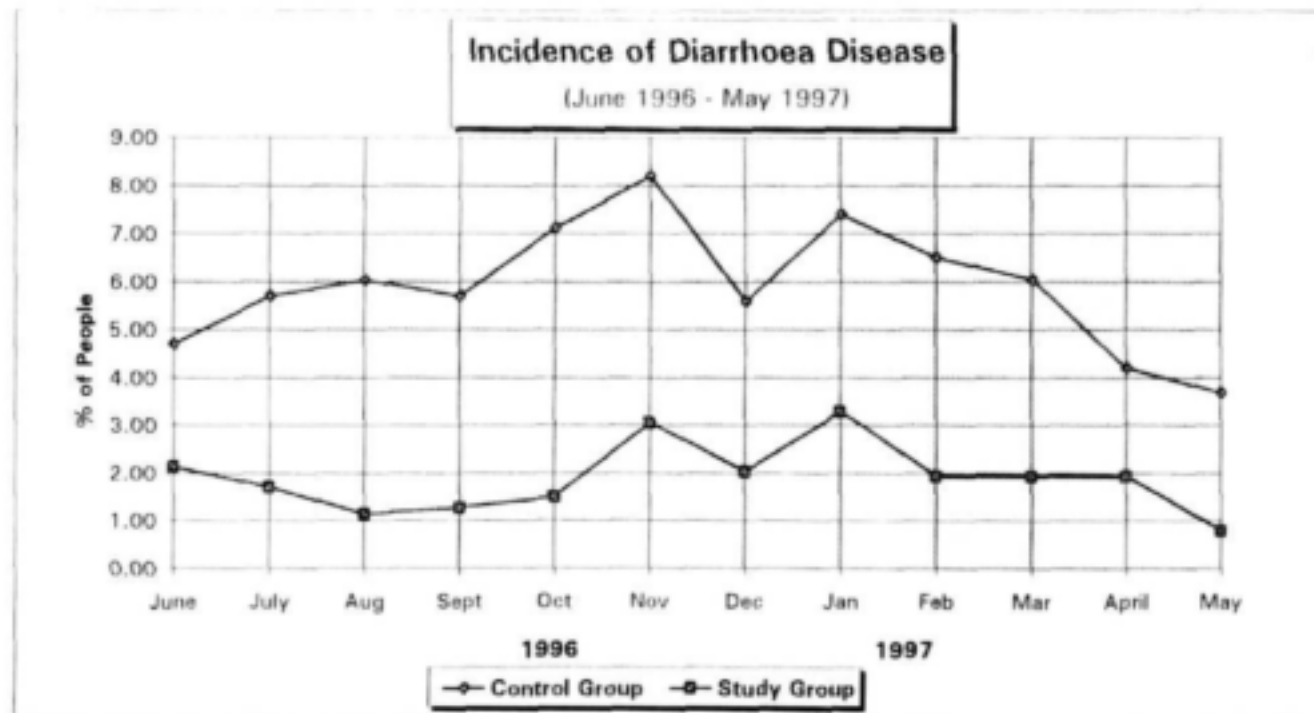
% of People Infected	1996							1997				
	June	July	Aug	Sept	Oct	Nov	Dec	Jan	Feb	Mar	April	May
Control Group	4.70	5.70	6.03	5.71	7.12	8.20	5.60	7.40	6.50	6.05	4.20	3.70
Study Group	2.14	1.71	1.14	1.28	1.50	3.06	2.04	3.30	1.95	1.95	1.95	0.80

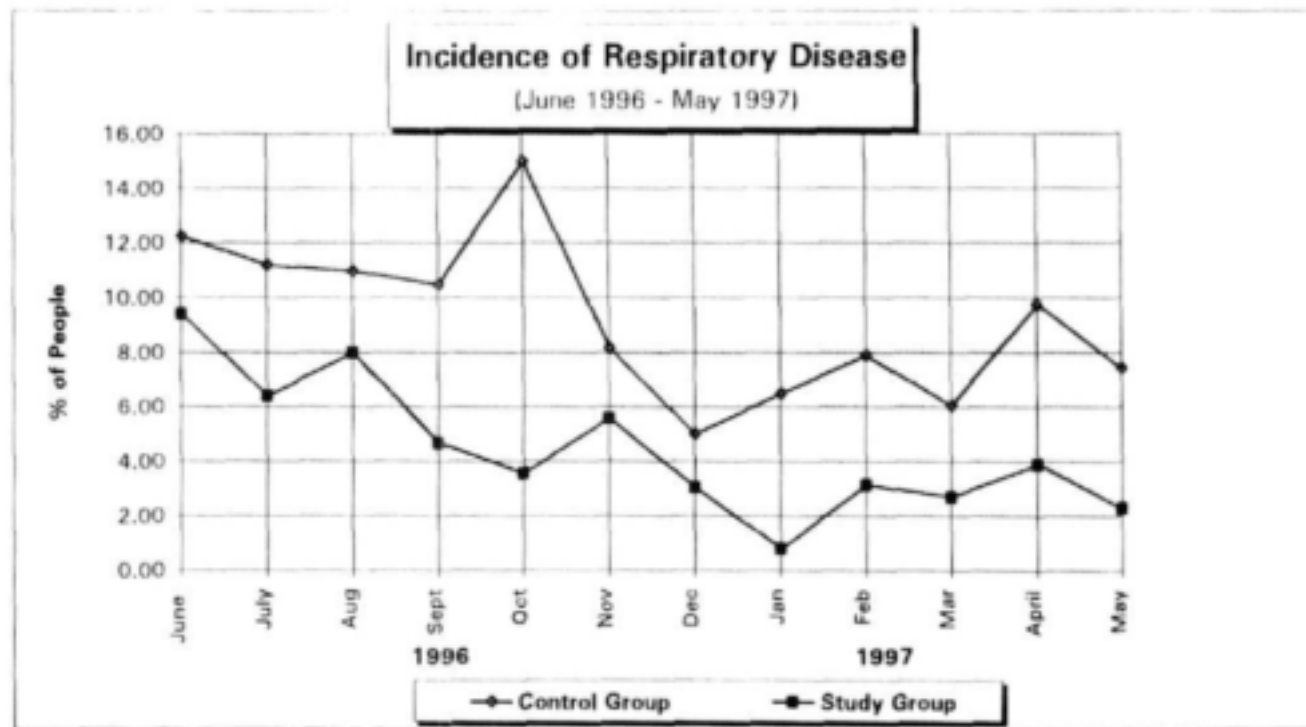
% of People Infected	1996								1997				
	June	July	Aug	Sept	Oct	Nov	Dec	Jan	Feb	Mar	April	May	
Control Group	12.23	11.18	10.96	10.48	15.00	8.15	5.00	6.50	7.90	6.05	9.75	7.43	
Study Group	9.41	6.41	7.98	4.70	3.57	5.60	3.06	0.80	3.15	2.70	3.90	2.30

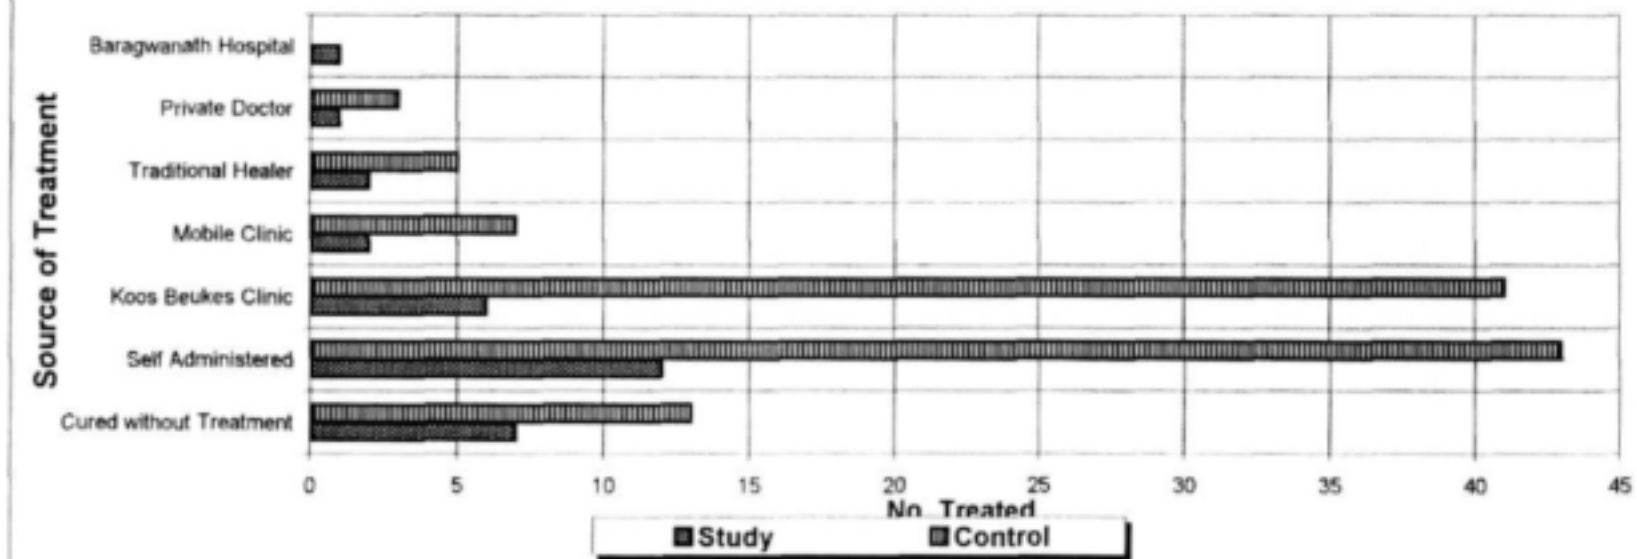
Source of Treatment Administered for Diarrhoea Episodes
(June 1996 - May 1997)

Source of Treatment	Study	Control	% (Study)	% (Control)
Cured without Treatment	7	13	22.58	11.61
Self Administered	12	43	38.71	38.39
Koos Beukes Clinic	6	41	19.35	36.61
Mobile Clinic	2	7	6.45	6.25
Traditional Healer	2	5	6.45	4.46
Private Doctor	1	3	3.23	2.68
Baragwanath Hospital	1	0	3.23	0
Total	31	112

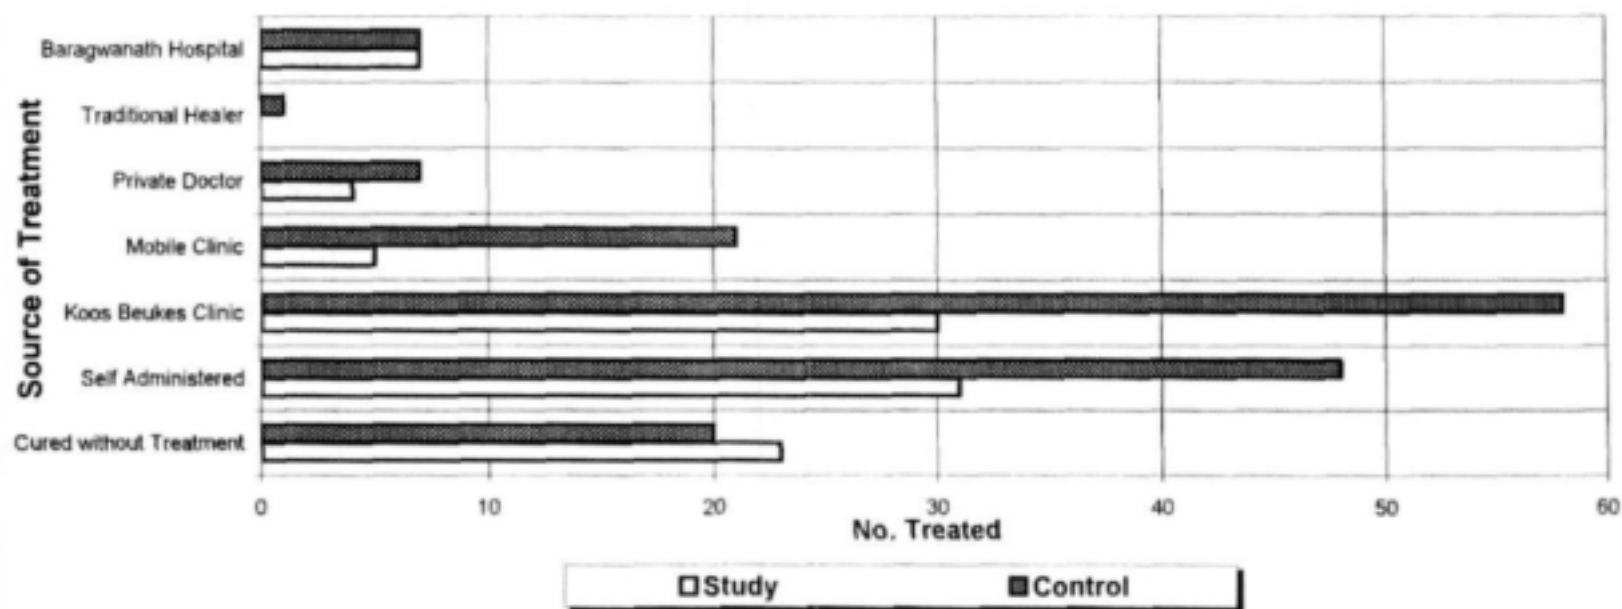
Source of Treatment Administered for Respiratory Episodes
(June 1996 - May 1997)

Source of Treatment	Study	Control	% (Stu)	% (Cont)
Cured without Treatment	23	20	23	12.35
Self Administered	31	48	31	29.63
Koos Beukes Clinic	30	58	30	35.80
Mobile Clinic	5	21	5	12.96
Private Doctor	4	7	4	4.32
Traditional Healer	0	1	0	0.62
Baragwanath Hospital	7	7	7	4.32
Total	100	162

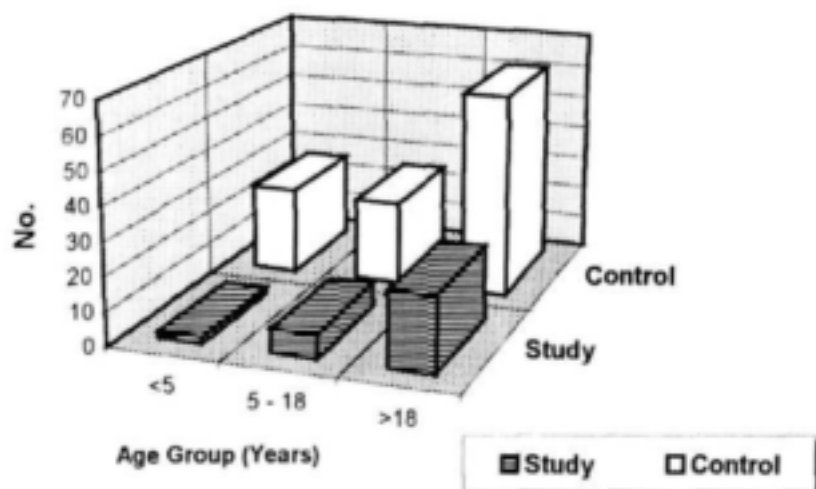
Diarrhoea Episodes: Total Frequency by Age Group

Distribution of Episodes of Diarrhoea: Total Frequency by Age Group

Age Group (Years)	Study	Control	% (Study)	% (Control)
<5	2	26	6.5	23.2
5 - 18	7	25	22.6	22.3
>18	22	61	71.0	54.5
Totals	31	112

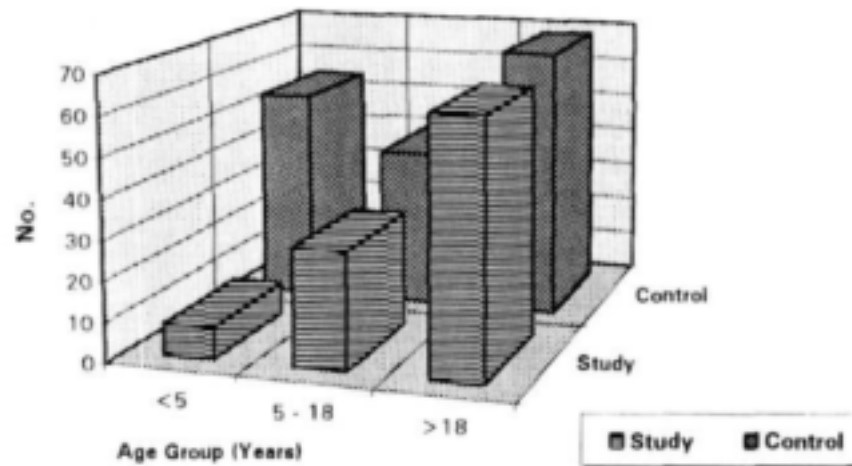
Respiratory Episodes: Total Frequency by Age Group

Distribution of Episodes of Respiratory Disease: Total Frequency by Age Group

Age Group (Years)	Study	Control	% (Study)	% (Control)
<5	8	54	8	33.3
5 - 18	29	40	29	24.7
>18	63	68	63	42
Totals	100	162

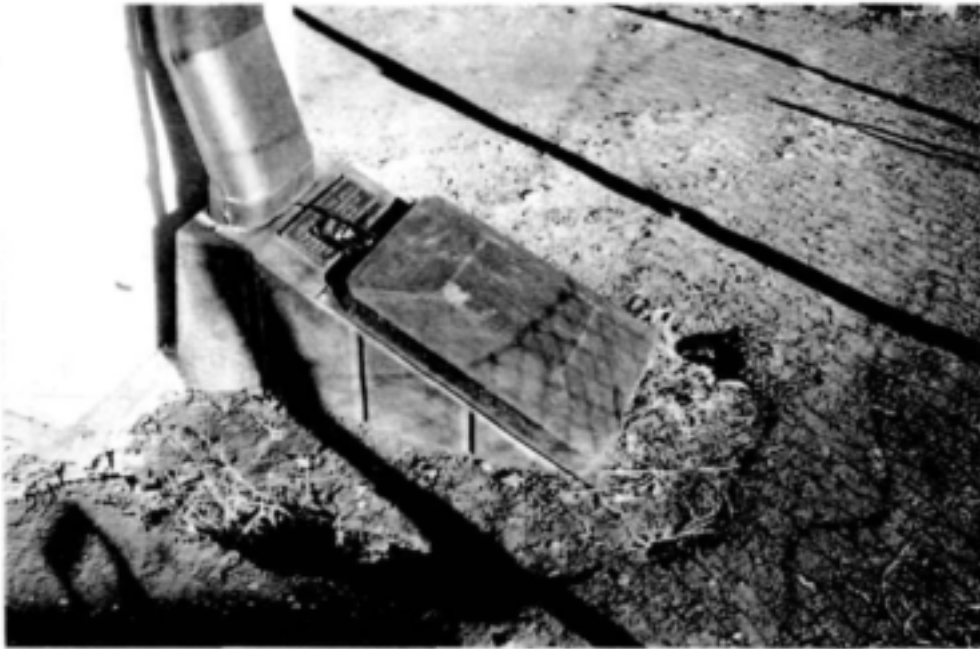
Photograph I : Subsidence of ground around Enviro Loo latrine container

- With the exception of the agitator rod (or paddle) mechanism (see below), the **physical integrity** of the Enviro Loo latrines stood up well to use over the 12 month trial period. Some subsidence of ground occurred during the year around a few of the latrines which resulted in the inward bulging of the latrine container sides. This is thought to be mainly attributable to the failure to adequately compact the ground around the latrines during installation or as a result of insufficient stormwater control on the site. Minor problems were also experienced with some toilet doors which did not close well and two windmasters which did not easily turn in very light wind conditions. None of these minor problems proved to be fatal flaws.

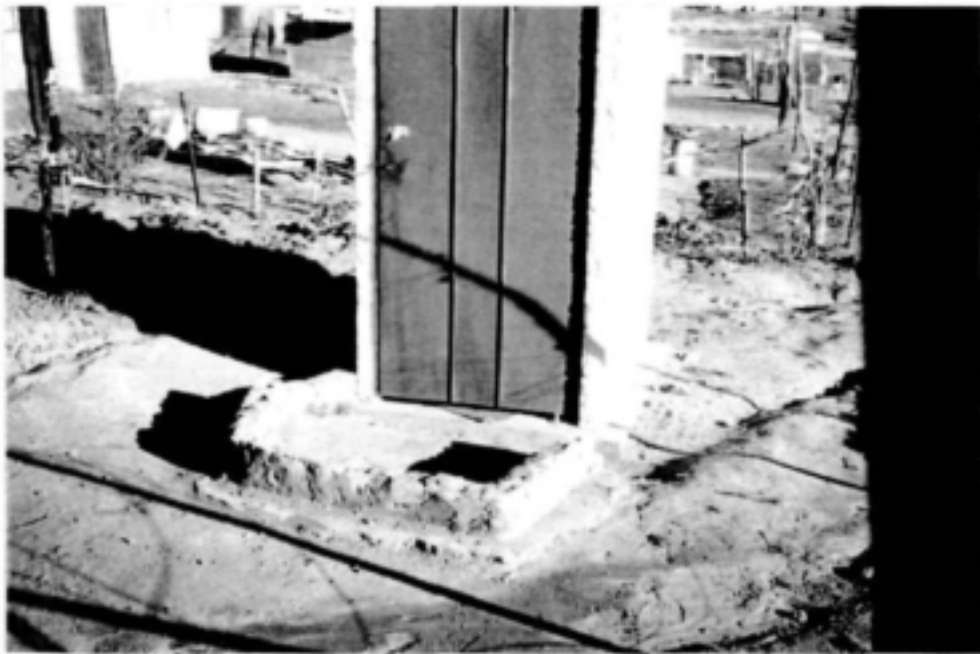
Photograph J : Stormwater control structure erected by Enviro Loo latrine user

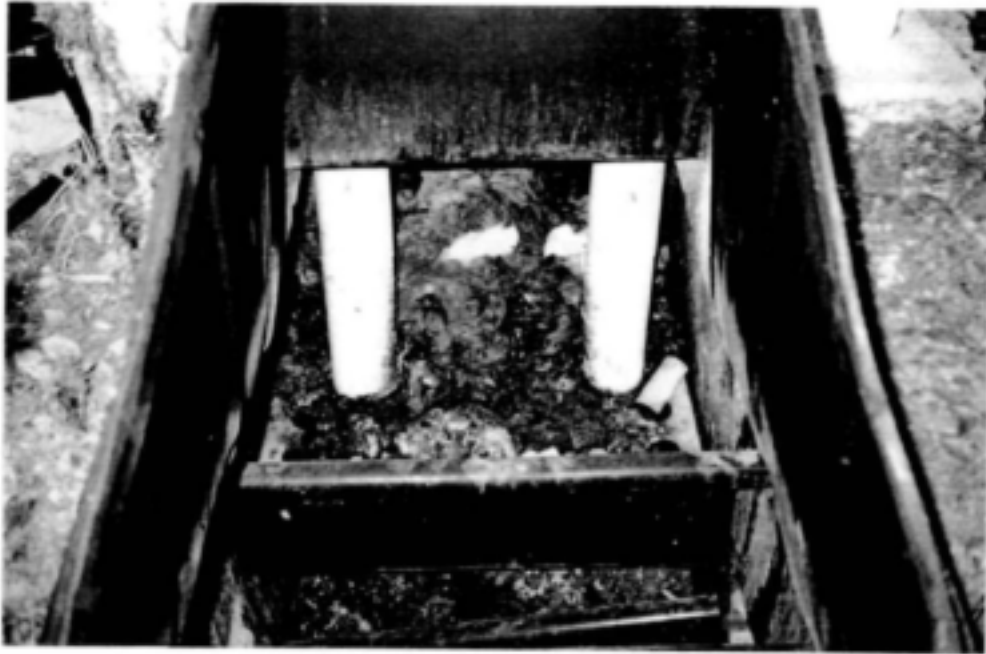
Photograph K : View of typical waste pile in Enviro Loo latrine container (June 1997)

- The **waste** which accumulated inside the container during the trial period remained small in volume and largely confined to the upper grid (see Photographs in Appendix I). In no container had the waste reached the bottom (third) grid (where the collection box is situated) in sufficient quantities for removal. In some instances, however, waste had fallen onto the middle or second grid. The waste appeared quite moist in the centre of the upper grid (where fresh faecal material was falling), but drier at the edges (where the application of compost could be discerned - ie the presence of partially decomposed woody or straw material was visible). Toilet paper and newspaper were still clearly identifiable, but no other anal cleansing material was recognised. Apart from the odd piece of plastic or cloth, no other waste material was observed inside the latrine containers.

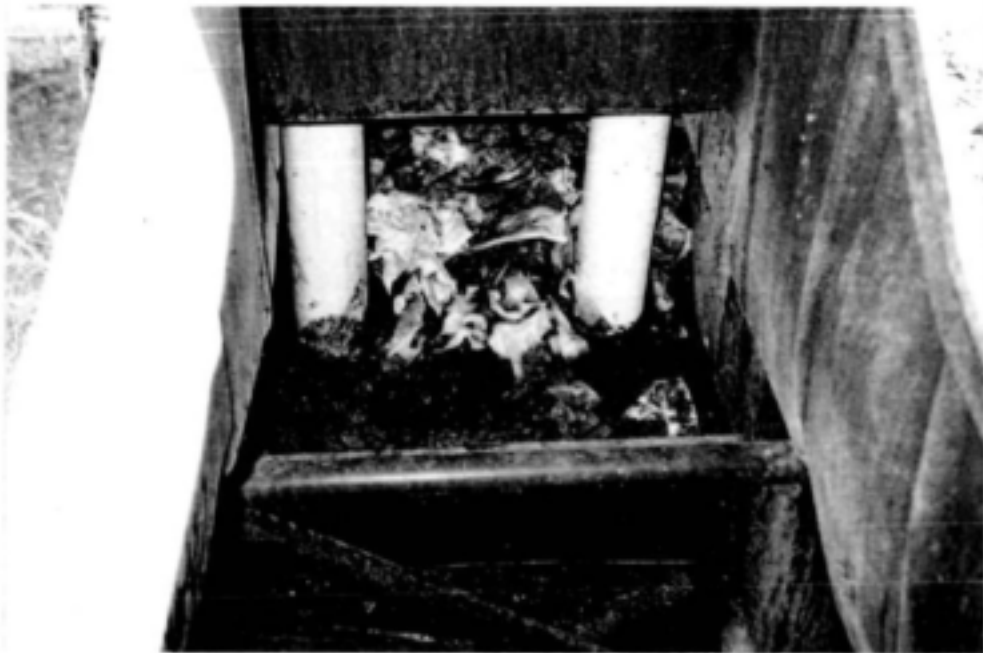
Photograph L :
View of latrine container contents (June 1997) showing heavy use of newspaper as an anal
cleansing material
