An Evaluation of the Enviro Loo Composting Latrine in an Informal Settlement Area in Greater Johannesburg

Report to the Water Research Commission
and
the Greater Johannesburg Metropolitan Council
by
Stewart Scott

WRC Report No KV 112/98

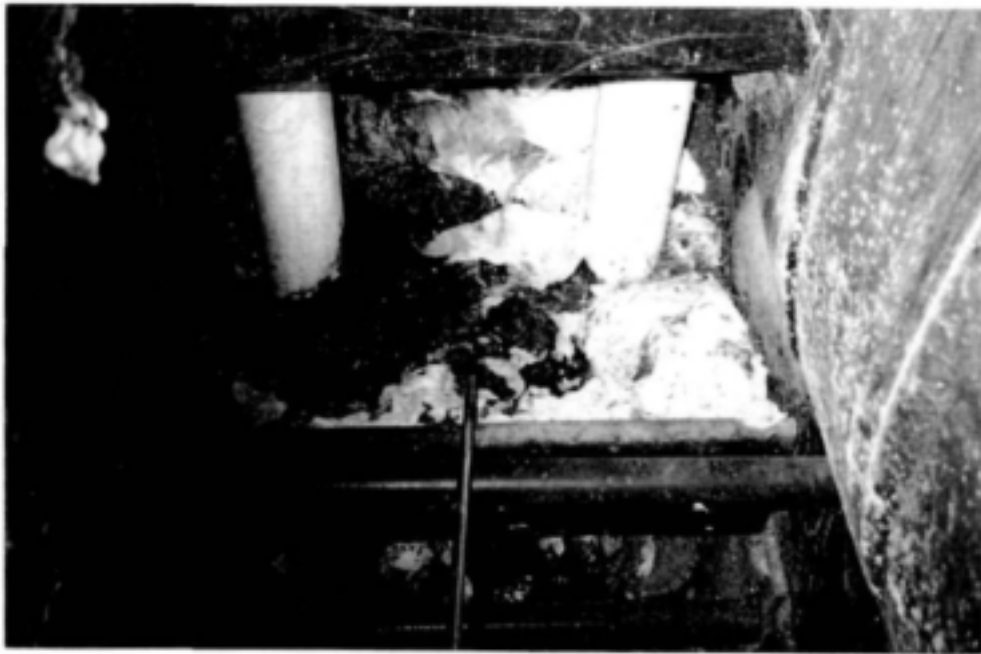
Photograph M :

View of temperature probe inside waste pile in latrine container (June 1997)

- All temperature readings (see Appendix J) in the waste piles taken at the end of the trial were low (average 5 °C) and comparable to air temperatures inside the container (ie between 2 and 10°C). Although taken during the winter season, such temperatures indicate that conditions in the container are unfavourable at this stage with regard to both encouraging biological activity and the killing of pathogens. Since the waste pile is small, any heat produced by microbial activity is quickly dissipated. pH readings were between 7.0 and 8.8 indicating neutral or alkaline conditions favourable to aerobic decomposition (an acidic pH would be generated by acid fermentation products under anaerobic conditions).

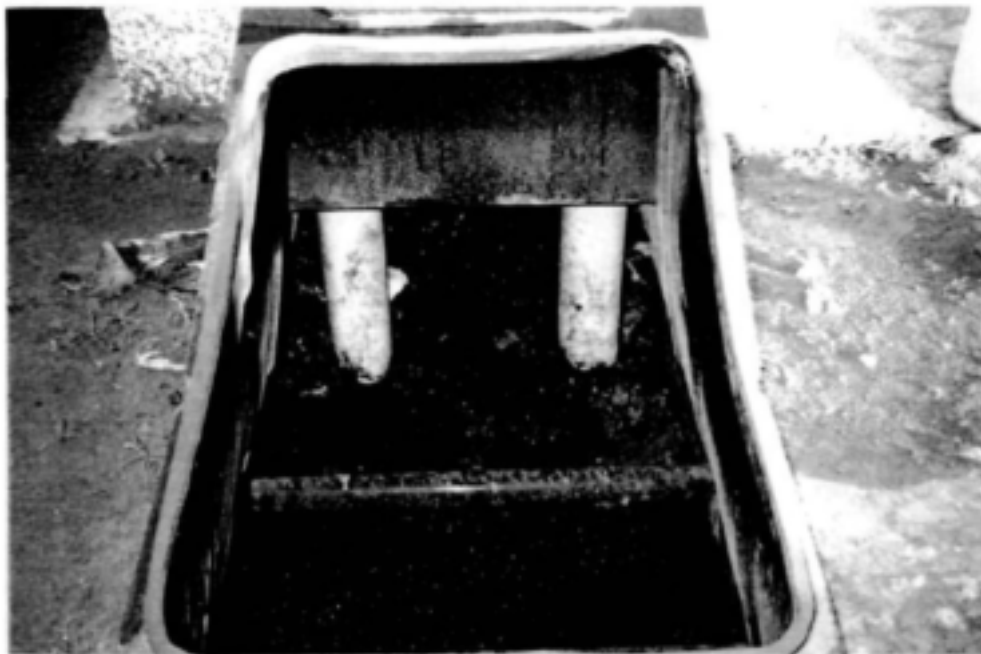
Photograph N : Flooded latrine container as a result of incorrect wastewater disposal

- The presence of excessive quantities of water in the toilet containers of up to 10 (one third) of the Enviro Loo latrines during the course of the 12 month trial period stressed the **importance of both user education and stormwater control**. The amount of water found in the containers varied and in five instances, the volume of water was substantial. In the case of these latter latrines, restoration of the proper functioning of the toilets required the pumping out of the water either by the GJMC or Enviro Options. Investigations into these occurrences revealed that washing up or bath water ("grey water") was disposed of into the latrine either by household members who did not understand the education received in this regard, or, as
