Sanitation

The crusade for sufficient school sanitation

A current Water Research Commission (WRC) study is exploring the status of sanitation in rural schools, and reviews best practice for infrastructure design.

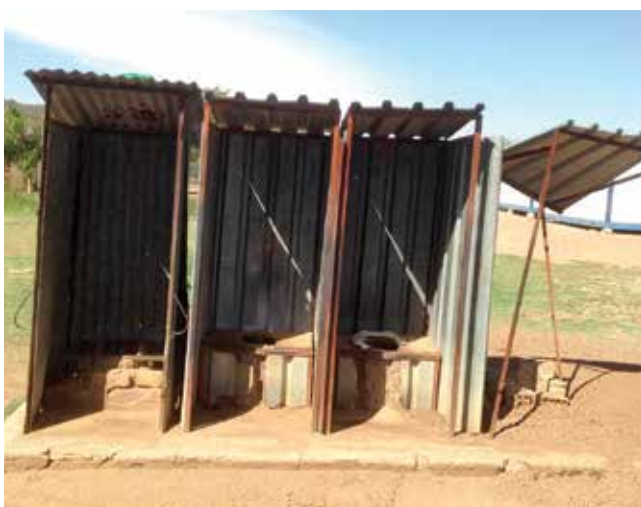
Toilets with missing doors offer learners no privacy when using the toilet.

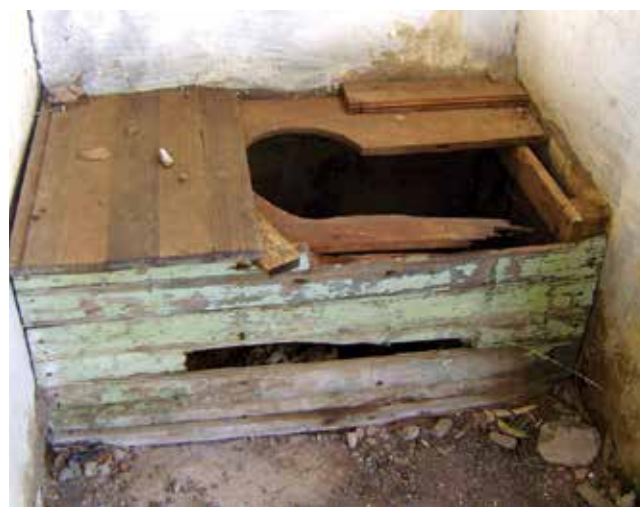
Broken pedestals over pit toilets cause dangerous conditions for learners, especially those in primary school.

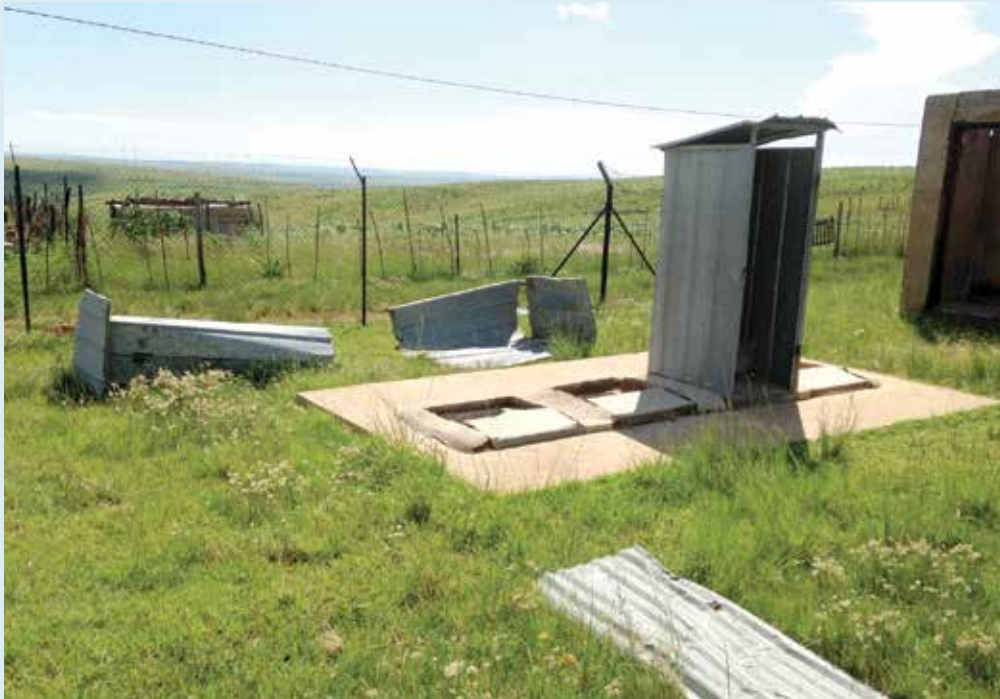
Adequate construction and maintenance of toilet facilities is a significant issue at many schools.

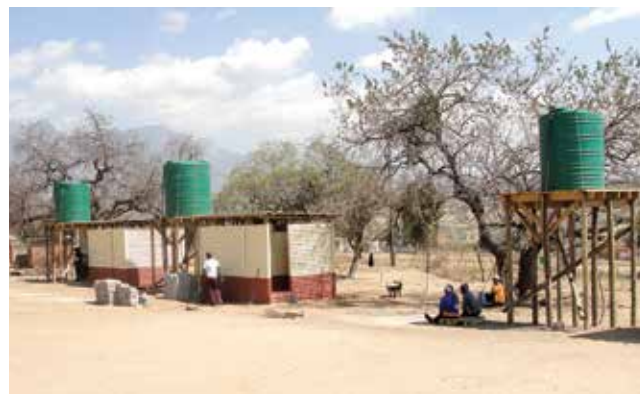
The WRC is funding a project to construct pour flush toilets at six Limpopo primary and secondary schools. The toilets are housed in timber frame units, with the timber coming from removed alien invasive vegetation.

Pour-flush or low-flush toilets potentially offer the best of both worlds, bridging the gap between the convenience of flush systems and the sustainability of VIP systems. With a pour-flush toilet, one to three litres of water is poured into the bowl to flush the toilet, pushing the excreta through the water-seal

and into the collection chamber. With a low-flush toilet, a cistern dispenses three litres of water around the pan with each flush. Both types cost significantly less than a full-flush toilet, although about 20% more than a VIP, and greywater can be used for flushing.

With WRC funding, Partners in Development developed a pour-flush prototype in 2010, which was modified into a low-flush system in 2013. Both types terminate in a simple soakaway or leach pit, which is relatively small compared to a septic tank. Ideally, twin pits should be installed, so that when one becomes full the other can be used instead. The full pit is allowed to dry out for two to four years and then emptied, ready to be used again once the operational pit reaches its capacity.
