# Performance Assessment Systems

For Urban Water Supply and Sanitation in India

Sanitation Assessment in *Sinnar*, Maharashtra

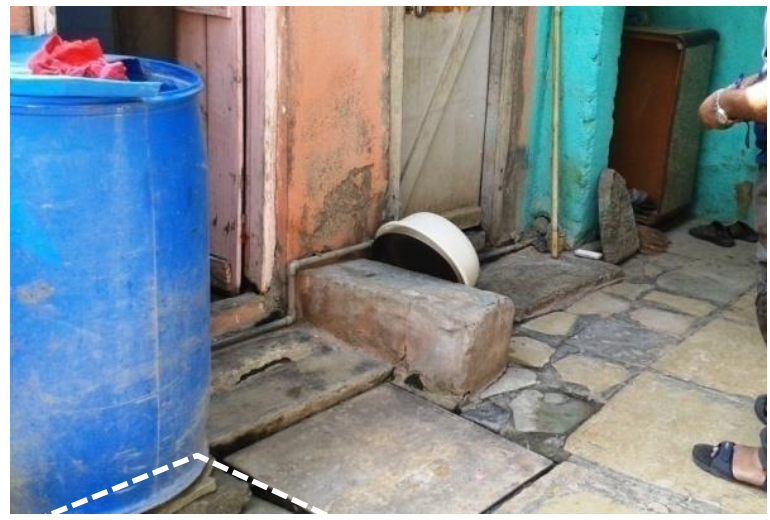
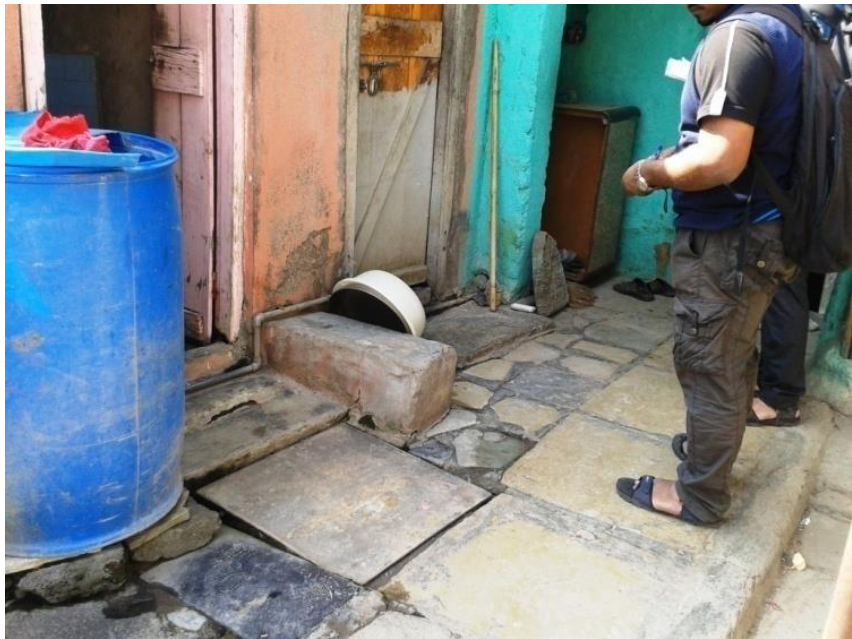
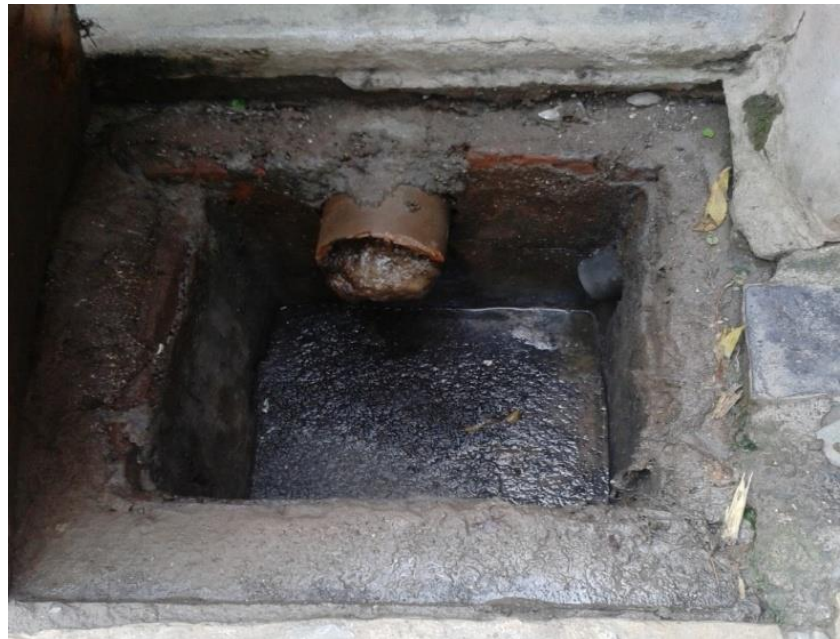
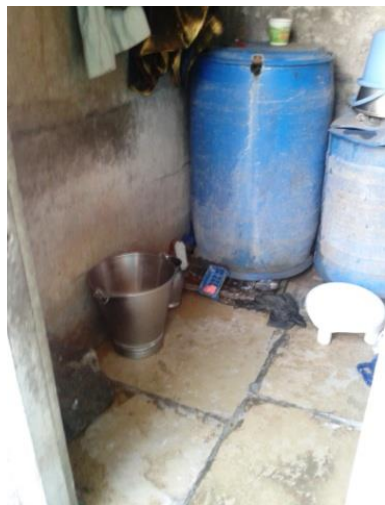
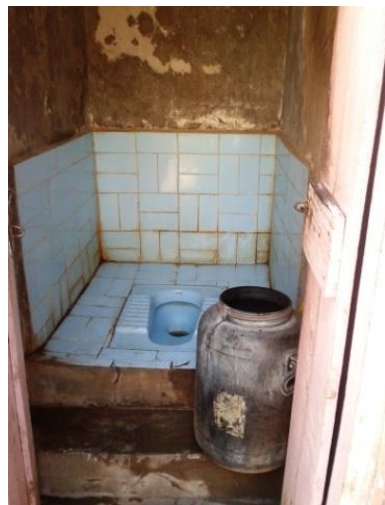
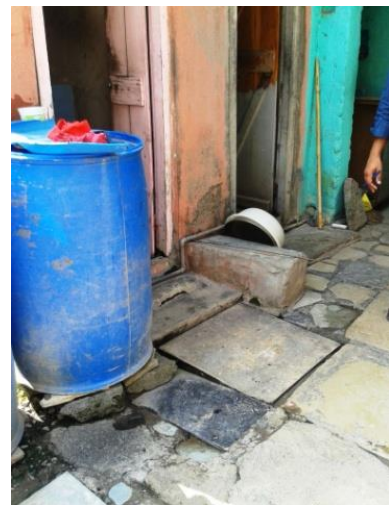
# CASE 1: CHOUDA CHOWK

Length (m)	Breadth (m)	Height (m) (300mm free board has been considered)		Volume of the tank (Cum)
			(Cleaning interval - 2 year)	(Cleaning interval - 3 year)	
<b>Recommended Size of the Septic tank (5 Users) (CPHEEO)</b>	1.5	0.75	1.3	1.35	<b>1.46</b> (Two year Cleaning Interval) <b>1.52</b> (Three year cleaning interval)

Sr No	Location, Area	Waste water	Parameters										
			BOD (mg/l)			COD (mg/l)			pH		TSS (mg/l)		
			Inlet	Outlet	% Reduction	Inlet	Outlet	% Reduction	Inlet	Outlet	Inlet	Outlet	% Reduction
1	Chouda Chowk	Black Water	--	189	--	--	507	--	--	6.23	--	392	--

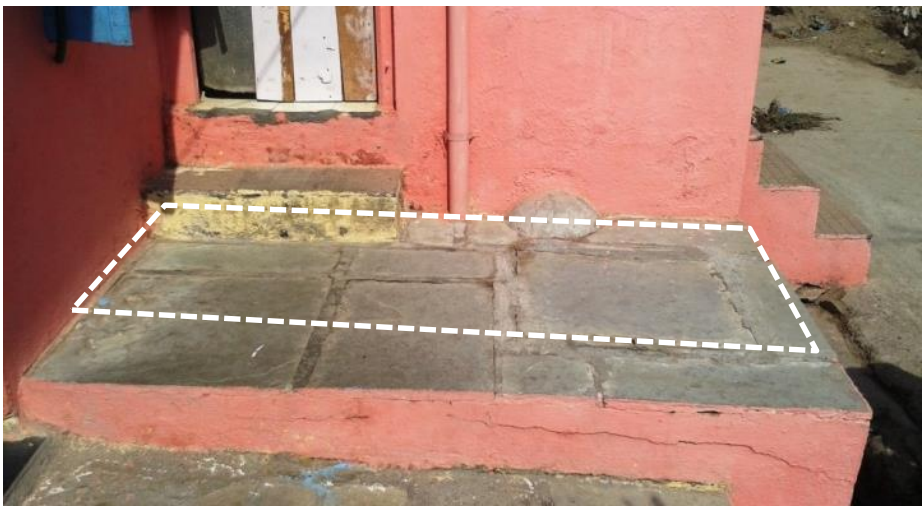
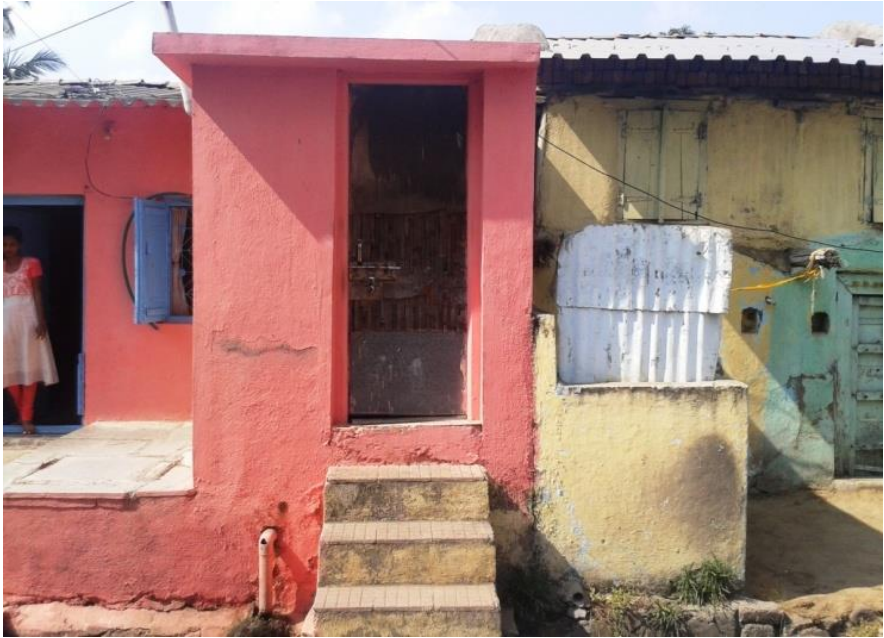
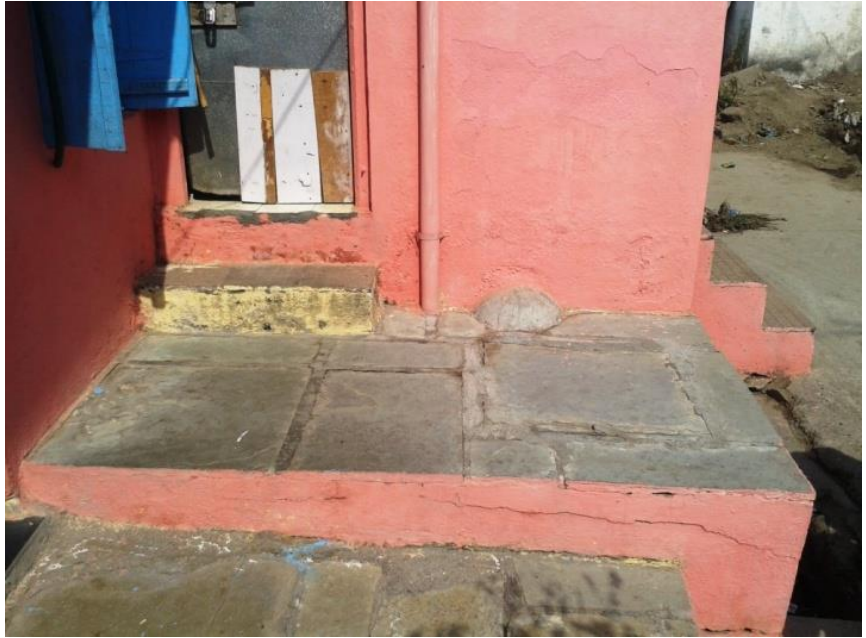
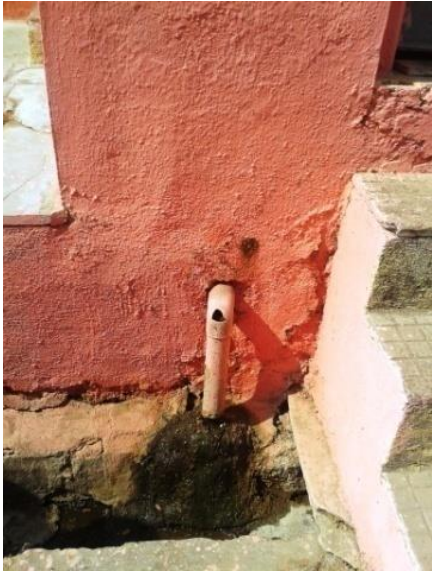
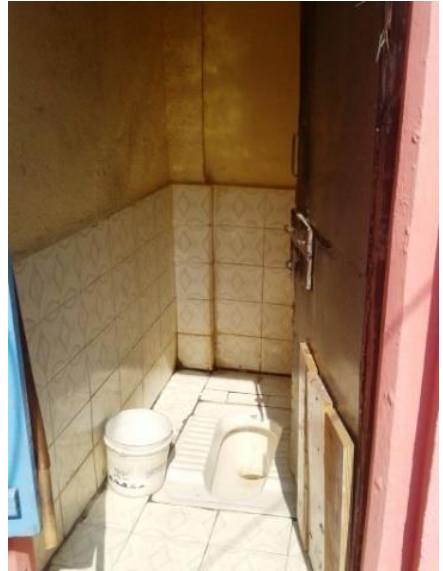
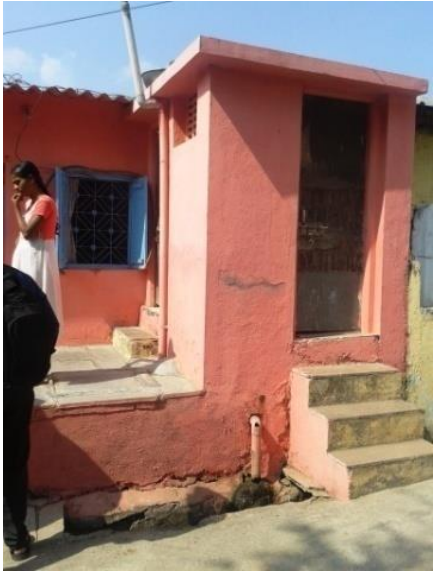
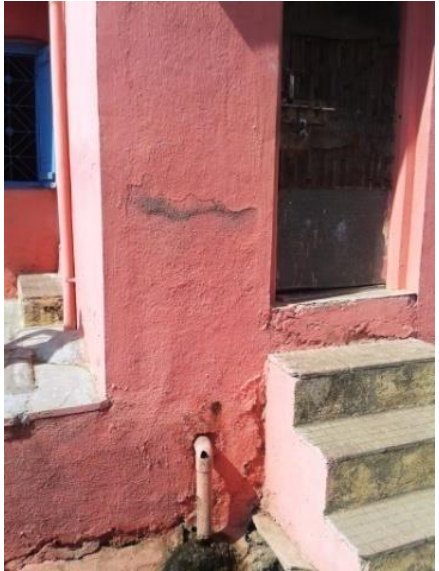
# CASE 2: KALPATARU HOSPITAL

<b>Pawandas Laxman Pardeshi</b>													
<u>Users</u> <b>9</b>	<u>Building type</u> <b>Ground floor</b>	<u>Inputs to septic tank</u> <b>Black water</b>	<u>Cleaning frequency of the tank</u> <b>Nil</b>	<u>When was septic tank last emptied?</u> <b>Not Yet Cleaned (Since construction year 2003)</b>	<u>How toilet is cleaned?</u> <b>Daily(Water) &amp; Weekly (Harpic/ detergent)</b>								
		<b>Length (m)</b>	<b>Breadth (m)</b>	<b>Height (m)</b> (300mm free board has been considered)		<b>Volume of the tank (Cum)</b>							
				(Cleaning interval - 2 year)	(Cleaning interval - 3 year)								
<b>Recommended Size of the Septic tank (10 Users) (CPHEEO)</b>		2	0.9	1.3	1.70	<b>2.34</b> (Two year Cleaning Interval) <b>3.06</b> (Three year cleaning interval)							
		<b>L</b>	<b>B</b>	<b>Height (m)</b>		<b>Volume of the tank (Cum)</b>							
<b>Actual Size of the tank (9 Users)</b>		1.65	1.5	1.05		<b>2.60</b>

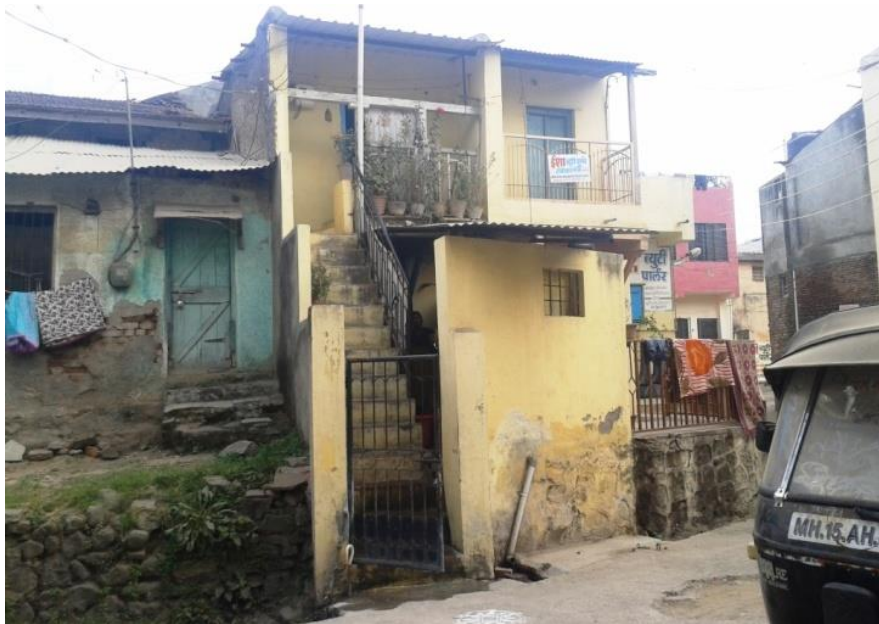
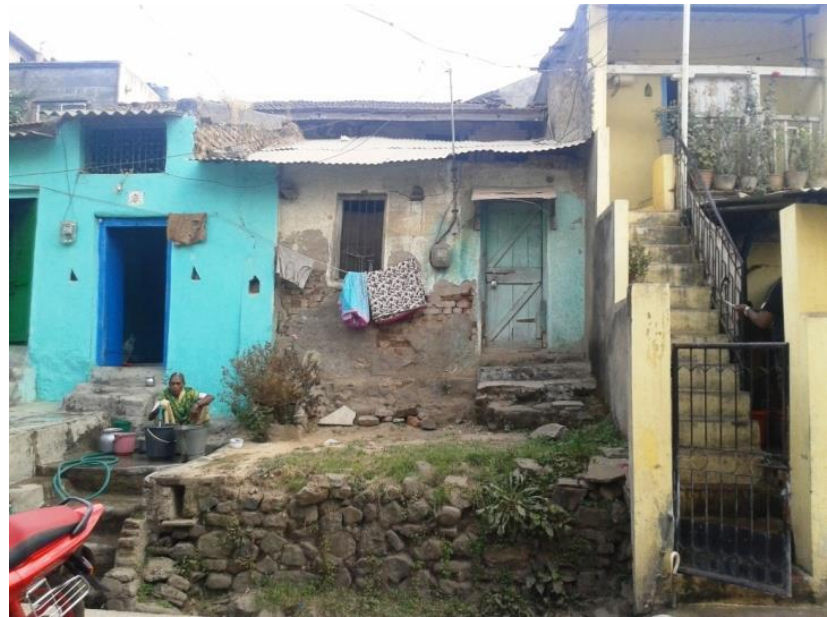
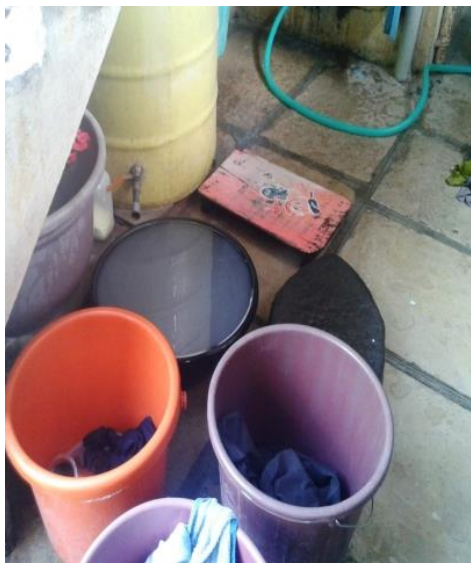
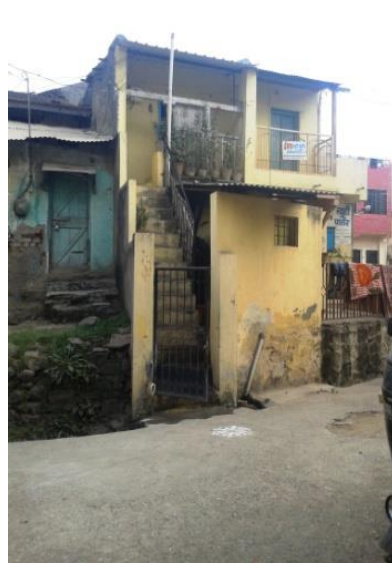
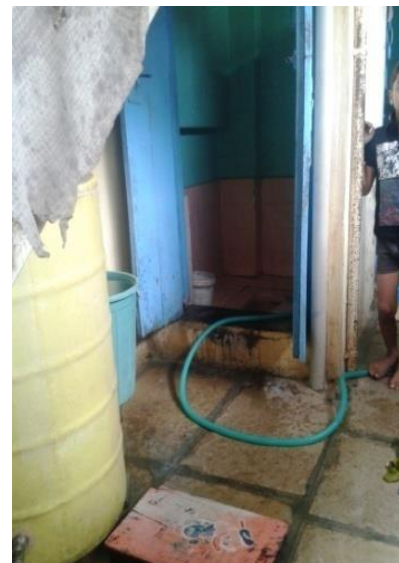
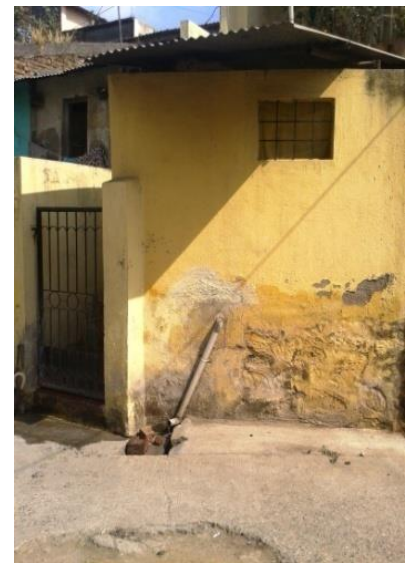
# CASE 3: NASHIK VES

<b>Gajewar Suresh Laxman</b>												
<u>Users</u> <b>8</b>	<u>Building type</u> <b>G+1</b>	<u>Inputs to septic tank</u> <b>Black water</b>	<u>Cleaning frequency of the tank</u> <b>Nil</b>			<u>When was septic tank last emptied?</u> <b>Not Yet Cleaned (Since construction year 1998)</b>			<u>How toilet is cleaned?</u> <b>Daily(Water) &amp; Weekly (Harpic/ detergent)</b>			
		<b>Length (m)</b>	<b>Breadth (m)</b>	<b>Height (m)</b> (300mm free board has been considered)				<b>Volume of the tank (Cum)</b>				
		(Cleaning interval - 2 year)		(Cleaning interval - 3 year)								
<b>Recommended Size of the Septic tank (10 Users) (CPHEEO)</b>		2	0.9	1.3		1.7		<b>2.34</b> (Two year Cleaning Interval) <b>3.06</b> (Three year cleaning interval)				
		<b>L</b>	<b>B</b>	<b>Height (m)</b>				<b>Volume of the tank (Cum)</b>				
<b>Actual Size of the tank (8 Users)</b>		2.85	1.8	1.8				<b>9.23</b>				
<b>Observations</b>							<b>Oversized (202% Extra)</b>

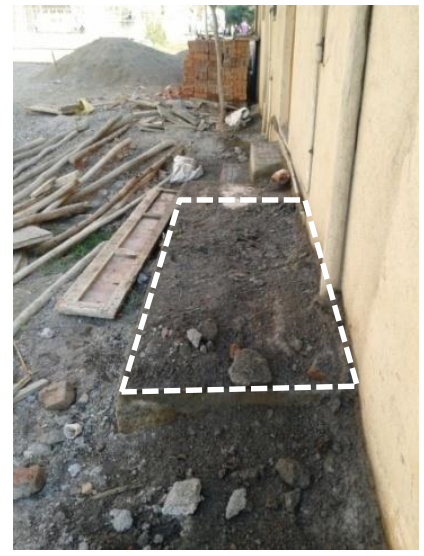
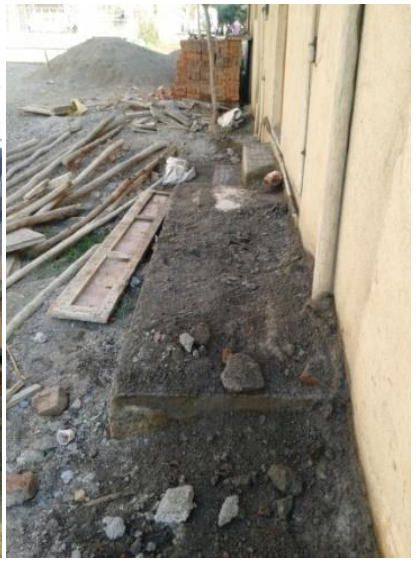
# CASE 5: DHOKE NAGAR

Anant Unde													
<u>Users</u> <b>5</b>	<u>Building type</u> <b>G + 1</b>	<u>Inputs to septic tank</u> <b>Black water</b>	<u>Cleaning frequency of the tank</u> <b>Nil</b>	<u>When was septic tank last emptied?</u> <b>Not yet cleaned (Since construction year 2006)</b>	<u>How toilet is cleaned?</u> <b>Daily by use of Water (only)</b>								
		<b>Length (m)</b>	<b>Breadth (m)</b>	<b>Height (m) (300mm free board has been considered)</b>		<b>Volume of the tank (Cum)</b>							
				(Cleaning interval - 2 year)	(Cleaning interval - 3 year)								
<b>Recommended Size of the Septic tank (5 Users) (CPHEEO)</b>		1.5	0.75	1.3	1.35	<b>1.46 (Two year Cleaning Interval)</b> <b>1.52 (Three year cleaning interval)</b>							
		<b>L</b>	<b>B</b>	<b>Height (m)</b>		<b>Volume of the tank (Cum)</b>							
<b>Actual Size of the tank (5 Users)</b>		2.55	0.5	1.8		<b>2.30</b>							
<b>Observations</b>											<b>Oversized (51% extra)</b>

WATER QUALITY													
Sr No	Location, Area	Waste water	Parameters										
			BOD (mg/l)			COD (mg/l)			pH		TSS (mg/l)		
			Inlet	Outlet	% Reduction	Inlet	Outlet	% Reduction	Inlet	Outlet	Inlet	Outlet	% Reduction
1	Dhoke Nagar	Black Water	200	176	12	700	562	19.71	6.53	7.65	500	135	73

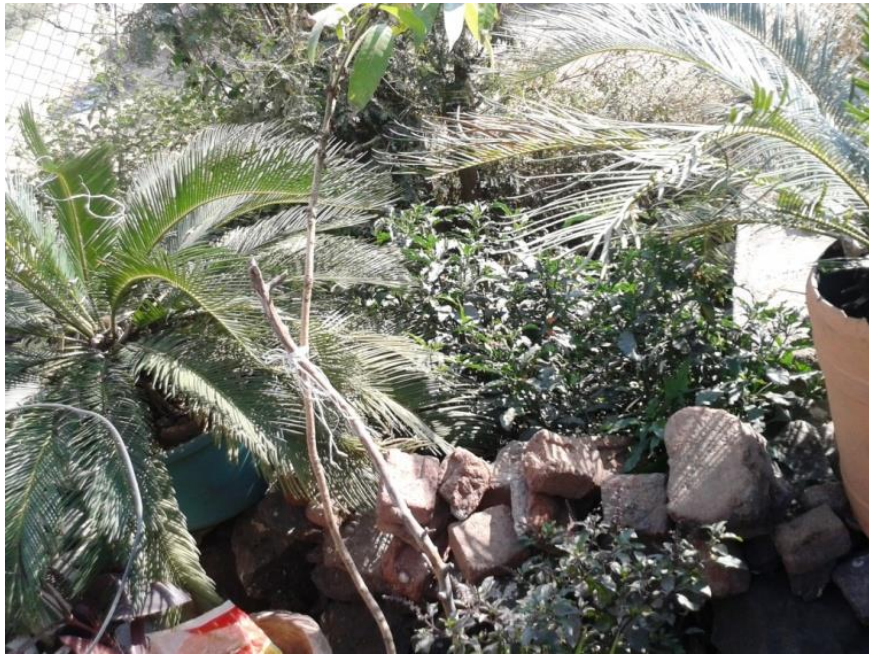
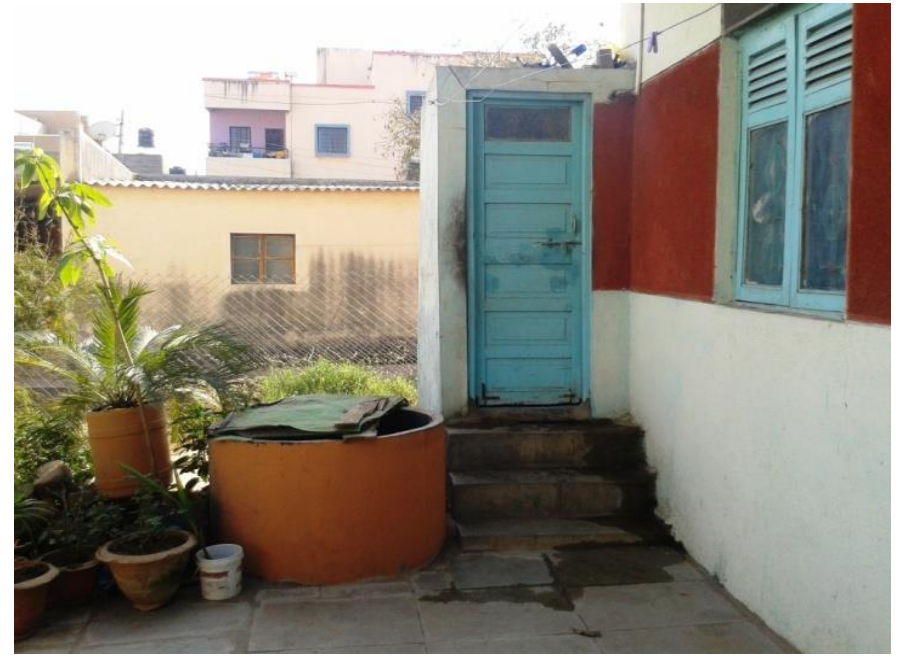
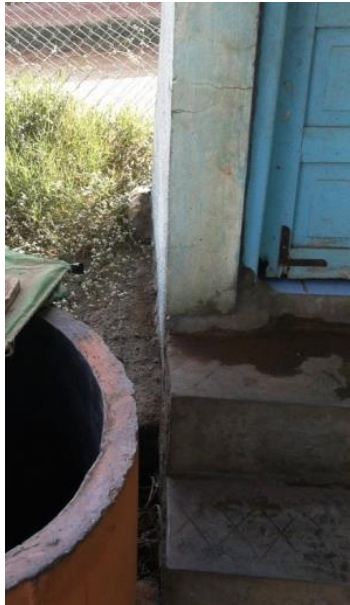
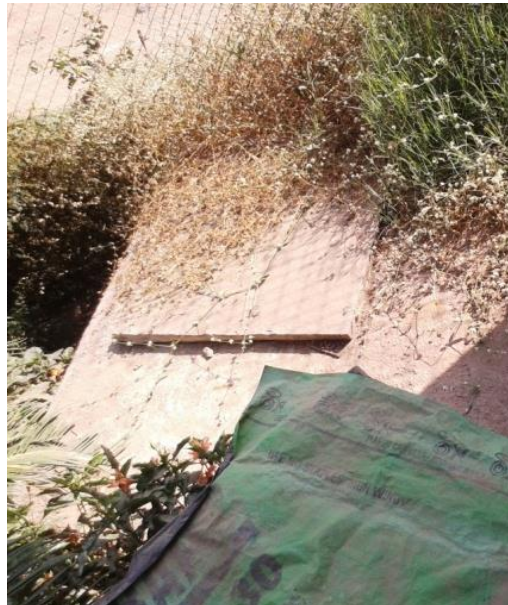
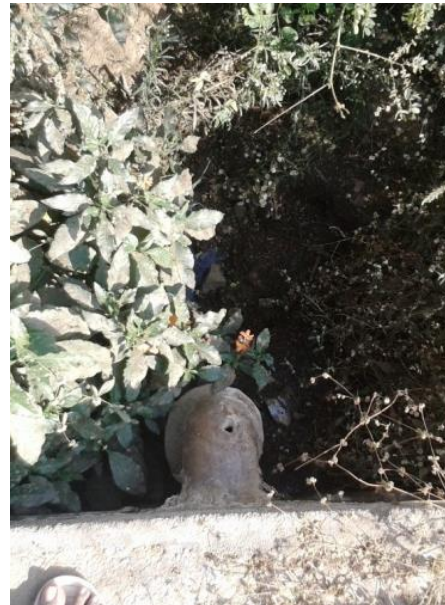
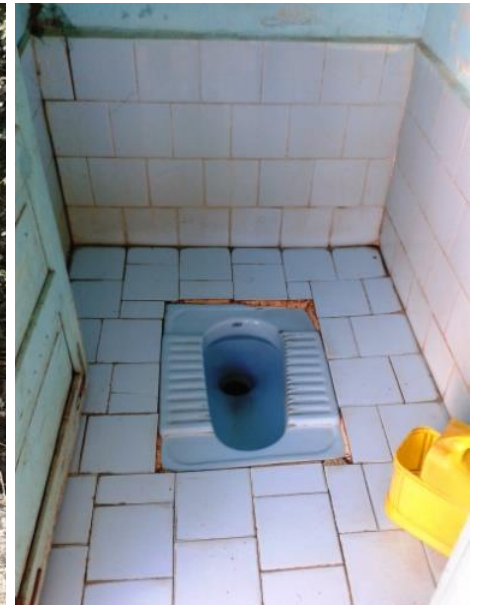
# CASE 6: KAMAL NAGAR, BEHIND GMG COLLEGE

Ramkisan Gade												
<u>Users</u> <b>7</b>	<u>Building type</u> <b>Ground Floor</b>	<u>Inputs to septic tank</u> <b>Black water</b>	<u>Cleaning frequency of the tank</u> <b>Two times</b>	<u>When was septic tank last emptied?</u> <b>Last year-Feb or March 2013</b>	<u>How toilet is cleaned?</u> <b>Daily (Water) &amp; Weekly (Harpic/ detergent)</b>							
	<b>Length (m)</b>	<b>Breadth (m)</b>	<b>Height (m) (300mm free board has been considered)</b>		<b>Volume of the tank (Cum)</b>							
			(Cleaning interval - 2 year)	(Cleaning interval - 3 year)								
<b>Recommended Size of the Septic tank (10 Users) (CPHEEO)</b>	2	0.9	1.3	1.7	<b>2.34 (Two year Cleaning Interval)</b> <b>3.06 (Three year cleaning interval)</b>							
	<b>L</b>	<b>B</b>	<b>Height (m)</b>		<b>Volume of the tank (Cum)</b>							
<b>Actual Size of the tank (7 Users)</b>	1.5	0.9	0.9		<b>1.22</b>							
<b>Observations</b>										<b>Undersized (60% smaller)</b>

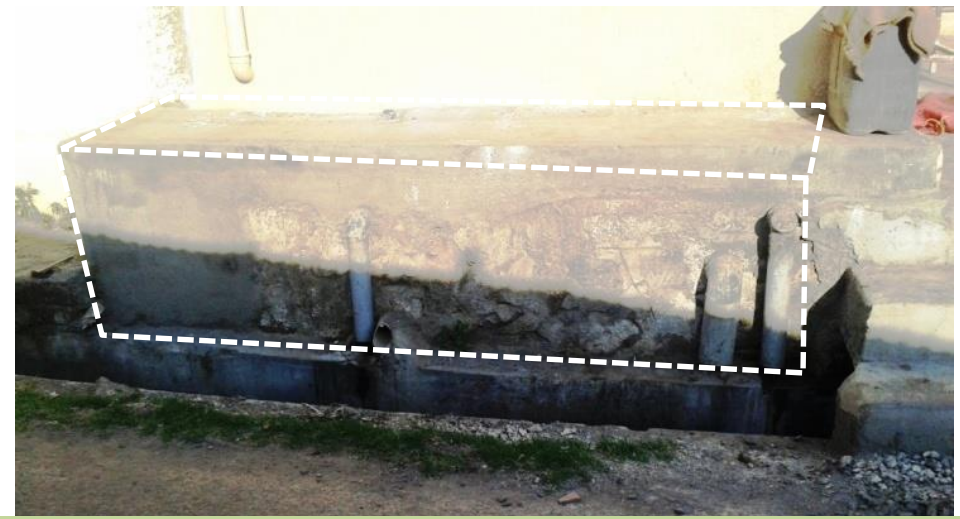
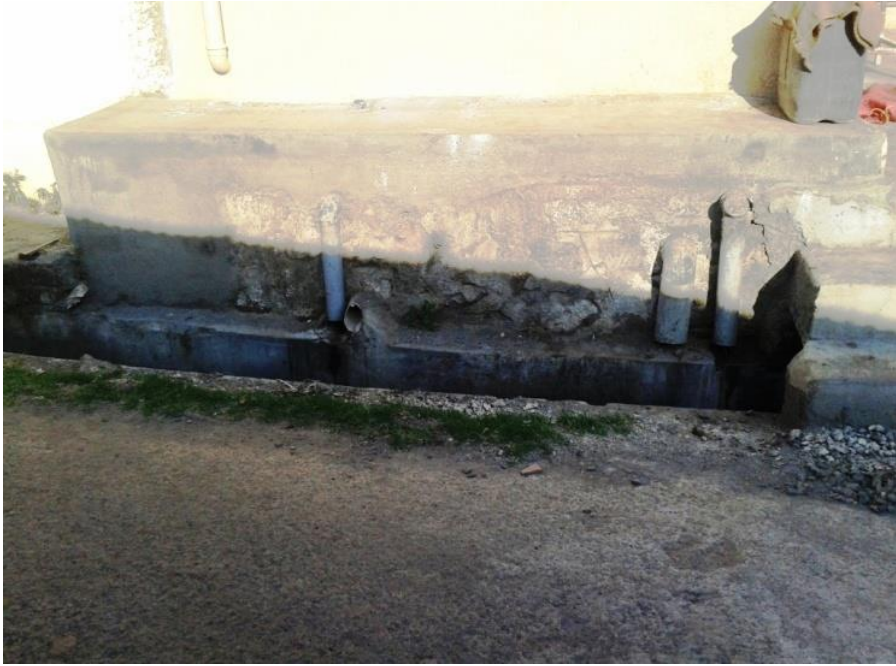
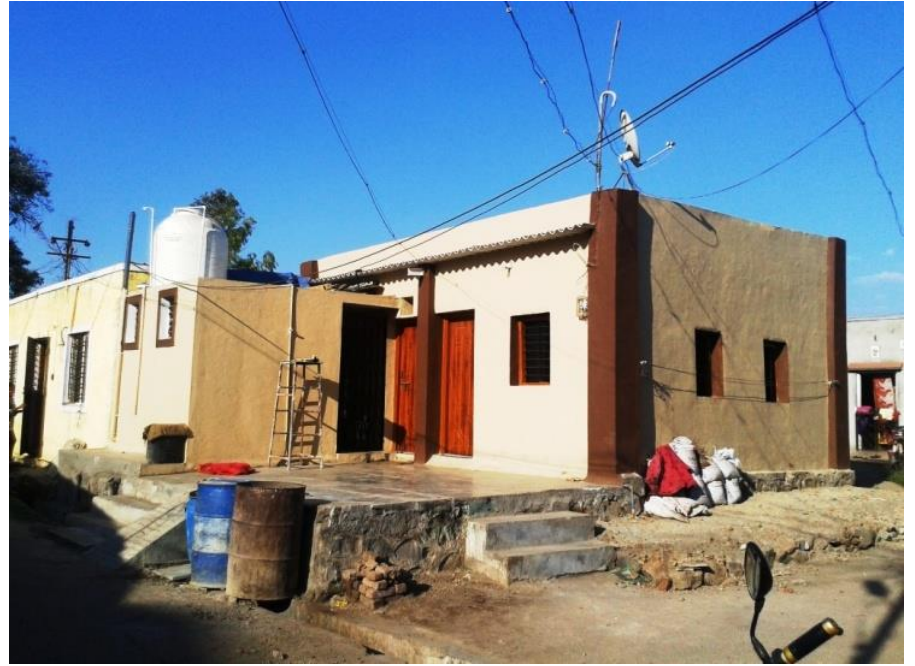
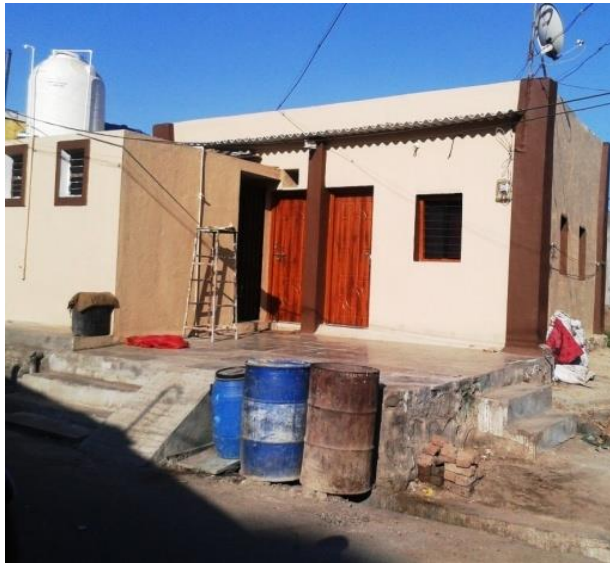
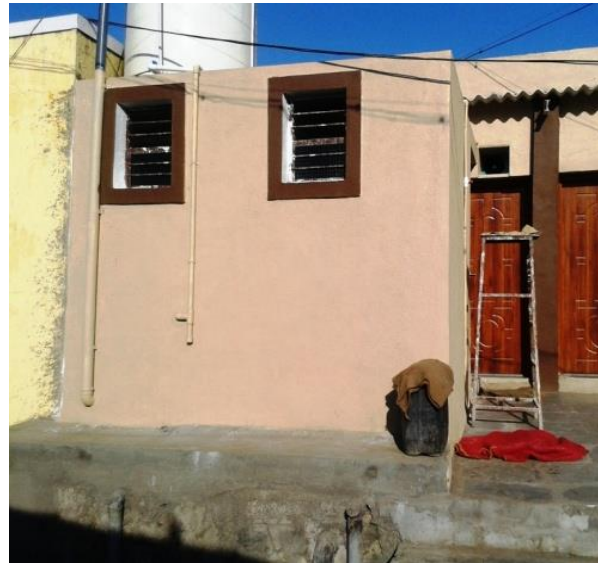
# CASE 7: TELI GALLI VAYUVESH, POST OFFICE ROAD

Length (m)	Breadth (m)	Height (m) (300mm free board has been considered)		Volume of the tank (Cum)
			(Cleaning interval - 2 year)	(Cleaning interval - 3 year)	
<b>Recommended Size of the Septic tank (5 Users) (CPHEEO)</b>	1.5	0.75	1.3	1.35	<b>1.46</b> (Two year Cleaning Interval) <b>1.52</b> (Three year cleaning interval)

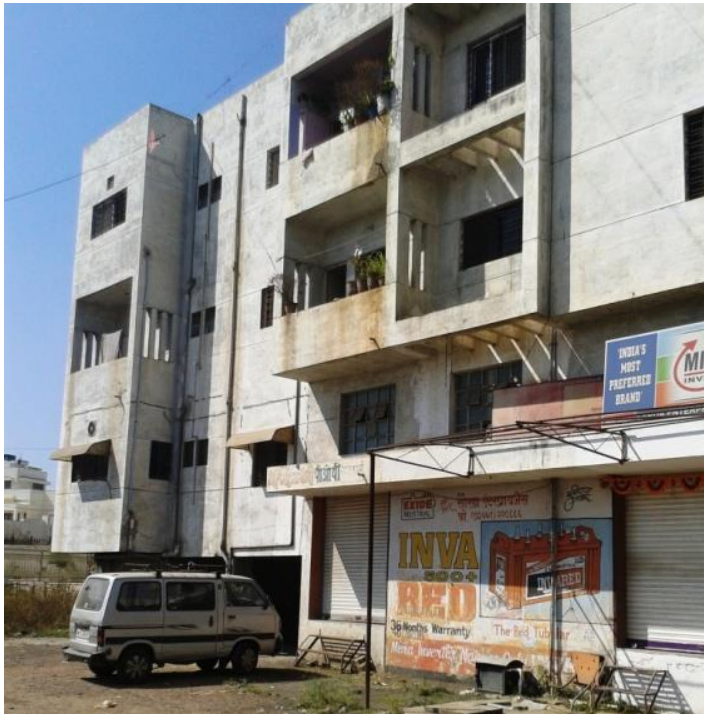
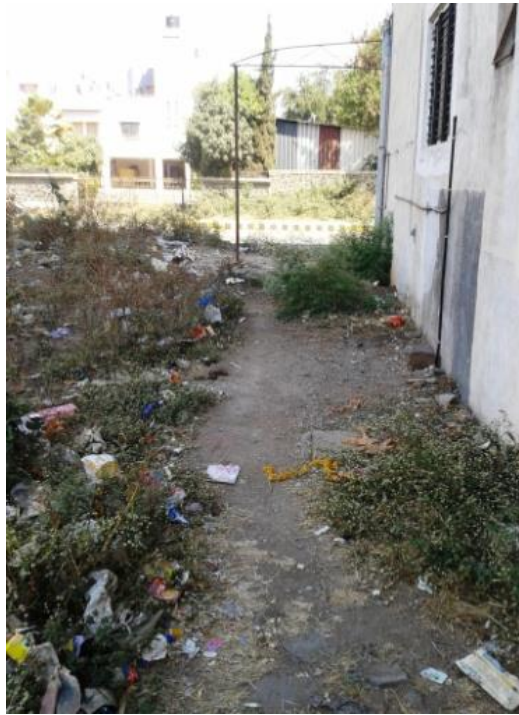
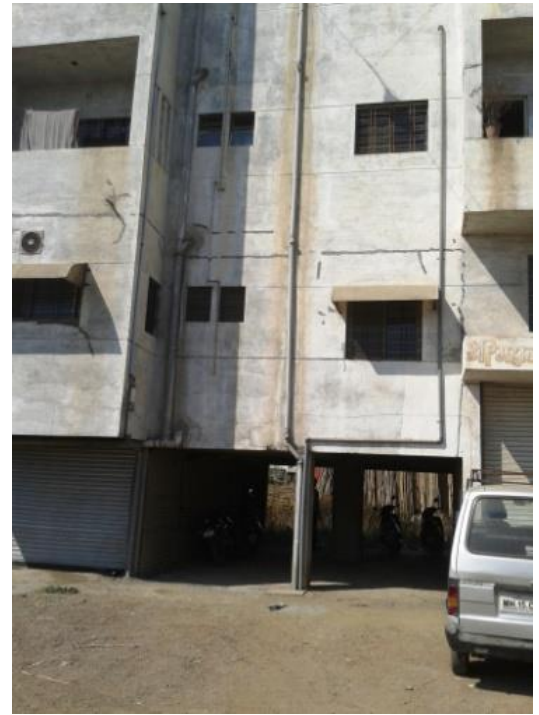
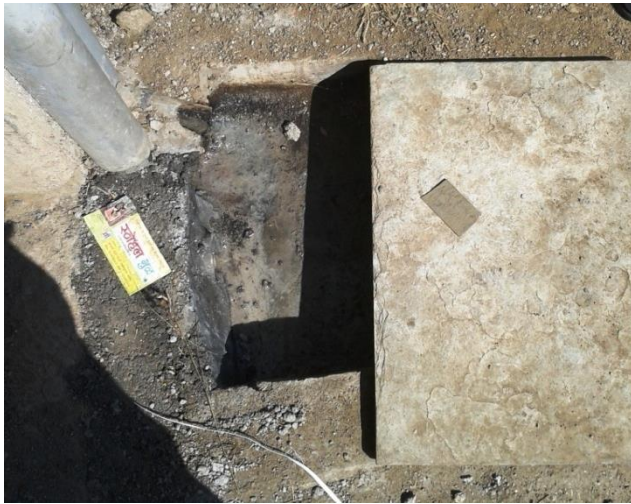
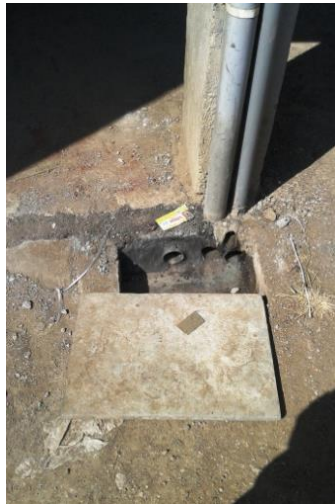
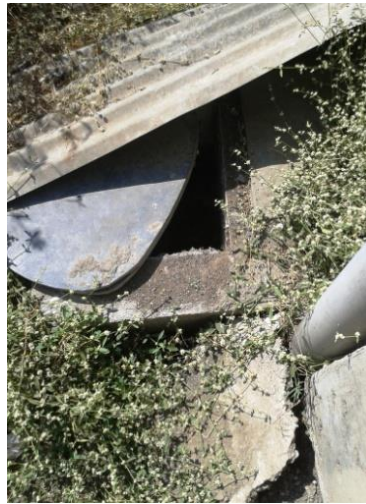
# CASE 11: DEVI ROAD, GANPATI SAW MILL

<b>Yashwant Uttamrao Deshmukh (Abhishek Apartments)</b>												
<u>Users</u> <b>34</b>	<u>Building type</u> <b>G+4</b>	<u>Inputs to septic tank</u> <b>Black + Gray water</b>			<u>Cleaning frequency of the tank</u> <b>Nil</b>			<u>When was septic tank last emptied?</u> <b>Not yet cleaned (Since construction year 2005)</b>		<u>How toilet is cleaned?</u> <b>Daily (Water) &amp; Monthly (Harpic/ detergent)</b>		
		<b>Length (m)</b>	<b>Breadth (m)</b>	<b>Height (m)</b> (300mm free board has been considered)				<b>Volume of the tank (Cum)</b>				
				(Cleaning interval - 2 year)		(Cleaning interval - 3 year)						
<b>Recommended Size of the Septic tank (50 Users) (CPHEEO)</b>		5	2	1.3		1.35		<b>13.00</b> (Two year Cleaning Interval) <b>15.40</b> (Three year cleaning interval)				
		<b>Length (m)</b>	<b>Breadth (m)</b>	<b>Height (m)</b>				<b>Volume of the tank (Cum)</b>				
<b>Actual Size of the tank (34 Users)</b>		4.35	1.8	1.5				<b>11.75</b>

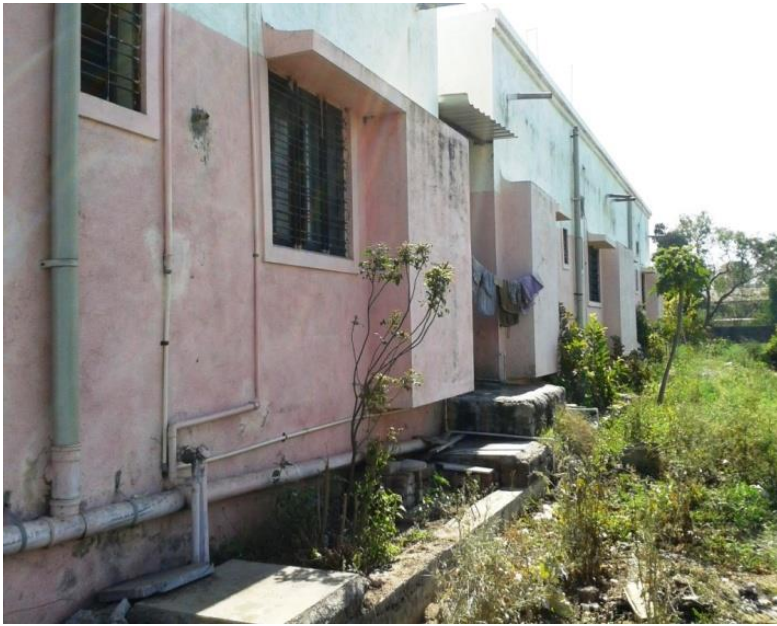
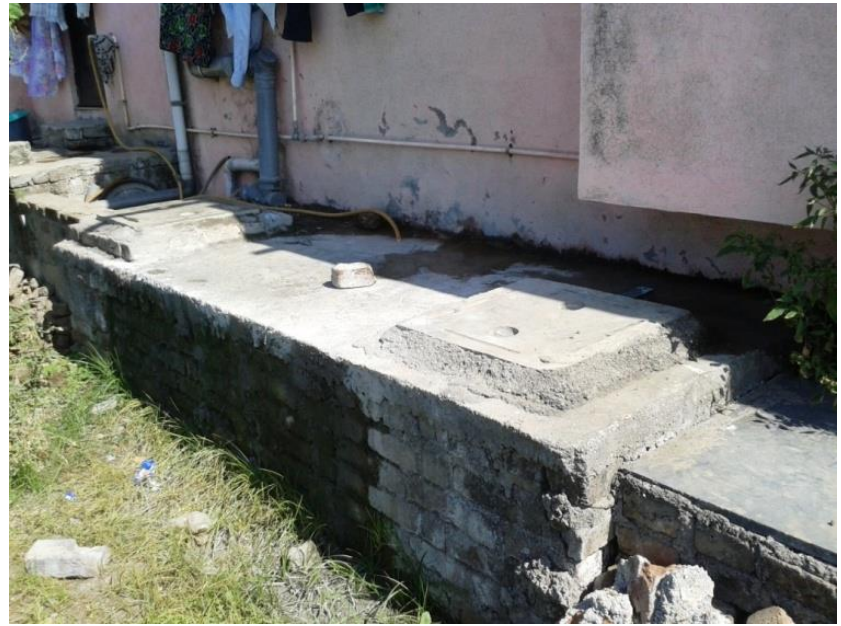
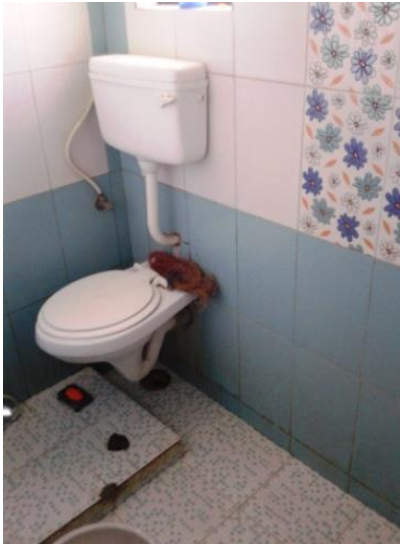
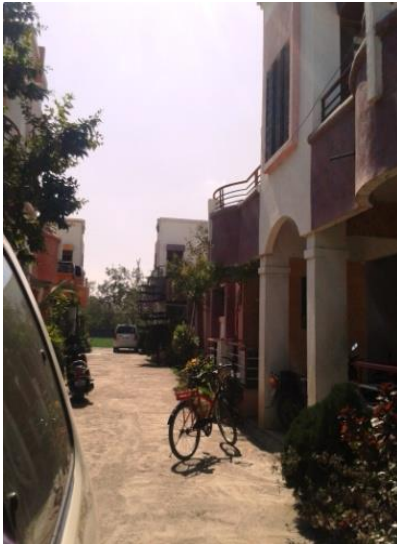
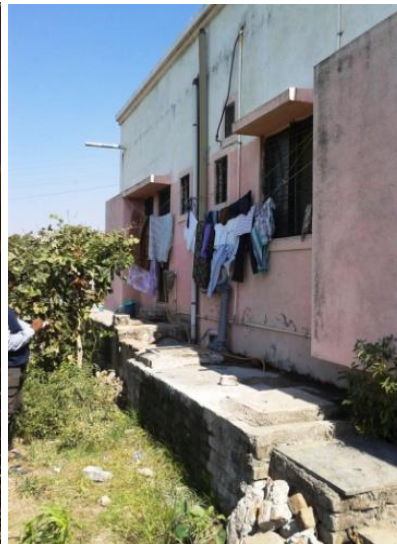
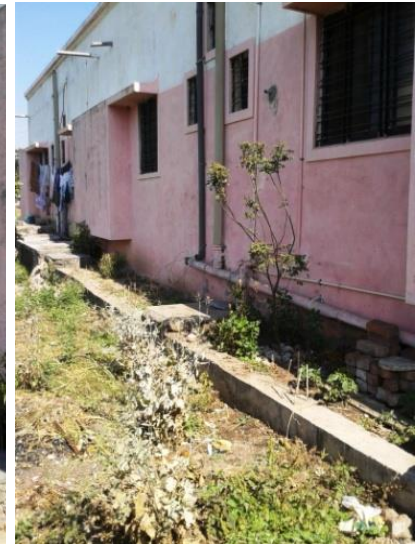
# CASE 12: TEACHERS COLONY, RAMNAGARI DEVI ROAD

<b>Sanjay Baloba Avhad</b>					
<u>Users</u> <b>5</b>	<u>Building type</u> <b>G + 1</b>	<u>Inputs to septic tank</u> <b>Black water</b>	<u>Cleaning frequency of the tank</u> <b>Once time</b>	<u>When was septic tank last emptied?</u> <b>A year ago (Nov or Dec 2012)</b>	<u>How toilet is cleaned?</u> <b>Daily (Water) &amp; Monthly (Harpic/ detergent)</b>

<b>Length (m)</b>	<b>Breadth (m)</b>	<b>Height (m)</b> (300mm free board has been considered)		<b>Volume of the tank (Cum)</b>
			(Cleaning interval - 2 year)	(Cleaning interval - 3 year)	
<b>Recommended Size of the Septic tank (5 Users) (CPHEEO)</b>	1.5	0.75	1.3	1.35	<b>1.46</b> (Two year Cleaning Interval) <b>1.52</b> (Three year cleaning interval)

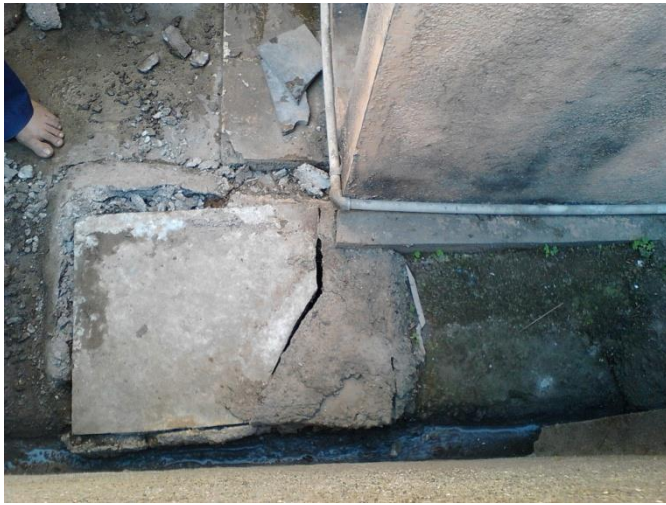
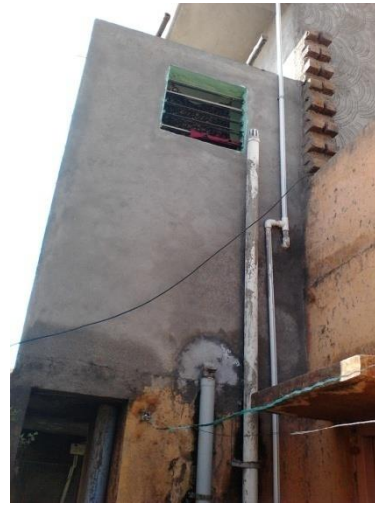
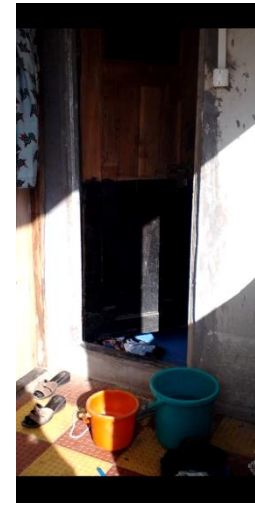
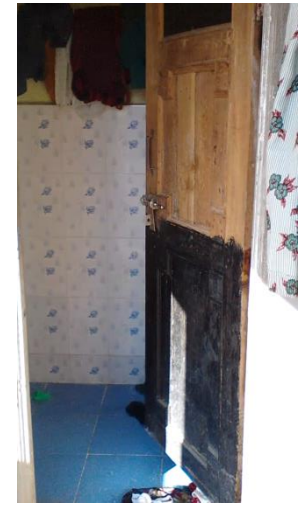
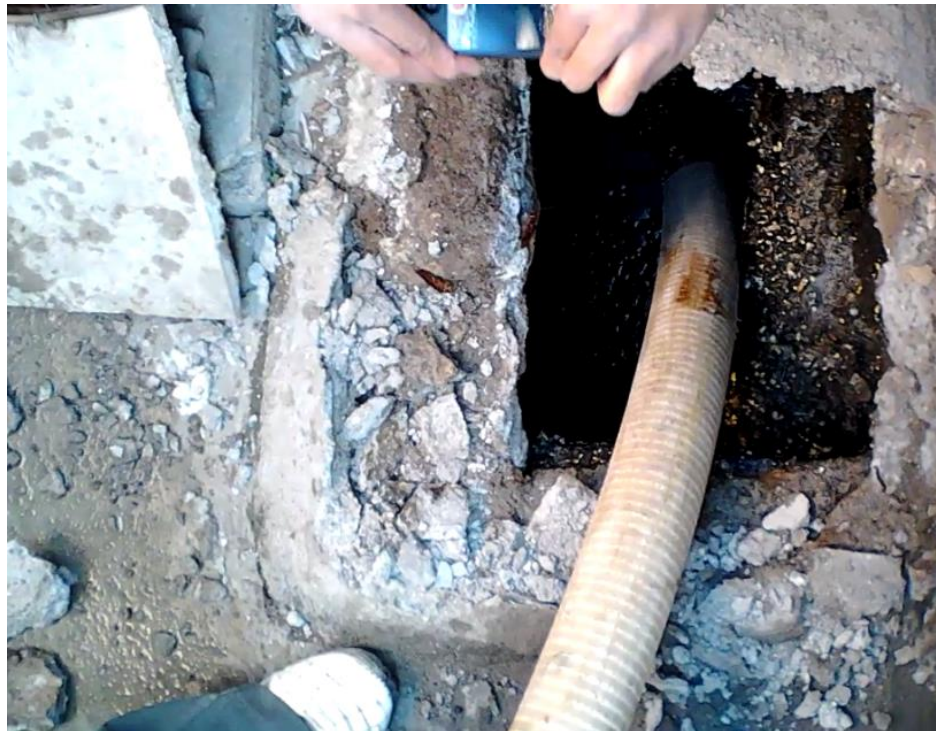
# CASE 13: SANJIVANI NAGAR, SHARADWADI ROAD

Ishwar Bhagwan Zalte												
Users	Building type	Inputs to septic tank	Cleaning frequency of the tank	When was septic tank last emptied?		How toilet is cleaned?						
4	G + 1	Black water	Once every year	March 2014		Daily (Water) & Monthly (Harpic/ detergent)						
Recommended Size of the Septic tank (5 Users) (CPHEEO)	Length (m)	Breadth (m)	Height (m) (300mm free board has been considered)		Volume of the tank (Cum)							
			(Cleaning interval - 2 year)	(Cleaning interval - 3 year)								
	1.5	0.75	1.3	1.35	1.46 (Two year Cleaning Interval) 1.52 (Three year cleaning interval)							
Actual Size of the tank (4 Users)	L	B	Height (m)		Volume of the tank (Cum)							
	3	1.2	1.2		4.32							
					Observations	Oversized (184% extra)

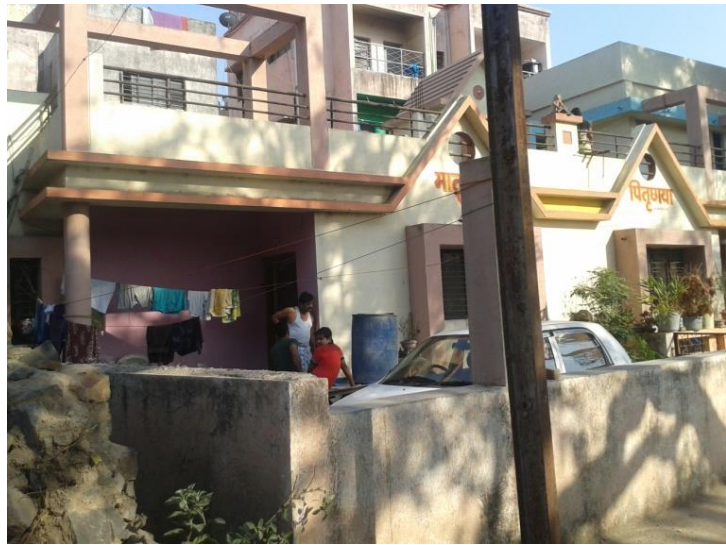
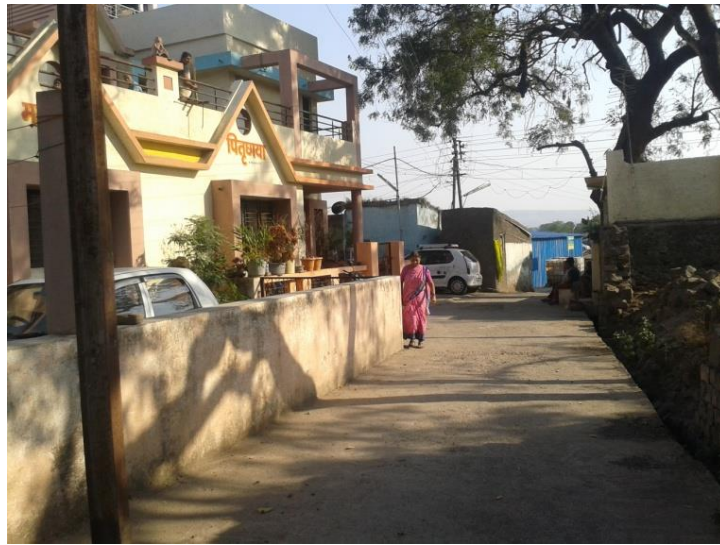
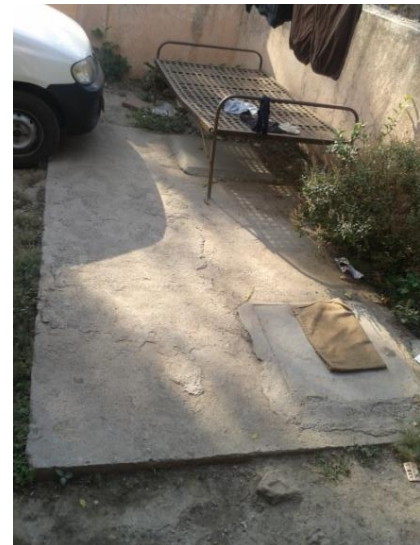
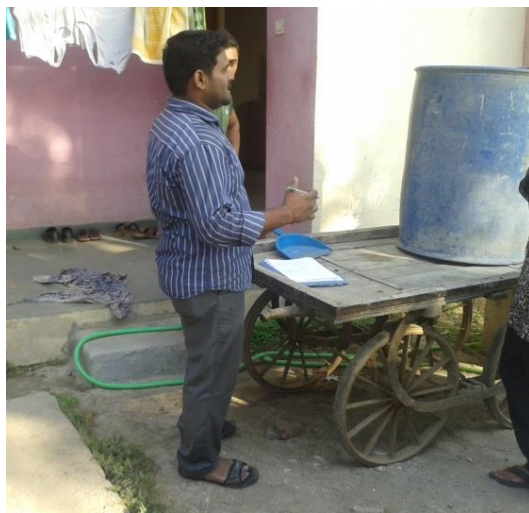
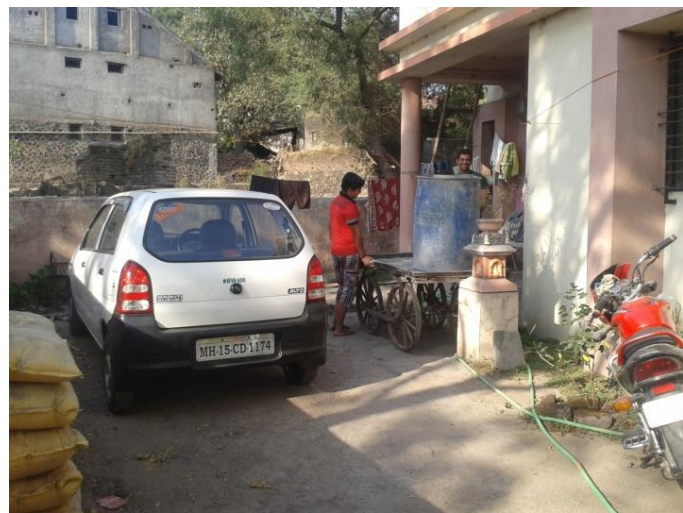
# CASE 15: BASE GALLI, TANAJI CHOLWK

<b>Pramod Narayan Lachke</b>													
<u>Users</u> <b>8</b>	<u>Building type</u> <b>Ground Floor</b>	<u>Inputs to septic tank</u> <b>Black+Grey Water</b>	<u>Cleaning frequency of the tank</u> <b>One time</b>			<u>When was septic tank last emptied?</u> <b>Last month (Feb 2014)</b>			<u>How toilet is cleaned?</u> <b>NA</b>				
			<b>Length (m)</b>	<b>Breadth (m)</b>	<b>Height (m)</b> (300mm free board has been considered)			<b>Volume of the tank (Cum)</b>					
					(Cleaning interval - 2 year)	(Cleaning interval - 3 year)							
<b>Recommended Size of the Septic tank (10 Users) (CPHEEO)</b>			2.0	0.9	1.3	1.7		<b>2.43</b> (Two year Cleaning Interval) <b>3.06</b> (Three year cleaning interval)					
			<b>L</b>	<b>B</b>	<b>Height (m)</b>			<b>Volume of the tank (Cum)</b>					
<b>Actual Size of the tank (8 Users)</b>			3.0	1.98	1.52			<b>9.04</b>					
								<b>Observations</b>	<b>Oversized (352% Extra)</b>

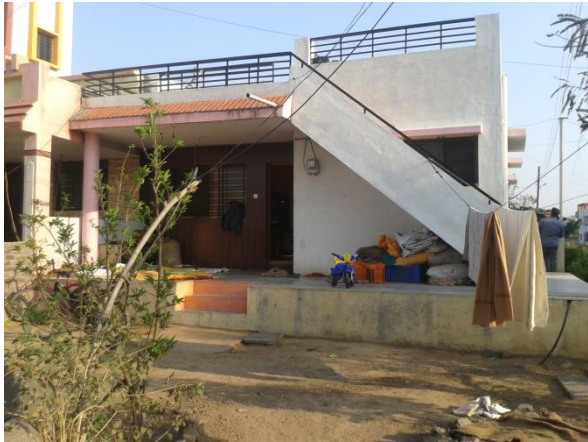
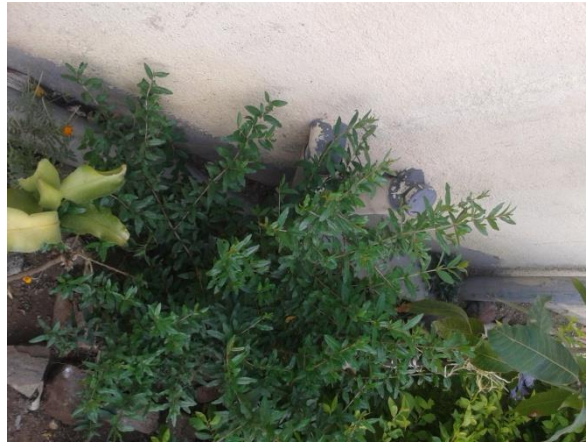
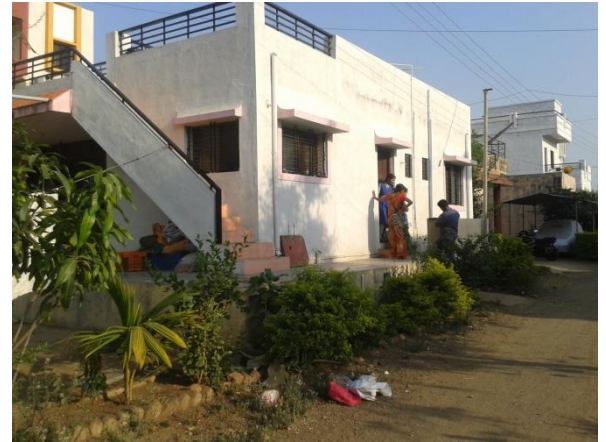
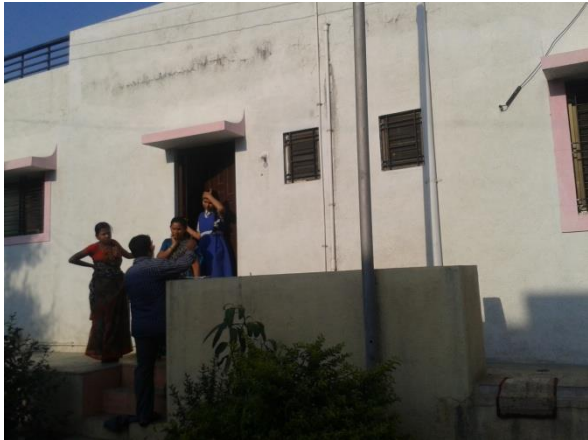
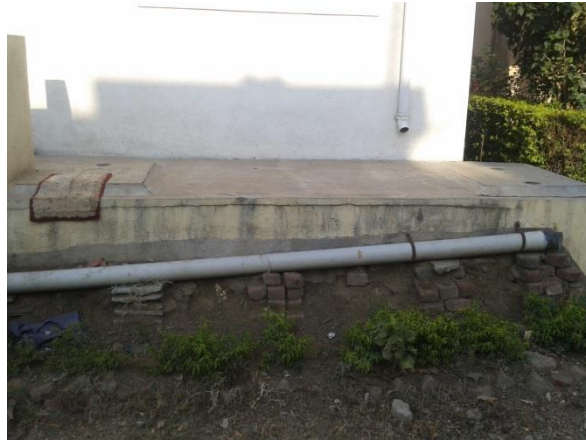
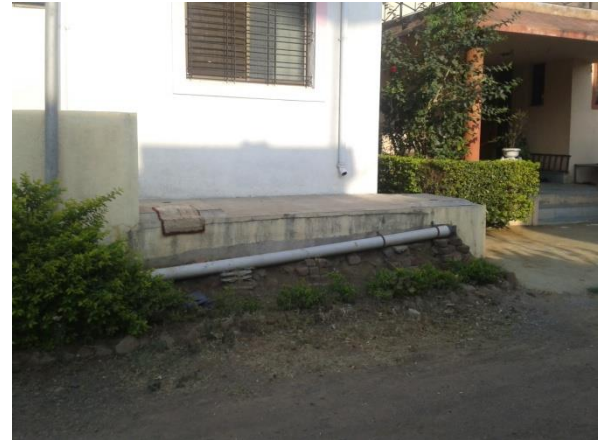
**CASE 16: SHREENAGAR, NAYGAON ROAD**

<b>Rajendra Pundlik Bhadange</b>					
<u>Users</u> <b>9</b>	<u>Building type</u> <b>Ground Floor</b>	<u>Inputs to septic tank</u> <b>Black Water</b>	<u>Cleaning frequency of the tank</u> <b>Nil</b>	<u>When was septic tank last emptied?</u> <b>Not yet cleaned (Since construction year 2011)</b>	<u>How toilet is cleaned?</u> <b>Daily (Water) &amp; Weekly (Harpic)</b>

Length (m)	Breadth (m)	Height (m) (300mm free board has been considered)		Volume of the tank (Cum)
			(Cleaning interval - 2 year)	(Cleaning interval - 3 year)	
<b>Recommended Size of the Septic tank (10 Users) (CPHEEO)</b>	2.0	0.9	1.3	1.7	<b>2.34</b> (Two year Cleaning Interval) <b>2.57</b> (Three year cleaning interval)
	<b>L</b>	<b>B</b>	<b>Height (m)</b>		<b>Volume of the tank (Cum)</b>
<b>Actual Size of the tank (9 Users)</b>	3.91	1.06	1.52		<b>6.05</b>
<b>Observations</b>					<b>Oversized (135% Extra)</b>
