# Performance Assessment Systems

For Urban Water Supply and Sanitation in India

Sanitation Assessment in *Sinnar*, Maharashtra

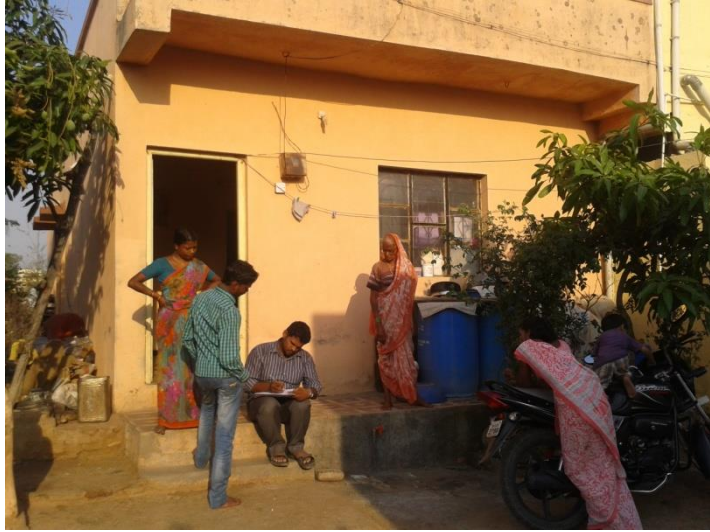
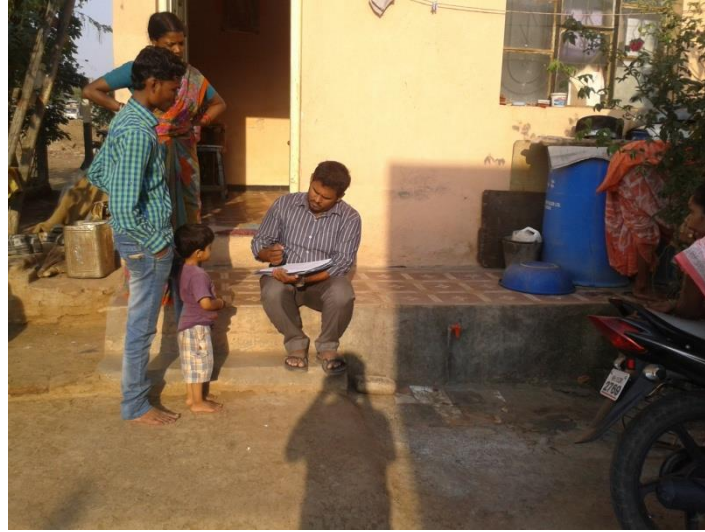
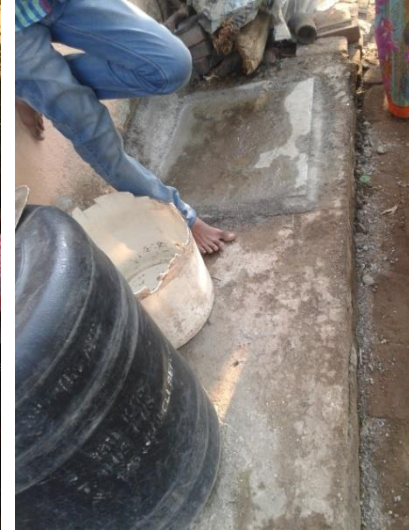
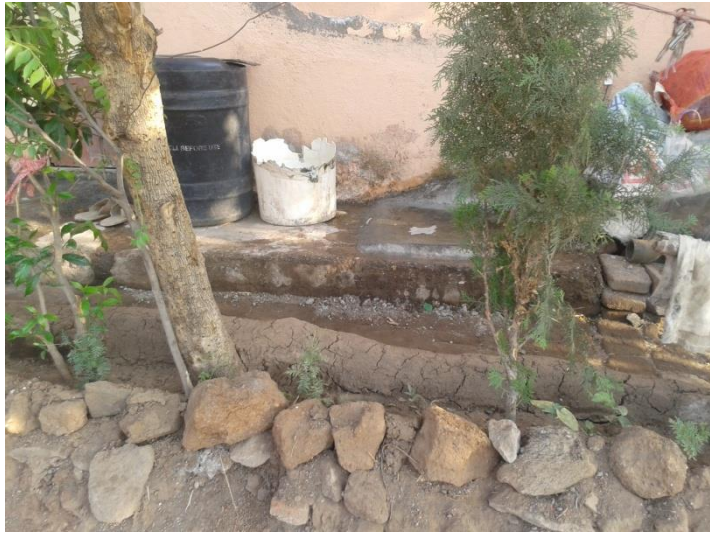
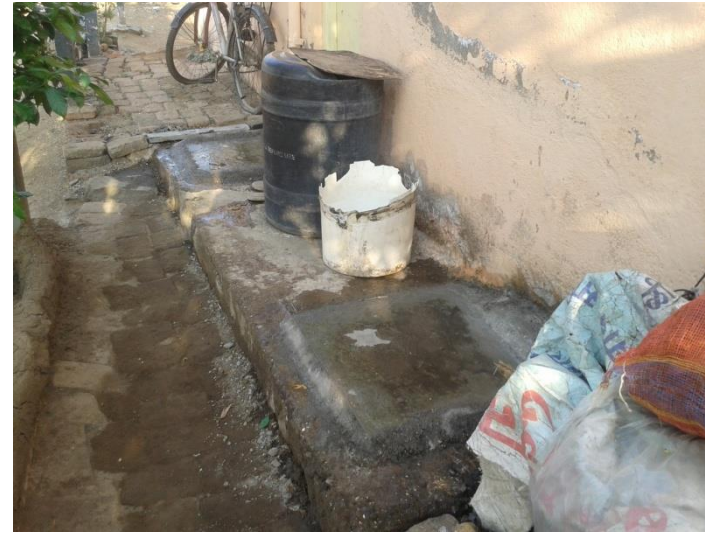
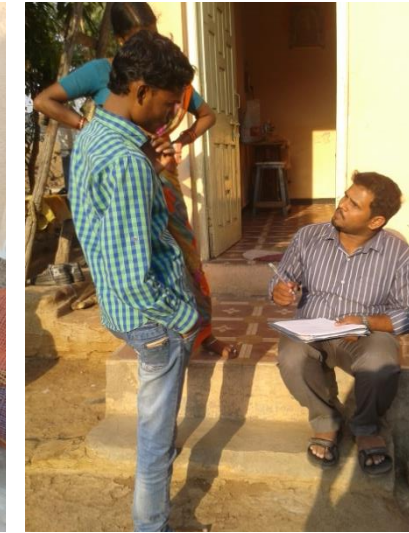
# CASE 17: SAILATTA NAGAR-B, HANDEMALA

<b>Raghunath Aware</b>														
<u>Users</u> <b>9</b>	<u>Building type</u> <b>Ground Floor</b>	<u>Inputs to septic tank</u> <b>Black Water</b>	<u>Cleaning frequency of the tank</u> <b>One time</b>			<u>When was septic tank last emptied?</u> <b>Two years ago-2012</b>			<u>How toilet is cleaned?</u> <b>Daily (Water) &amp; Weekly (Harpic)</b>					
		<b>Length (m)</b>	<b>Breadth (m)</b>	<b>Height (m)</b> (300mm free board has been considered)					<b>Volume of the tank (Cum)</b>					
				(Cleaning interval - 2 year)			(Cleaning interval - 3 year)							
<b>Recommended Size of the Septic tank (10 Users) (CPHEEO)</b>		2.0	0.9	1.3			1.43			<b>2.34</b> (Two year Cleaning Interval) <b>2.57</b> (Three year cleaning interval)				
		<b>Length (m)</b>	<b>Breadth (m)</b>	<b>Height (m)</b>					<b>Volume of the tank (Cum)</b>					
<b>Actual Size of the tank (9 Users)</b>		2.74	0.48	1.52					<b>2.01</b>

<b>Observations</b>									<b>Undersized (22% Smaller)</b>

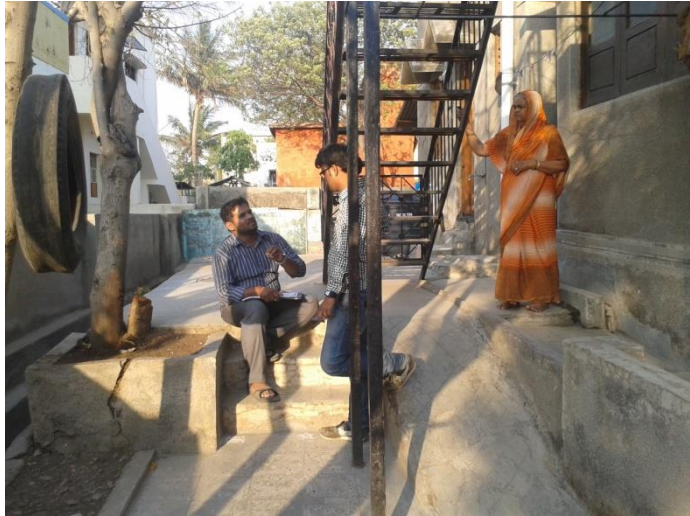
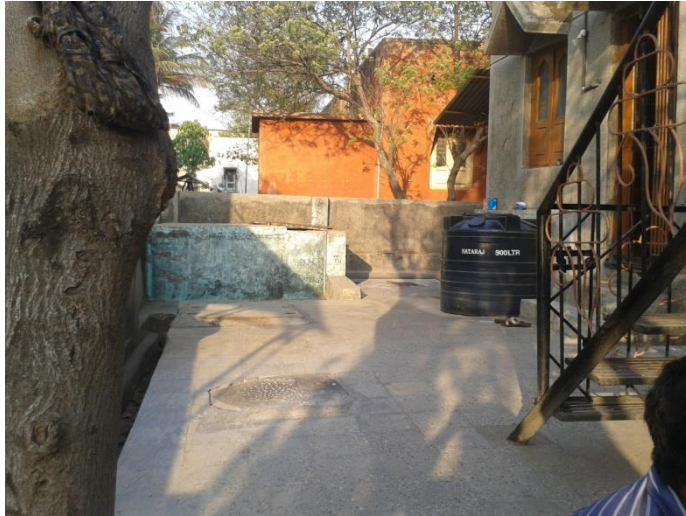
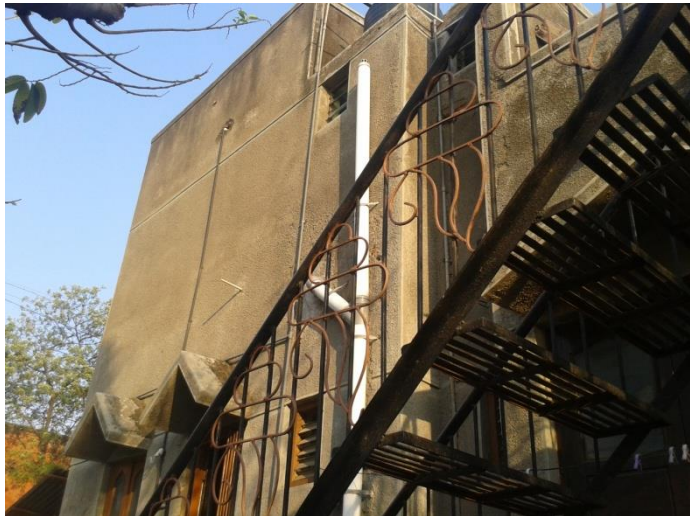
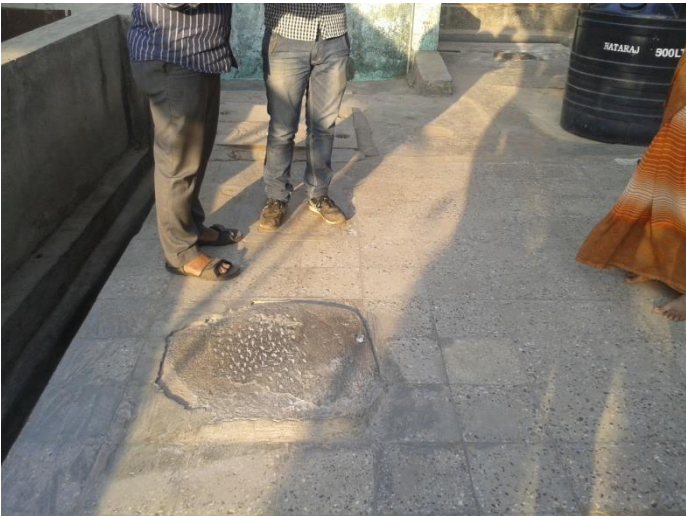
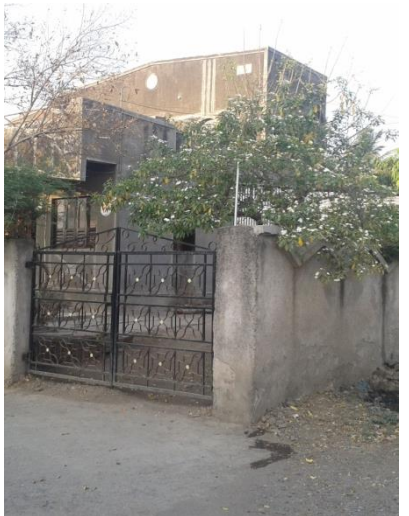
# CASE 18: BHAIRAVNATH HOUSING SOCIETY, NAYGAON ROAD

Length (m)	Breadth (m)	Height (m) (300mm free board has been considered)		Volume of the tank (Cum)
			(Cleaning interval - 2 year)	(Cleaning interval - 3 year)	
<b>Recommended Size of the Septic tank (5 Users) (CPHEEO)</b>	1.5	0.75	1.3	1.35	<b>1.46 (Two year Cleaning Interval)</b> <b>1.52 (Three year cleaning interval)</b>
	<b>L</b>	<b>B</b>	<b>Height (m)</b>		<b>Volume of the tank (Cum)</b>
<b>Actual Size of the tank (4 Users)</b>	2.89	1.75	1.52		<b>7.73</b>
<b>Observations</b>					<b>Oversized (409% Extra)</b>

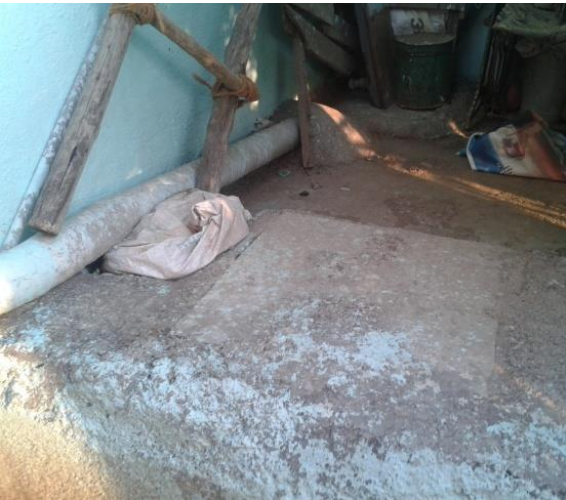
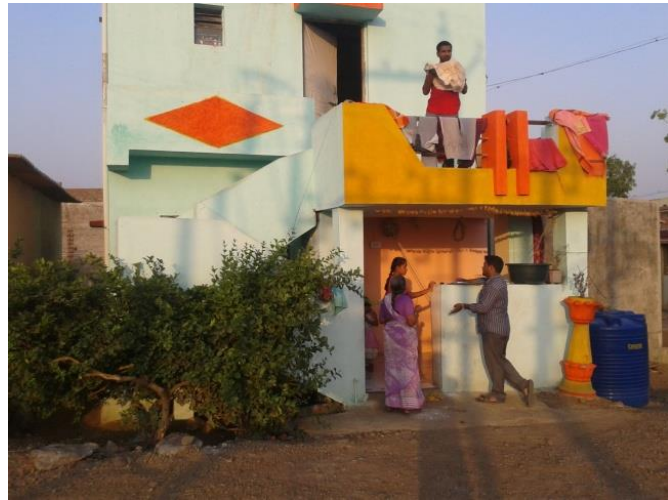
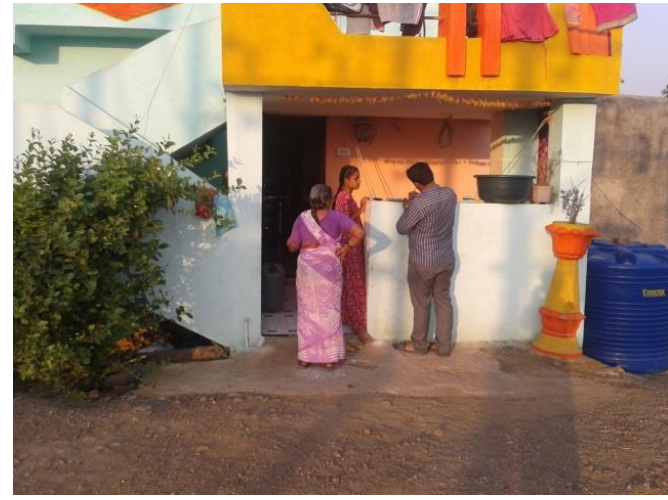
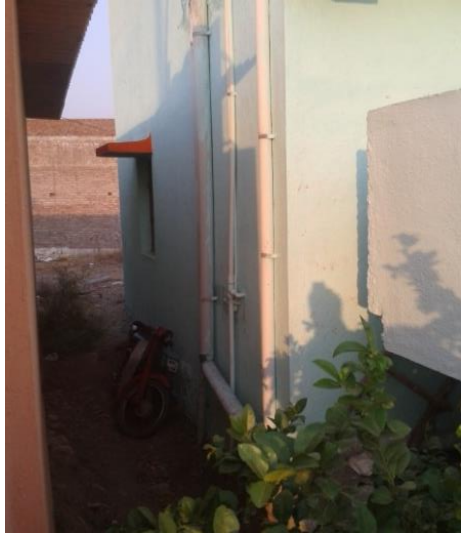
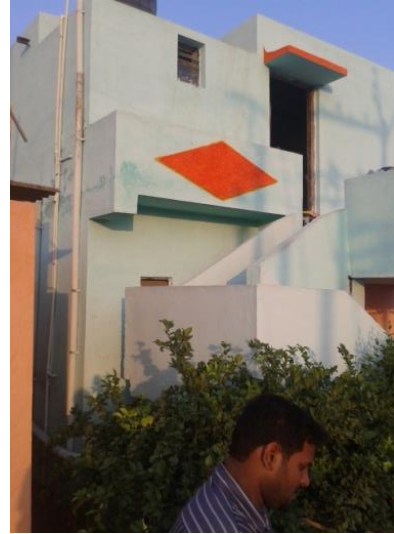
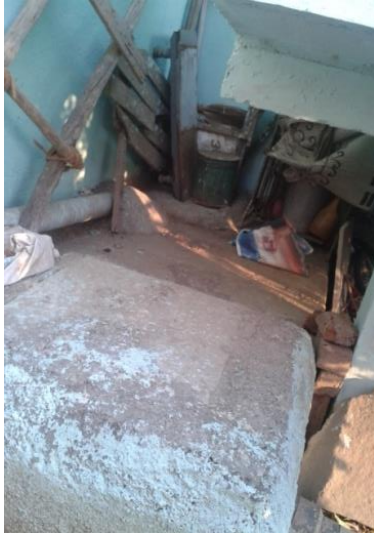
# CASE 19: JAIN NAGAR, KANADI MALA

<b>Sachin Suresh Mule</b>														
<u>Users</u> <b>5</b>	<u>Building type</u> <b>Ground Floor</b>	<u>Inputs to septic tank</u> <b>Black Water</b>	<u>Cleaning frequency of the tank</u> <b>Nil</b>			<u>When was septic tank last emptied?</u> <b>Not yet cleaned (Since construction year 2004)</b>				<u>How toilet is cleaned?</u> <b>Daily (Water) &amp; Weekly (Harpic)</b>				
		<b>Length (m)</b>	<b>Breadth (m)</b>	<b>Height (m)</b> (300mm free board has been considered)					<b>Volume of the tank (Cum)</b>					
				(Cleaning interval - 2 year)	(Cleaning interval - 3 year)									
<b>Recommended Size of the Septic tank (5 Users) (CPHEEO)</b>		1.5	0.75	1.3			1.35			<b>1.46</b> (Two year Cleaning Interval) <b>1.52</b> (Three year cleaning interval)				
		<b>Length (m)</b>	<b>Breadth (m)</b>	<b>Height (m)</b>					<b>Volume of the tank (Cum)</b>					
<b>Actual Size of the tank (5 Users)</b>		2.31	1.73	1.52					<b>6.08</b>

<b>Observations</b>										<b>Oversized (300% Extra)</b>

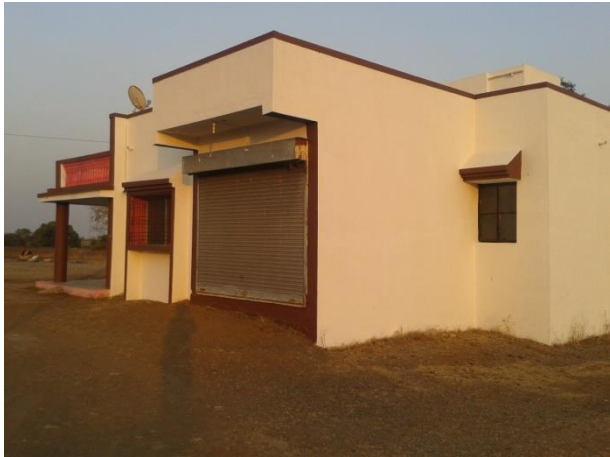
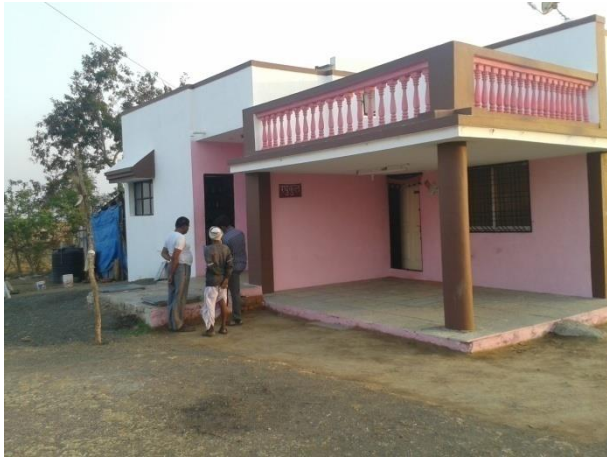
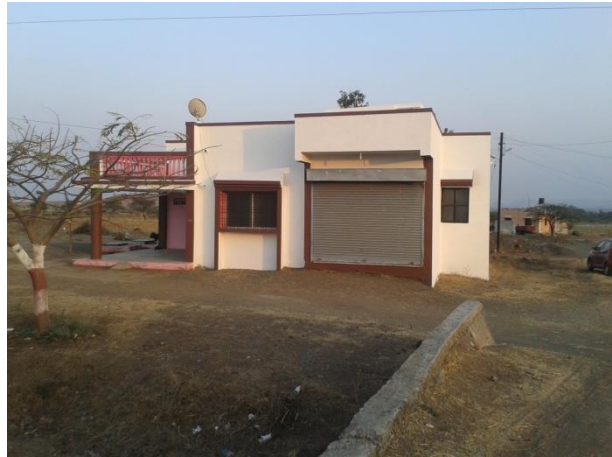
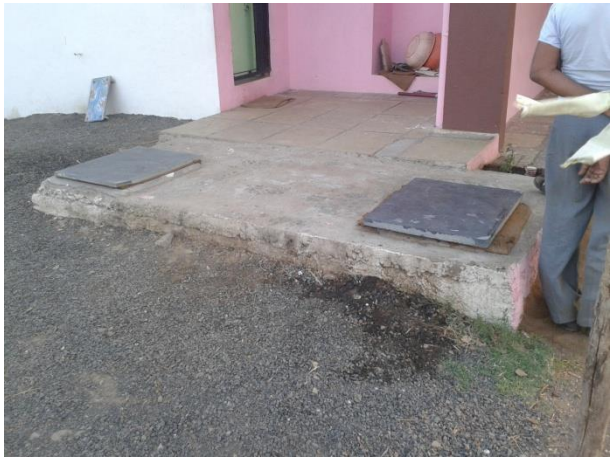
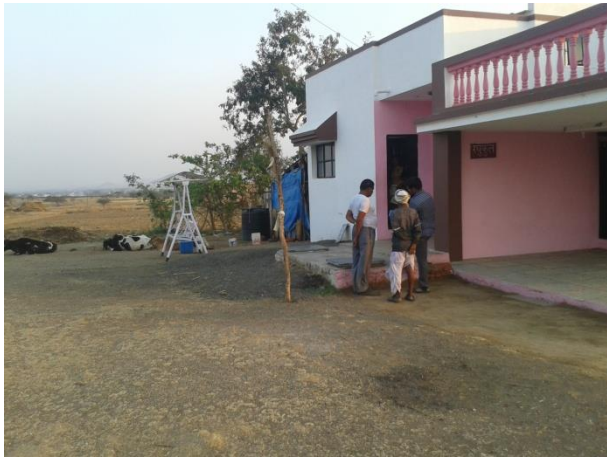
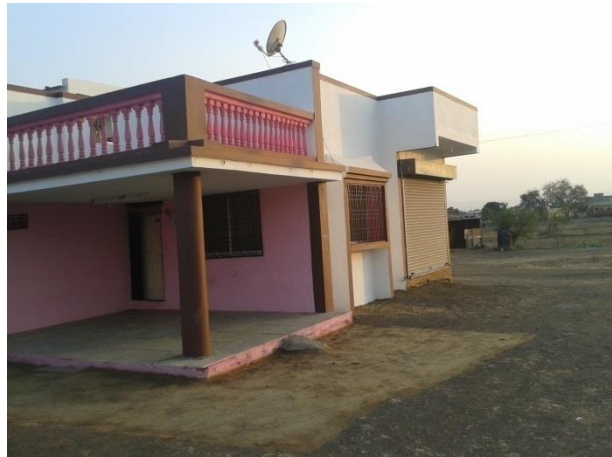
**CASE 20: RAGHUKUL PIMPRI ROAD.**

Length (m)	Breadth (m)	Height (m) (300mm free board has been considered)		Volume of the tank (Cum)
			(Cleaning interval - 2 year)	(Cleaning interval - 3 year)	
<b>Recommended Size of the Septic tank (5 Users) (CPHEEO)</b>	1.5	0.75	1.3	1.35	<b>1.46 (Two year Cleaning Interval) 1.52 (Three year cleaning interval)</b>
	Length (m)	Breadth (m)	Height (m)		Volume of the tank (Cum)
<b>Actual Size of the tank (2 Users)</b>	2.69	1.12	2.13		<b>6.42</b>
<b>Observations</b>					<b>Oversized (322% Extra)</b>

Sr No	Location, Area	Waste water	Parameters										
			BOD (mg/l)			COD (mg/l)			pH		TSS (mg/l)		
			Inlet	Outlet	% Reduction	Inlet	Outlet	% Reduction	Inlet	Outlet	Inlet	Outlet	% Reduction
1	Raghukul, Pimpri road	Black Water	--	510	--	--	1370	--	--	7.23	--	854	--

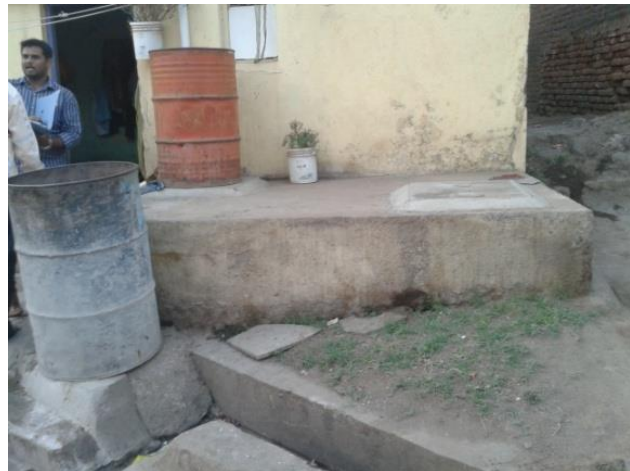
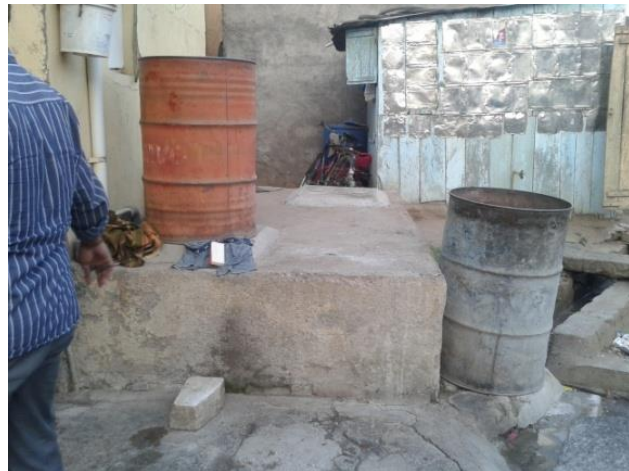
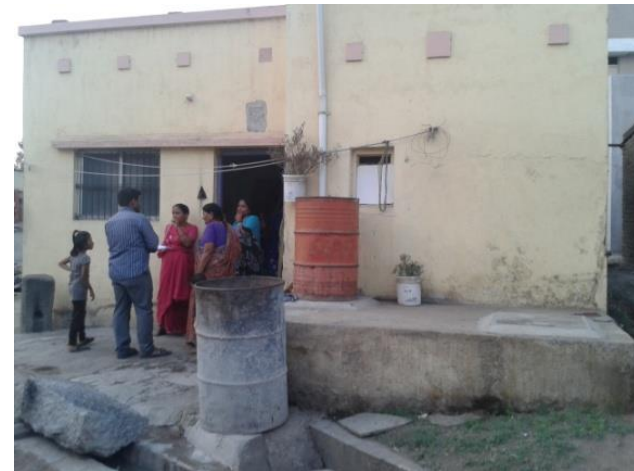
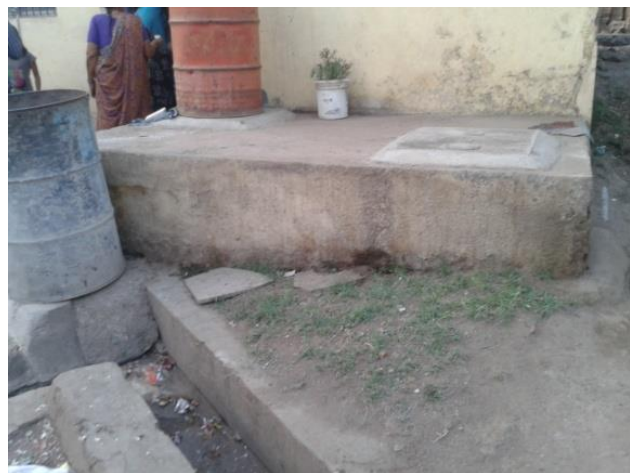
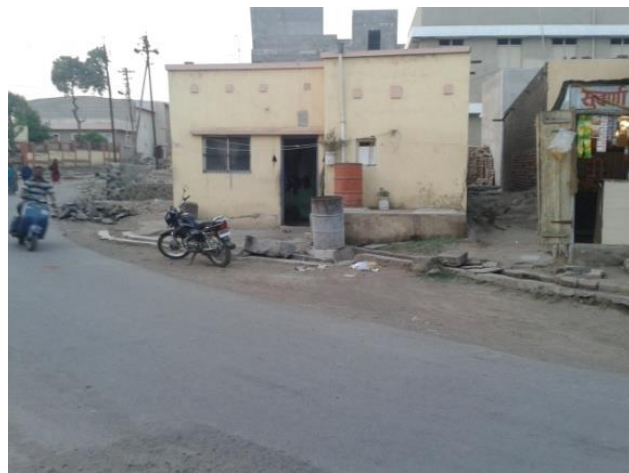
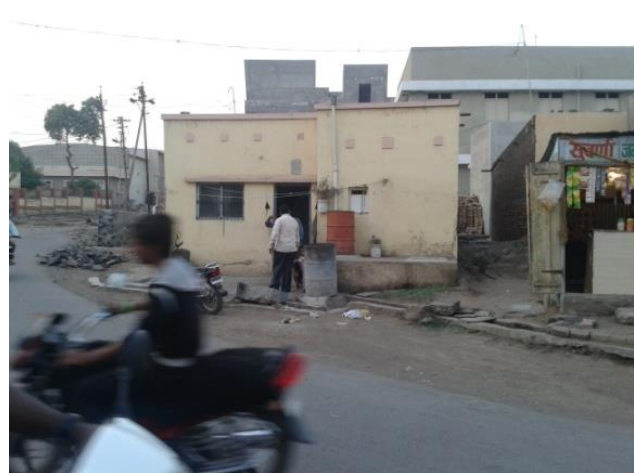
**CASE 21: VAWIES ROAD, OPPOSITE POST OFFICE**

<b>Length (m)</b>	<b>Breadth (m)</b>	<b>Height (m)</b> (300mm free board has been considered)		<b>Volume of the tank (Cum)</b>
			(Cleaning interval - 2 year)	(Cleaning interval - 3 year)	
<b>Recommended Size of the Septic tank (10 Users) (CPHEEO)</b>	2.0	0.9	1.3	1.7	<b>2.34</b> (Two year Cleaning Interval) <b>3.06</b> (Three year cleaning interval)

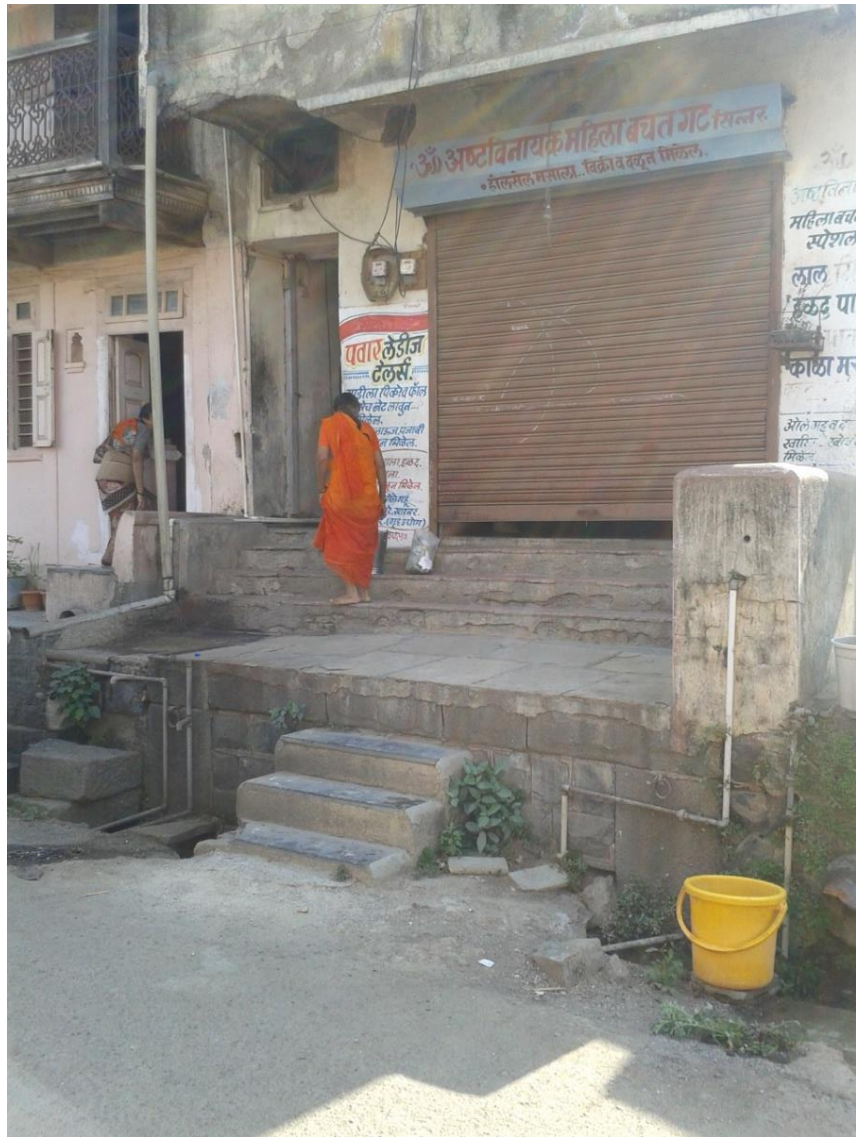
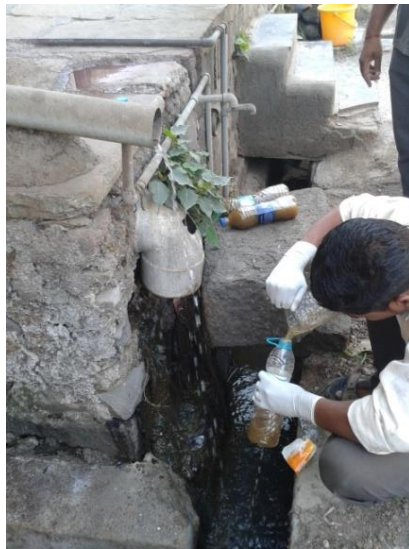
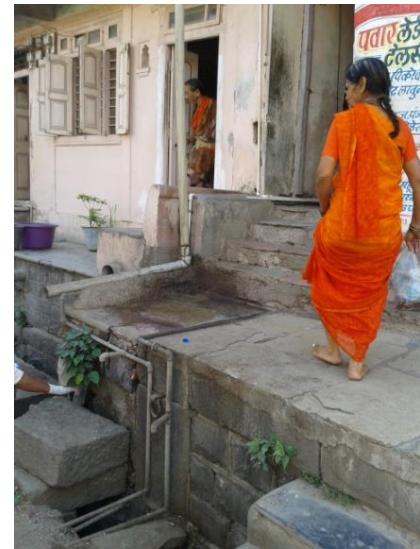
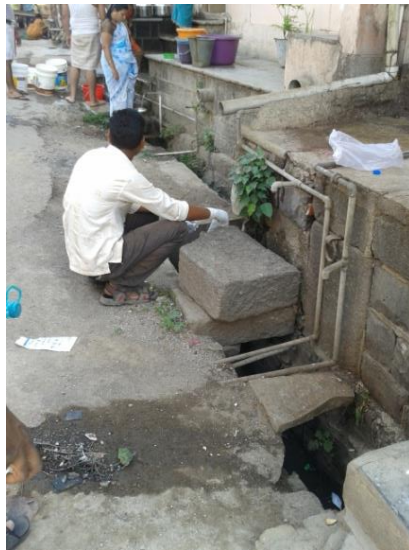
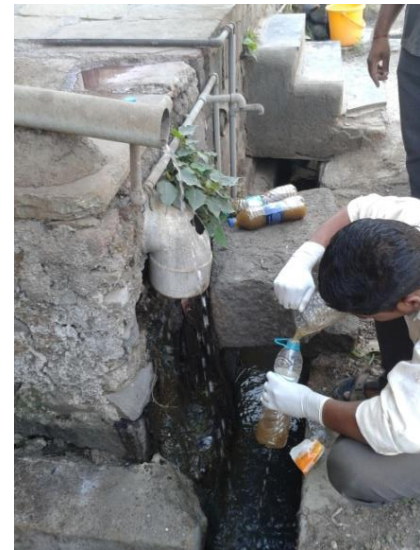
# CASE 22: KUMBHAR GALLI

<b>Ajay Pawar</b>															
<u>Users</u> <b>14</b>	<u>Building type</u> <b>G+1</b>	<u>Inputs to septic tank</u> <b>Black Water</b>	<u>Cleaning frequency of the tank</u> <b>Nil</b>	<u>When was septic tank last emptied?</u> <b>Not yet cleaned (Since construction year 2004)</b>	<u>How toilet is cleaned?</u> <b>Daily (Water) &amp; Weekly (Harpic)</b>										
		<b>Length (m)</b>	<b>Breadth (m)</b>	<b>Height (m)</b> (300mm free board has been considered)				<b>Volume of the tank (Cum)</b>							
				(Cleaning interval - 2 year)	(Cleaning interval - 3 year)										
<b>Recommended Size of the Septic tank (15 Users) (CPHEEO)</b>		2.0	0.9	1.6				2.3						<b>2.88</b> (Two year Cleaning Interval) <b>4.14</b> (Three year cleaning interval)	
		<b>Length (m)</b>	<b>Breadth (m)</b>	<b>Height (m)</b>				<b>Volume of the tank (Cum)</b>							
<b>Actual Size of the tank (14 Users)</b>		1.98	1.21	1.21				<b>2.94</b>

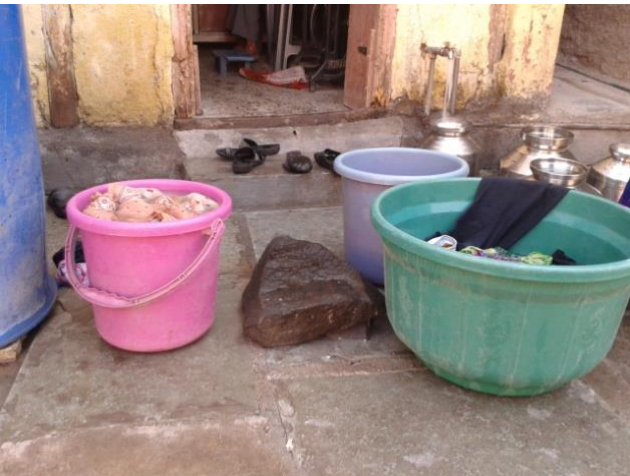
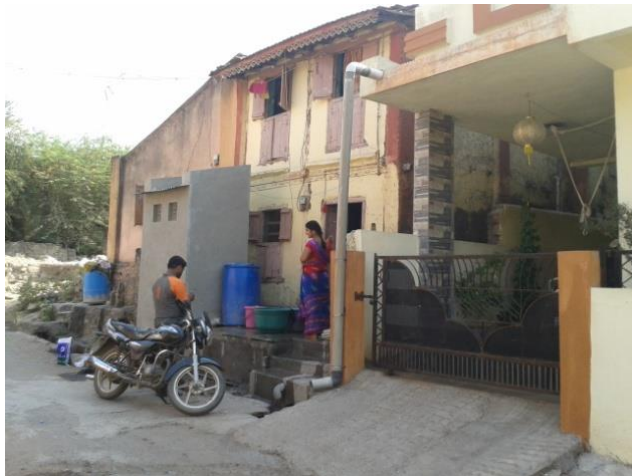
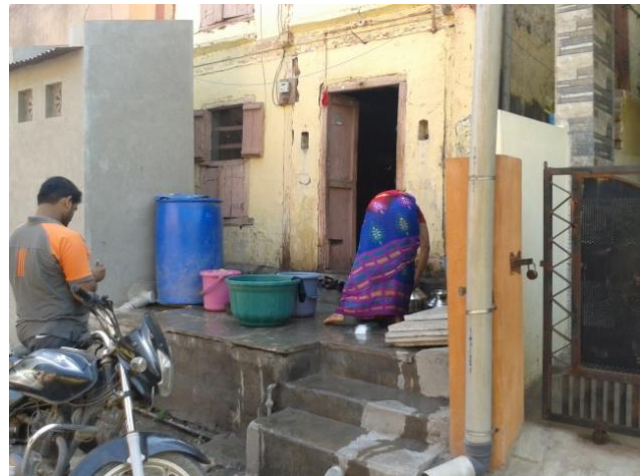
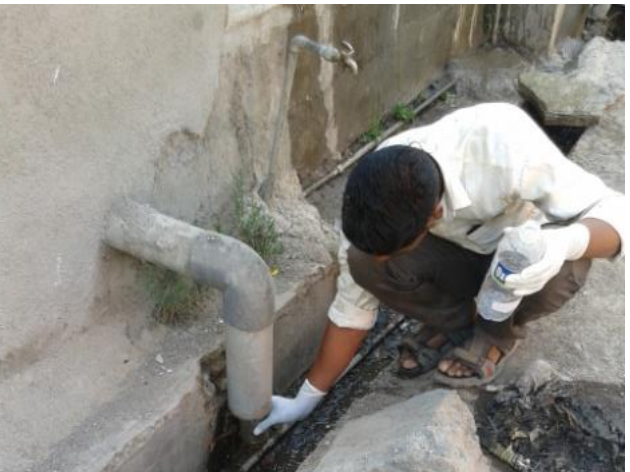
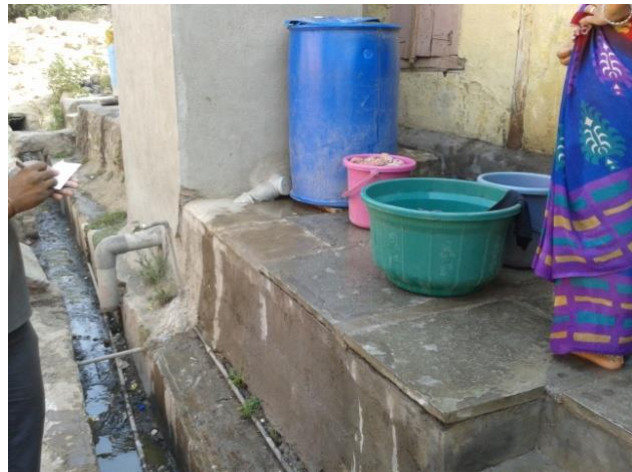
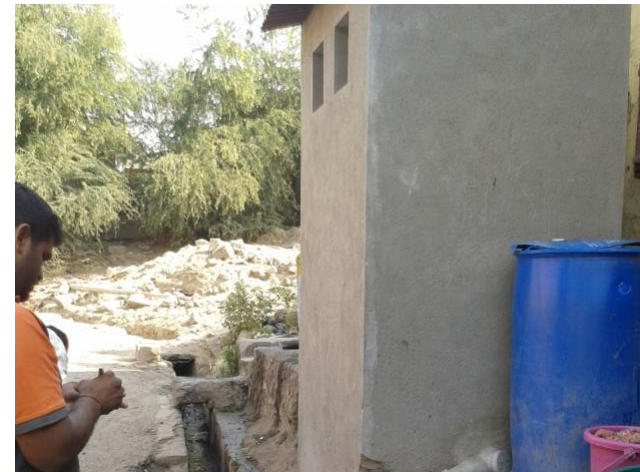
# CASE 23: SETTE GALLI

<b>Manoj Khedkar</b>						
<u>Users</u> <b>12</b>	<u>Building type</u> <b>G+1</b>	<u>Inputs to septic tank</u> <b>Black Water</b>	<u>Cleaning frequency of the tank</u> <b>Nil</b>	<u>When was septic tank last emptied?</u> <b>Not yet cleaned (Since construction year 2013)</b>	<u>How toilet is cleaned?</u> <b>Daily (Water) &amp; Weekly (Harpic)</b>	
		<b>Length (m)</b>	<b>Breadth (m)</b>	<b>Height (m)</b> (300mm free board has been considered)		<b>Volume of the tank (Cum)</b>
				(Cleaning interval - 2 year)	(Cleaning interval - 3 year)	
<b>Recommended Size of the Septic tank (15 Users) (CPHEEO)</b>		2.0	0.9	1.6	2.3	<b>2.88</b> (Two year Cleaning Interval) <b>4.41</b> (Three year cleaning interval)
		<b>L</b>	<b>B</b>	<b>Height (m)</b>		<b>Volume of the tank (Cum)</b>
<b>Actual Size of the tank (12 Users) (Precast ST)</b>		1.83 (Diameter)	NA	1.21		<b>2.23</b>
<b>Observations</b>						<b>Undersized (46% Smaller)</b>

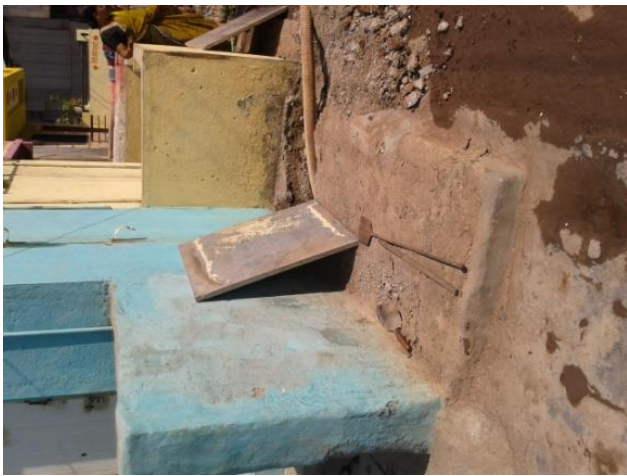
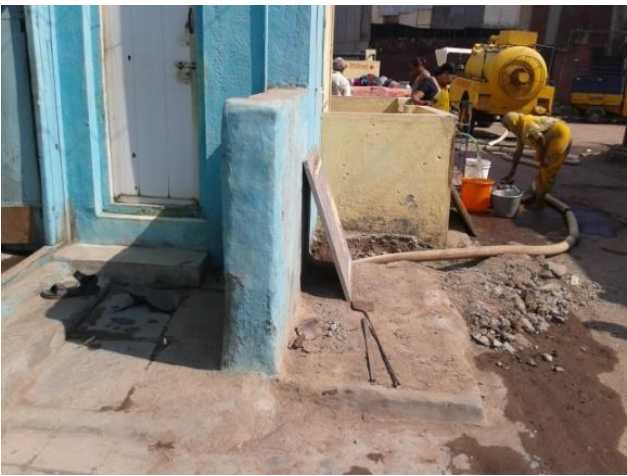
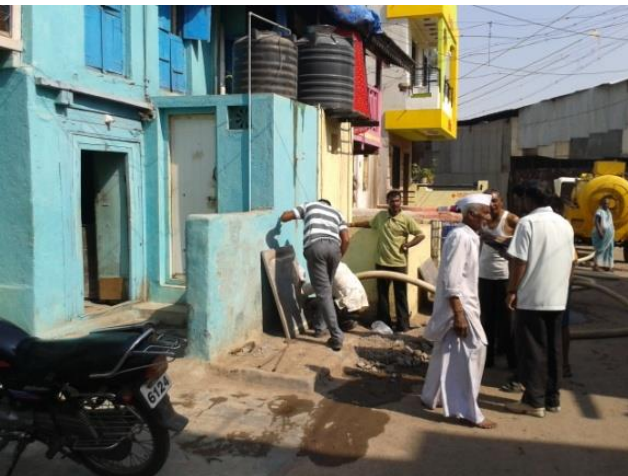
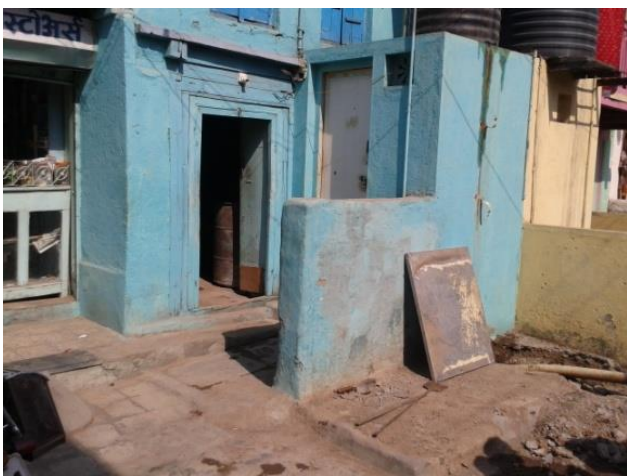
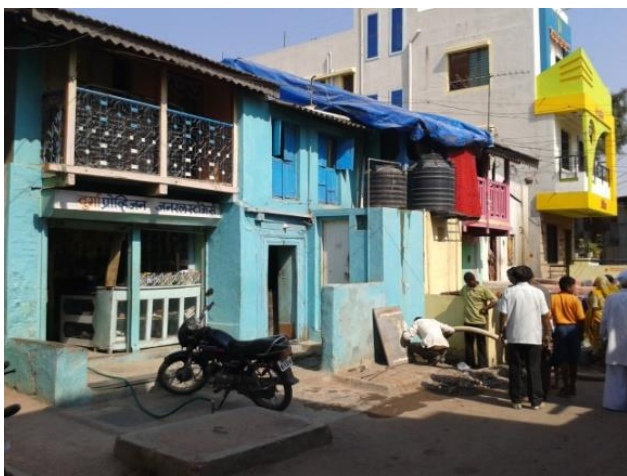
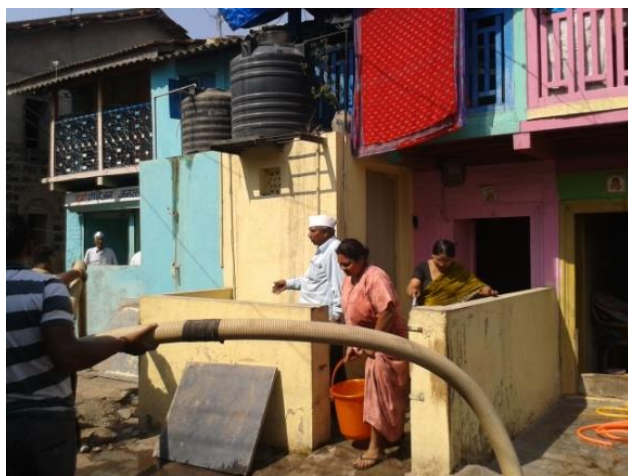
# CASE 24: LONDHE GALLI

<b>Chandadev Ingle</b>												
<u>Users</u> <b>4</b>	<u>Building type</u> <b>G+1</b>	<u>Inputs to septic tank</u> <b>Black Water</b>	<u>Cleaning frequency of the tank</u> <b>One time</b>	<u>When was septic tank last emptied?</u> <b>March 2014</b>	<u>How toilet is cleaned?</u> <b>Daily (Water) &amp; Weekly (Harpic)</b>							
	<b>Length (m)</b>	<b>Breadth (m)</b>	<b>Height (m)</b> (300mm free board has been considered)		<b>Volume of the tank (Cum)</b>							
			(Cleaning interval - 2 year)	(Cleaning interval - 3 year)								
<b>Recommended Size of the Septic tank (5 Users) (CPHEEO)</b>	1.5	0.75	1.3	1.35	<b>1.46 (Two year Cleaning Interval) 1.52 (Three year cleaning interval)</b>							
	<b>L</b>	<b>B</b>	<b>Height (m)</b>		<b>Volume of the tank (Cum)</b>							
<b>Actual Size of the tank (4 Users)</b>	2.13	0.91	1.37		<b>2.67</b>							
					<b>Observations</b>	<b>Oversized (76% Smaller)</b>

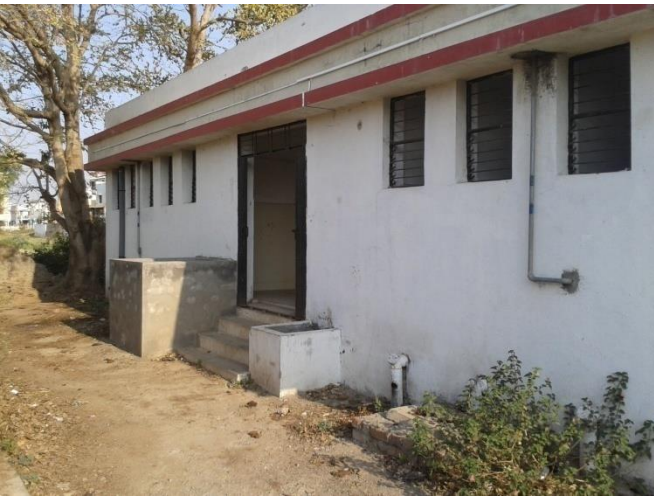
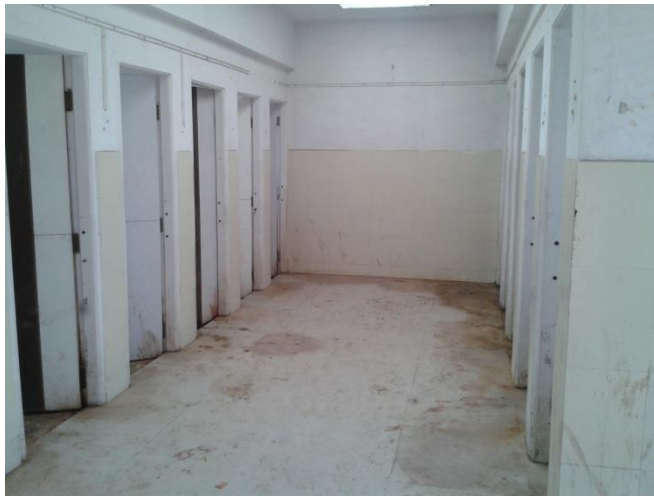
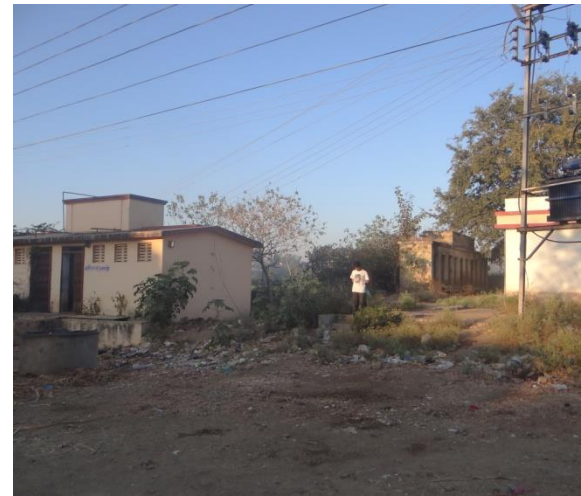
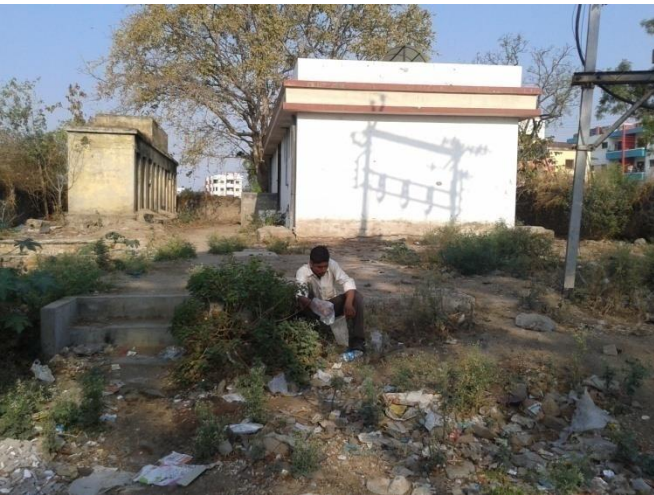
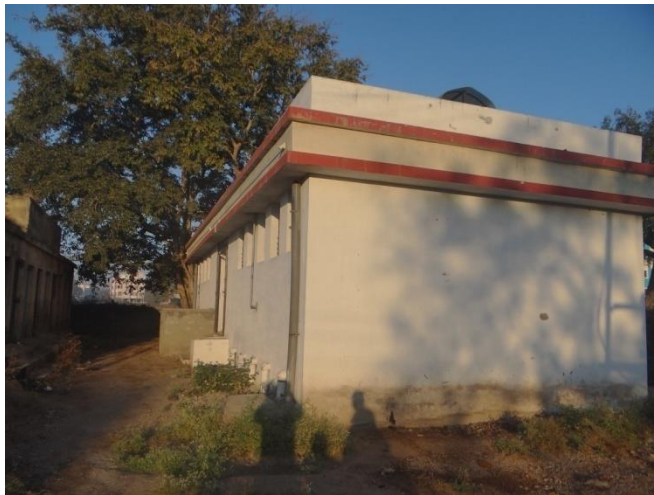
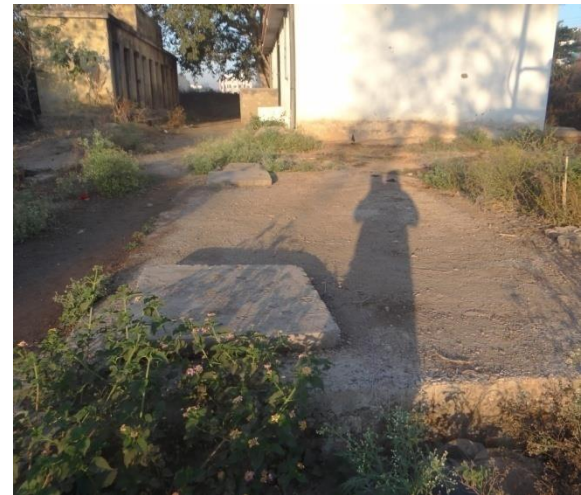
# CASE 1: COMMUNITY TOILET (Near Bail Bazar)

Sr No	Location, Area	Waste water	Parameters										
			BOD (mg/l)			COD (mg/l)			pH		TSS (mg/l)		
			Inlet	Outlet	% Reduction	Inlet	Outlet	% Reduction	Inlet	Outlet	Inlet	Outlet	% Reduction
1	Bail Bazar	Black water	--	465	--	--	1140	--	--	7.62	--	296	--

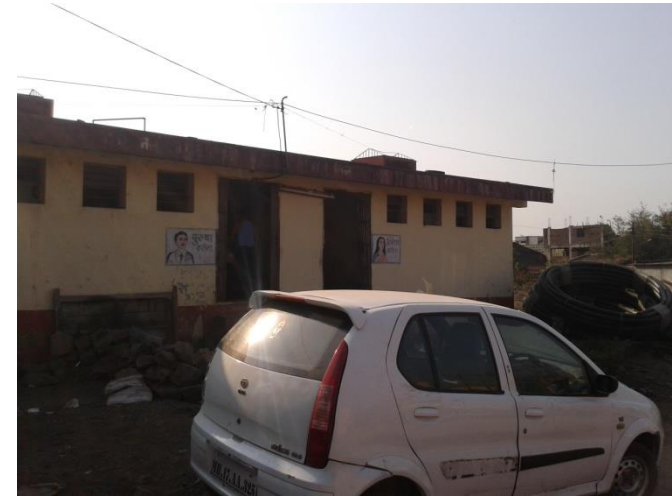
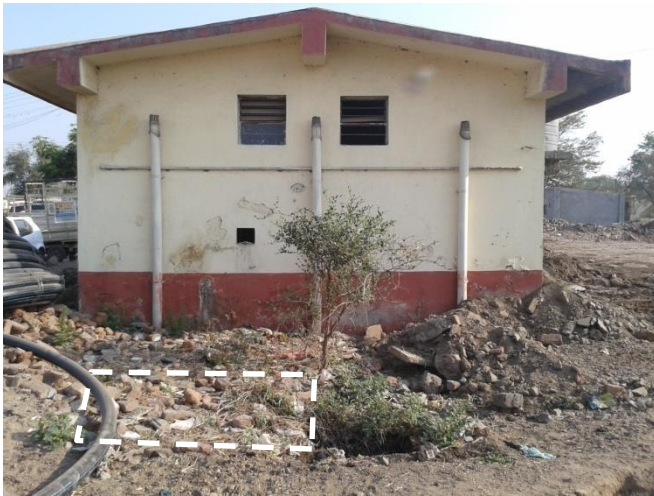
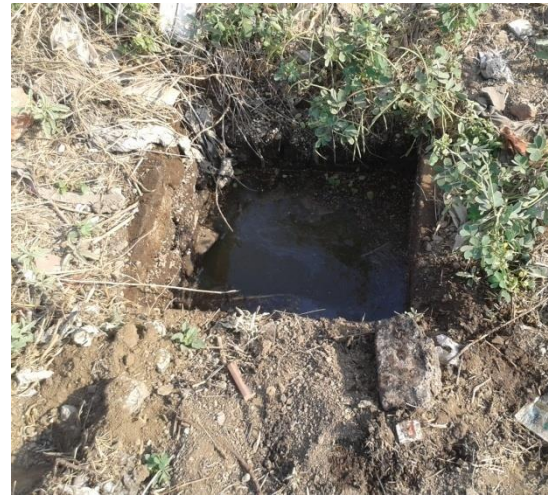
# CASE 2: COMMUNITY TOILET AT KHADAKPURA

Length (m)	Breadth (m)	Height(m) <small>(300 mm free board has been considered)</small>	Volume of the septic tank (Cu m)
<b>Actual Size of the tank</b>	4.97	2.99	2.00	<b>29.94</b>
<b>Recommended Size of the Septic tank (595 Users)</b> (Calculated based on certain assumption for same has been mentioned in previous slide <i>(Based on experience of experts/consultants)</i>	12.59	4.20	1.30	<b>68.74 (One year Cleaning Interval)</b>

<p style="text-align: center;">References:</p> <p>Indian Standards (2470 (PART 1) -1958), “ Code of practices for installation of septic tanks”, Design criteria and construction (Second revision)                      The capacities are recommended on the assumption that the discharges from only WC will be treated in the septic tank.</p>	<b>Undersized (56% Smaller)</b>
--	---------------------------------

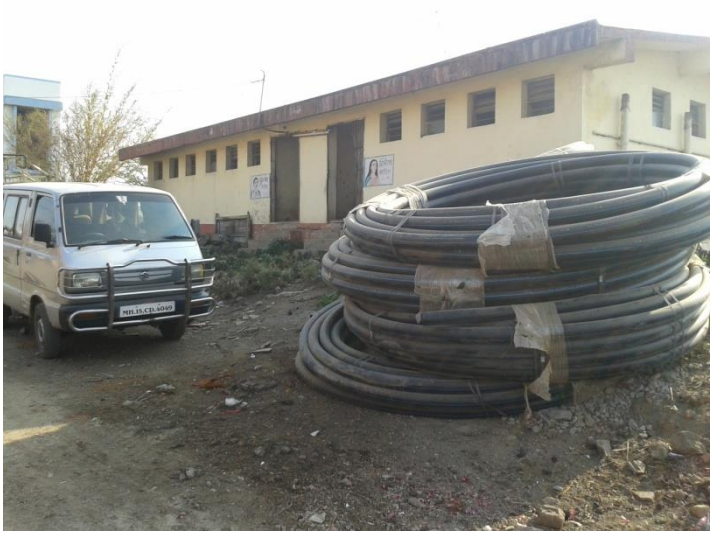
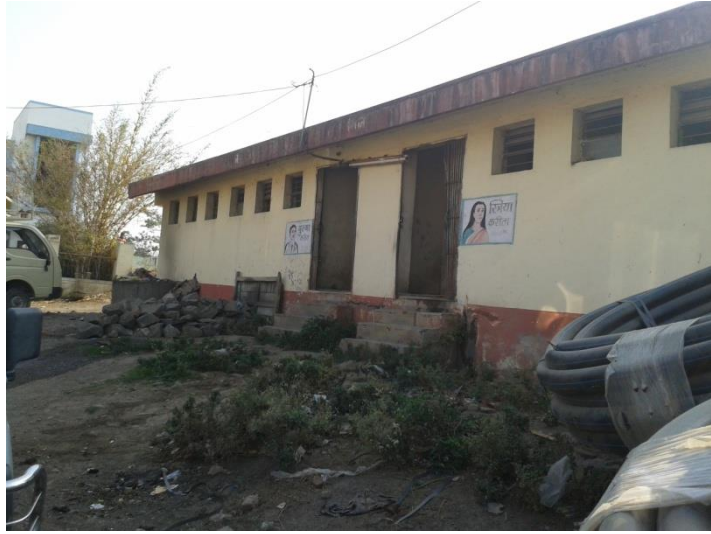
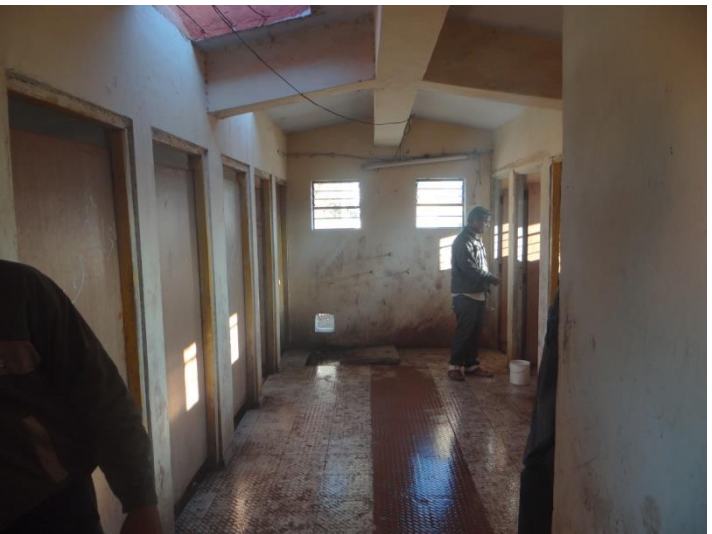
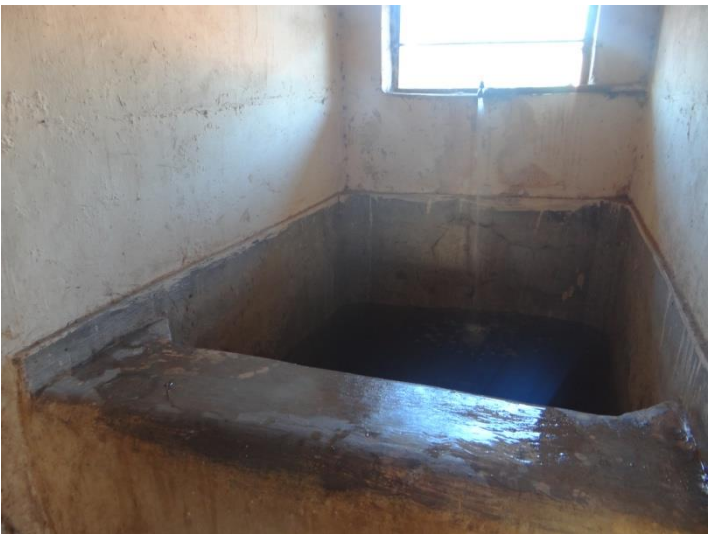
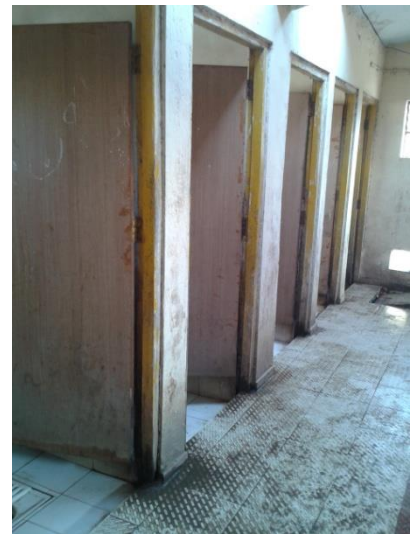
# CASE 2: COMMUNITY TOILET AT KHADAKPURA

<b>Users</b> 595	<b>Building type</b> Community toilet	<b>Inputs to septic tank</b> Black water	<b>Cleaning frequency of the tank</b> Once In Every Week	<b>How toilet is cleaned?</b> Daily
---------------------	--	---	---	--

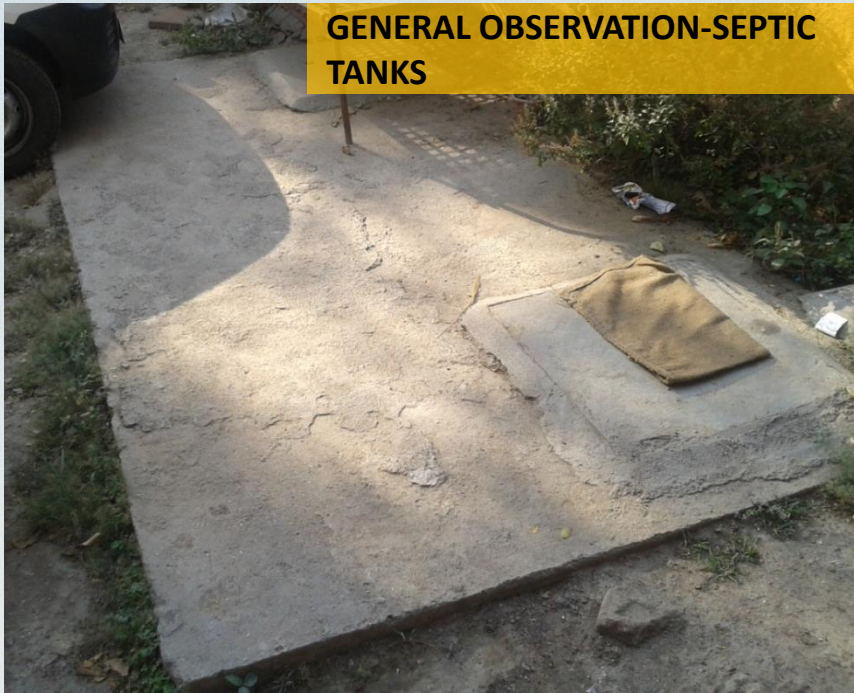
## GENERAL OBSERVATION-SEPTIC TANKS

### VENTILATION PIPES:

In some of the cases no ventilation pipes have been provided to the septic tanks. This is leading to significant odour problems in the vicinity

In few cases the septic tanks are not accessible for maintenance and repairs. This is probably due to location of them below the toilet blocks
