# Performance Assessment Systems

For Urban Water Supply and Sanitation in India

Sanitation Assessment in *Sinnar*, Maharashtra

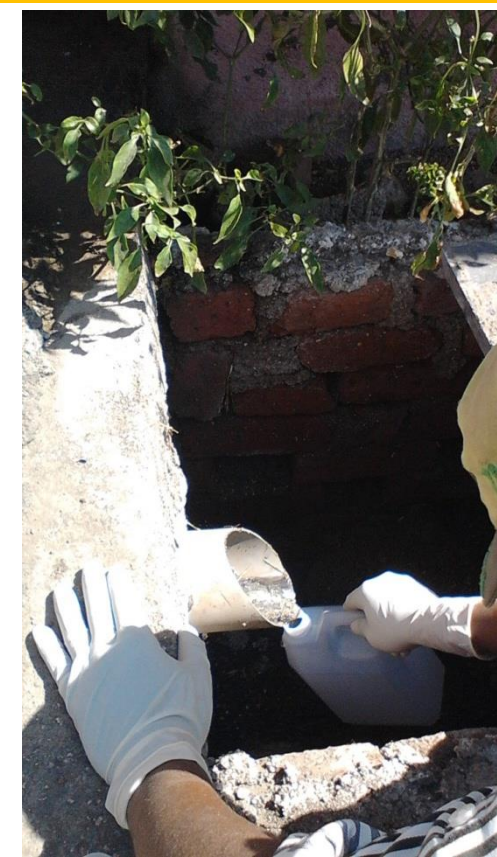
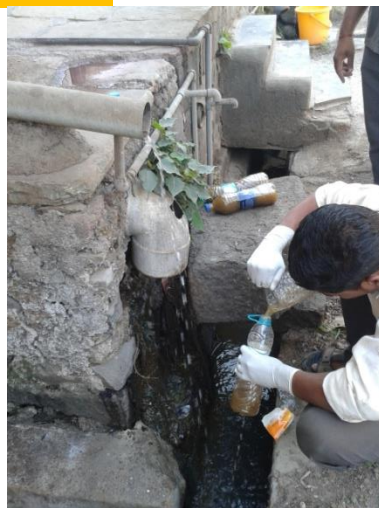
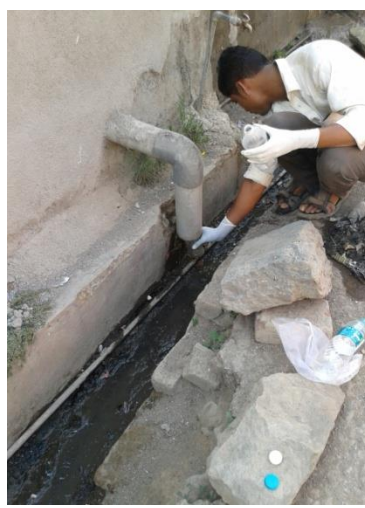
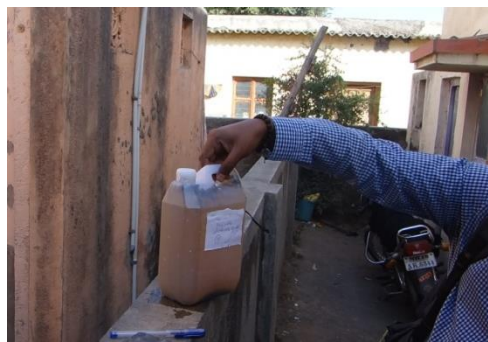
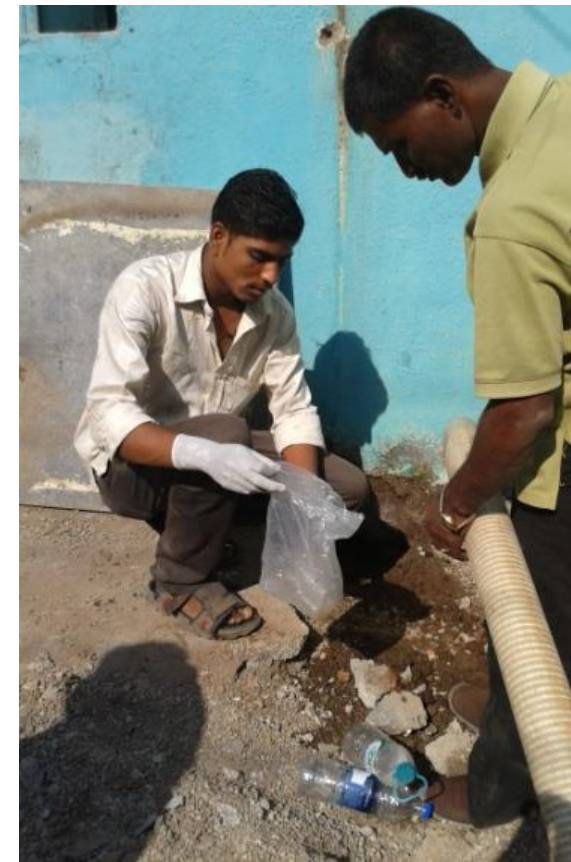
### Sample Collection Technique

**\*\*\*For comparing the BOD results of samples, few samples were collected from Inspection chambers to analyze Inlet BOD. It varied in the range of 100 to 600. It was considered as influent BOD value against which effluent values were compared. It is considered only for cases in residential areas. This has been explained in the next slide.**

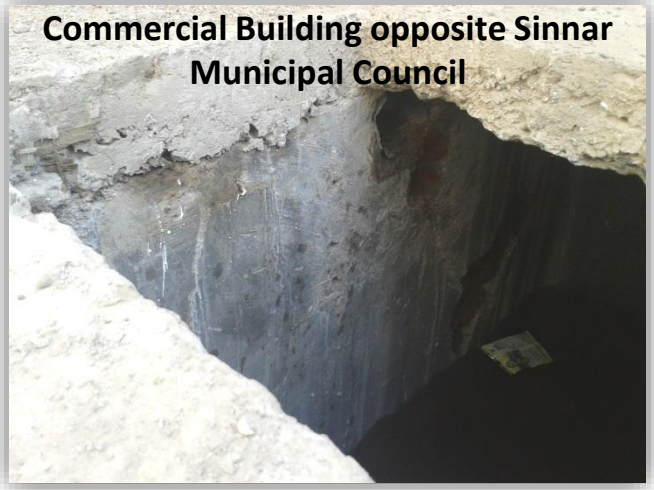
Existing Situation

**1.) Inlet/ Outlet Pipe:** As per best practices for construction of a septic tank, it is advisable to use a T- junction pipe joint at both the inlet and outlet of the septic tank. Usually 100 mm diameter PVC pipes are used for the purpose.

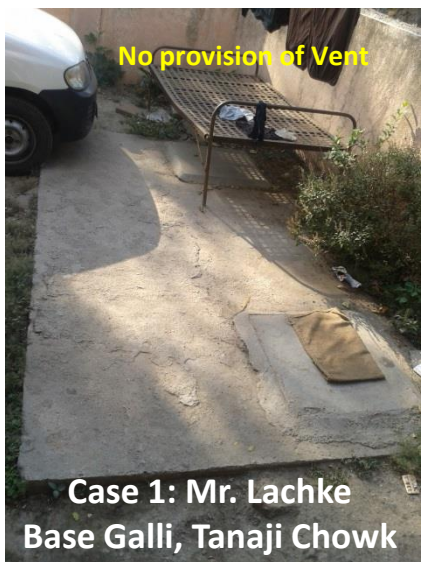
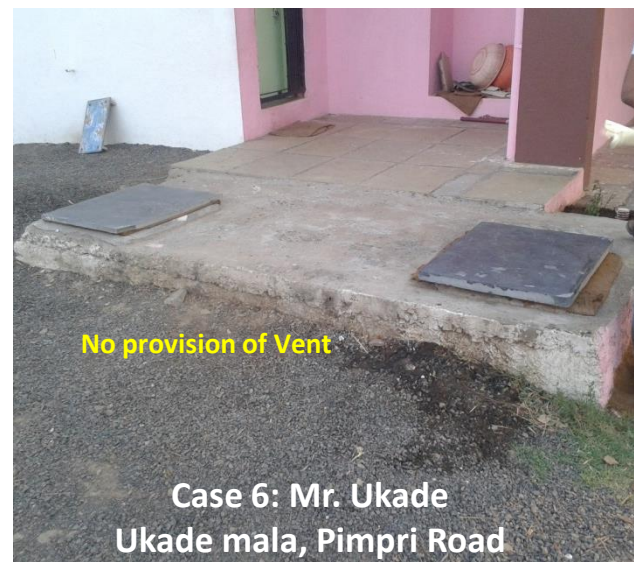
**2.) Ventilation Pipes:** In the cases studied, in several cases the ventilation pipes required for the septic tanks is absent. In a few cases ventilation pipes have been provided above the inspection chambers only.

For efficient working of the septic tanks the methods adopted for constructing a Septic tank must be as shown in the adjacent diagram.

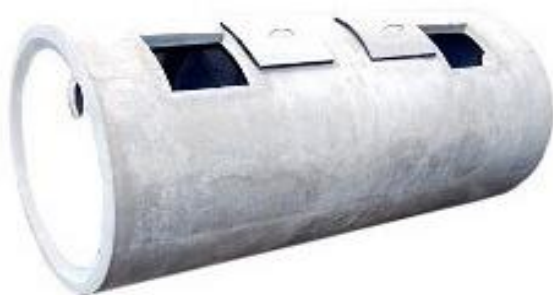
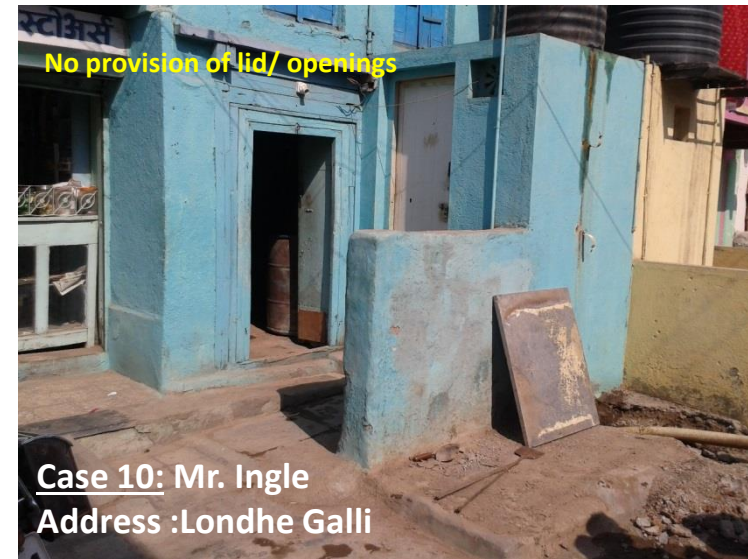
In few cases the septic tanks had no accessibility due to the location of septic tanks below the toilet block.

Ideally a septic tank must have atleast two manholes of adequate size and must be covered properly with a concrete lid. This opening help for keeping the maintenance of the septic tanks and the lids prevent odour problems as well as any mishaps/ accidents.

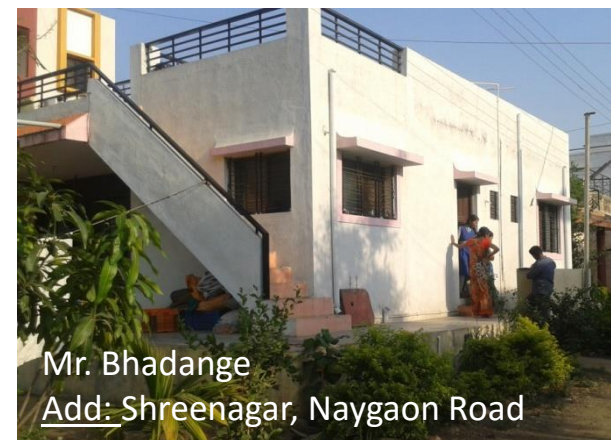
## 4.) Solutions for oversized Septic Tanks:

In a few cases studied, it was observed that the septic tanks are oversized as compared to the actual required sizes as per the standards.

To make proper use of the volume of the septic tanks the grey water generated in the households can also be let off into the septic tanks.

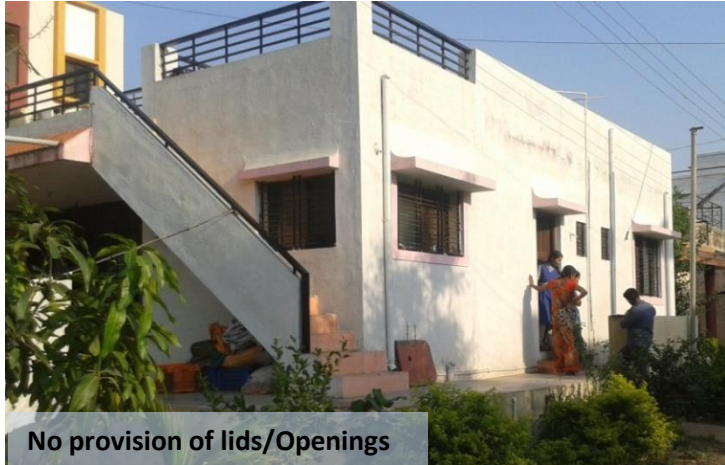
Proposed openable Cover

Note: in this case due to constraint of space (WC constructed over the septic tank) only one access can be provided.

Installation of cover	Criteria (IS CODE:2470)	Amount (INR)
Access opening & cover (1 Nos.)	<ul style="list-style-type: none"> <li>For Rectangular- Not less than 455x600 mm</li> <li>For circular- Not less than (circular opening) 500 mm dia</li> </ul>	600 (R.C.C) Local Market rate
Total cost (In Rs.) (Two number of manholes required )		1200

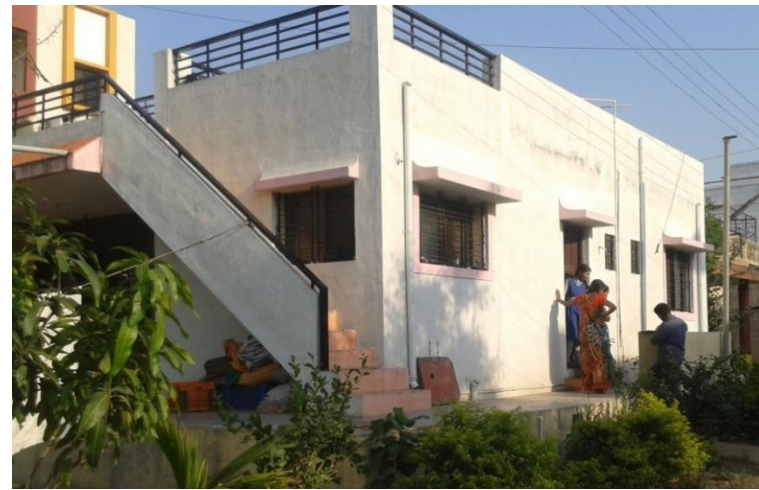
### Existing Scenario: Only Black water let-off into Septic Tank. Grey water is directly let-off into nearby drains

Installation of PVC pipe to combine (Grey water)	Criteria (IS CODE:2470)	Amount (INR)
Inlet pipe (PVC Pipe-required 5 meter)	100 mm dia	415
1 T Joint	100 mm dia	115
1 L joint (2 nos.)	100 mm dia	190
<b>Total (INR)</b>		<b>720</b>

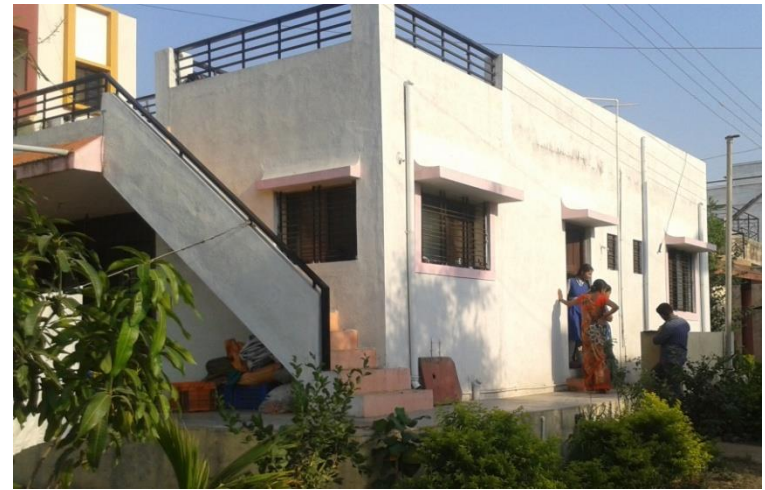
## COSTING DETAILS FOR CASE NO. 16

In this case, there is no ventilation pipe for the septic tank and the openings do not have a removable cover. Also the inlet, outlet of the septic tank do not have a T-junction PVC pipe and the grey water is not let-off in the septic tank. To implement all the above works, the costing has been given as follows

Sr no	Improvements	Cost (INR)
1	Installation of ventilation pipe	450
2	Access & Opening cover	1,200
3	Connect Grey Water pipe to septic tank	720
4	Construction of T junction	313
<b>TOTAL COST</b>		<b>2,683</b>
