Performance Assessment Systems

For Urban Water Supply and Sanitation in
India

Sanitation Assessment in *Wai*,
Maharashtra

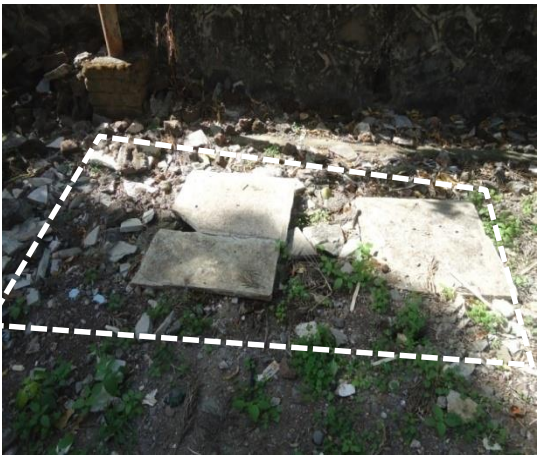
CASE 6: SHANTINAGAR SOCIETY, GROUP HOUSE(G+2) (PRABHAG 4)

<u>Users</u> 60	<u>Building type</u> G+2	<u>Inputs to septic tank</u> Black Water	<u>Cleaning frequency of ST</u> More Than 8-10 times	<u>When was the septic tank last emptied?</u> 2012 (Cleaning frequency- Once in every year)	<u>How toilet is cleaned?</u> Daily(Water) & Weekly (Harpic/ detergent)
			Height (m) (300mm free board has been considered)		Volume of the tank (cu m)
	Length (m)	Breadth (m)	(Cleaning interval - 2 year)	(Cleaning interval - 3 year)	
Recommended Size of the Septic tank (50 Users) (CPHEEO)	5.0	2.0	1.3	1.54	13.00 (Two year Cleaning Interval) 15.50 (Three year cleaning interval)
	L	B	Height (m)		Volume of the tank (cu m)
Actual Size of the tank (Users 60)	2.5	1.2	1.5		4.5
Observations					Undersized (71% Smaller)

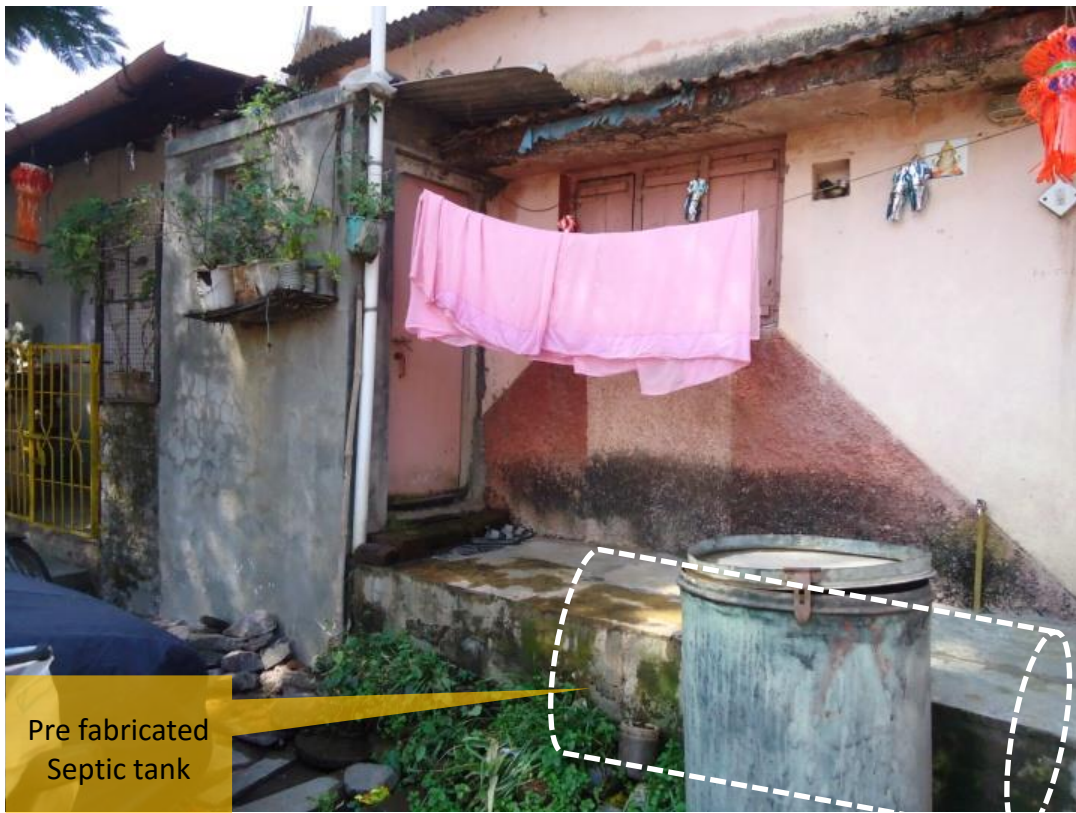
CASE 9: RAVIVAR PETH, DHOR GALLI (PRABHAG NO 2)

<u>Users</u> 3	<u>Building type</u> Ground Floor	<u>Inputs to septic tank</u> Black Water	<u>Cleaning frequency of ST</u> Nil	<u>When was the septic tank last emptied? (Precast Septic tank)</u> Not Yet cleaned Since construction year 2007-08)	<u>How toilet is cleaned?</u> Daily(Water) & Weekly (Harpic/ detergent)
--------------------------	---	--	---	--	---

Length (m)	Breadth (m)	Height (m) (300mm free board has been considered)		Volume of the tank (cu m)
			(Cleaning interval - 2 year)	(Cleaning interval - 3 year)	
Recommended Size of the Septic tank (5 Users) (CPHEEO)	1.5	0.75	1.3	1.35	1.46 (Two year Cleaning Interval) 1.52 (Three year cleaning interval)
	L	B	Height (m)		Volume of the tank (cu m)
Actual Size of the tank (3 Users)	2.7	--	1.2		3.02
Observations					Oversized (99% Bigger)

Sr No	Location, Area	Waste water	Parameters										
			BOD (mg/l)			COD (mg/l)			pH		TSS (mg/l)		
			Inlet	Outlet	% Reduction	Inlet	Outlet	% Reduction	Inlet	Outlet	Inlet	Outlet	% Reduction
1	Dhor Galli	Grey & Black Water (Sample was taken from the drain)	--	228	--	-	580	-	-	7.23	--	294	--

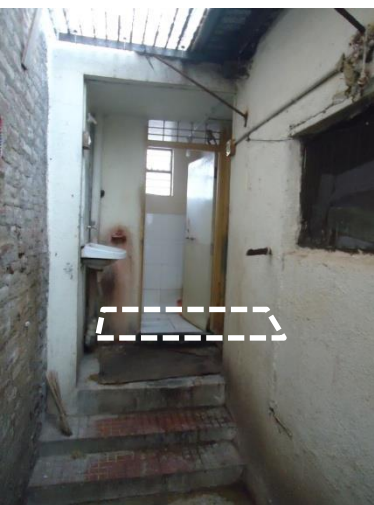
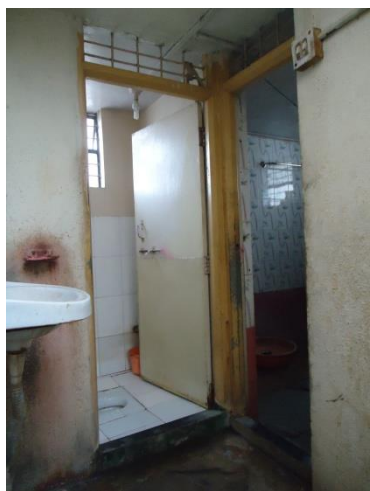
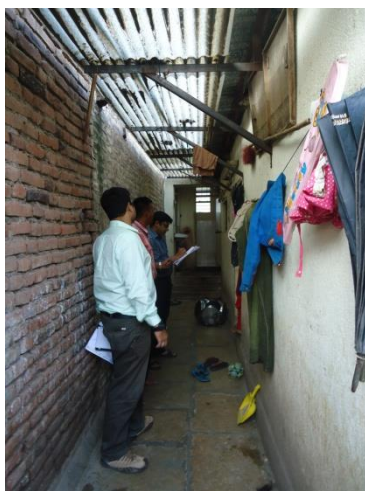
CASE 10: GANPATI ALI, INDIVIDUAL PLOT (PRABHAG NO 1)

<u>Users</u> 11	<u>Building type</u> G+1	<u>Inputs to septic tank</u> Black + Grey Water	<u>Cleaning frequency of ST</u> Nil	<u>When was the septic tank last emptied?</u> Not Yet cleaned (Since construction year 2011-12)	<u>How toilet is cleaned?</u> Daily(Water) & Weekly (Harpic/ detergent)	
		Length (m)	Breadth (m)	Height (m) (300mm free board has been considered)		Volume of the tank (cu m)
				(Cleaning interval - 2 year)	(Cleaning interval - 3 year)	
Recommended Size of the Septic tank (10 Users) (<i>CPHEEO</i>)		2.0	0.90	1.3	1.7	2.34 (Two year Cleaning Interval) 3.06 (Three year cleaning interval)
		L	B	Height (m)		Volume of the tank (cu m)
Actual Size of the tank (11 Users)		2.75	1.35	1.3		4.83
Observations						Oversized (58% Bigger)

Sr No	Location, Area	Waste water	Parameters										
			BOD (mg/l)			COD (mg/l)			pH		TSS (mg/l)		
			Inlet	Outlet	% Reduction	Inlet	Outlet	% Reduction	Inlet	Outlet	Inlet	Outlet	% Reduction
1	Ganpati Ali	Black Water	--	153	--	--	390	--	--	7.18	--	174	--

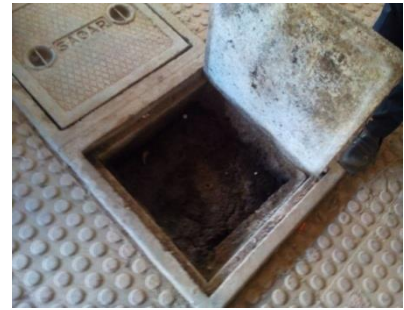
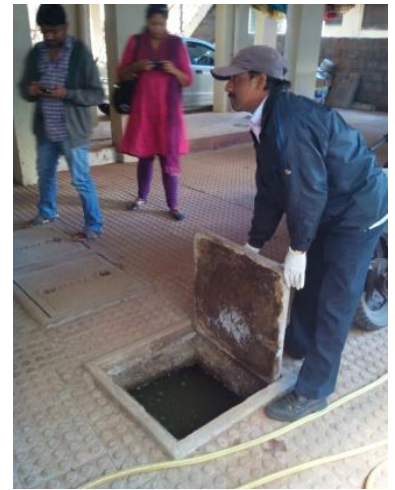
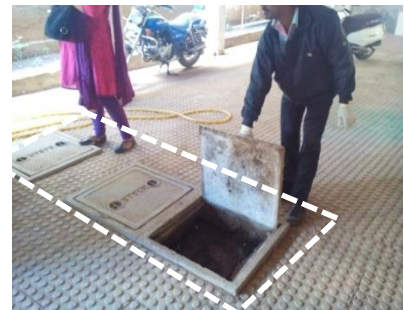
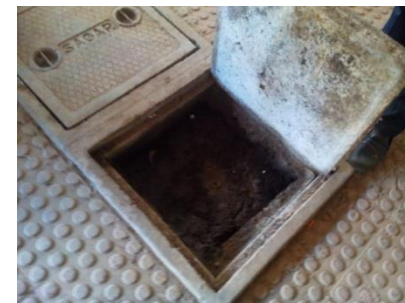
CASE 13: DHARMAPURI, APARTMENT (PRABHAG NO 1)

<u>Users</u> 30	<u>Building type</u> G+2	<u>Inputs to septic tank</u> Black water	<u>Cleaning frequency of ST</u> Once in a every year	<u>When was the septic tank last emptied?</u> In a year 2013 (Cleaning frequency -Once in a year)	<u>How toilet is cleaned?</u> Daily(Water) & Weekly (Harpic/ detergent)
	Length (m)	Breadth (m)	Height (m) (300mm free board has been considered)		Volume of the tank (cu m)
			(Cleaning interval - 2 year)	(Cleaning interval - 3 year)	
Recommended Size of the Septic tank (50 Users) (CPHEEO)	5.00	2.00	1.3	1.54	13.00 (Two year Cleaning Interval) 15.40 (Three year cleaning interval)
	L	B	Height (m)		Volume of the tank (cu m)
Actual Size of the tank (30 Users)	2.5	1.7	1.7		7.23
Observations					Undersized (53% Smaller)

Sr No	Location, Area	Waste water	Parameters										
			BOD (mg/l)			COD (mg/l)			pH		TSS (mg/l)		
			Inlet	Outlet	% Reduction	Inlet	Outlet	% Reduction	Inlet	Outlet	Inlet	Outlet	% Reduction
1	Dharmपुरi	Grey Water	--	87	--	--	210	--	--	7.66	--	108	--
2	Dharmपुरi	Black Water	109	42	61	328	105	67	7.51	7.36	146	48	67

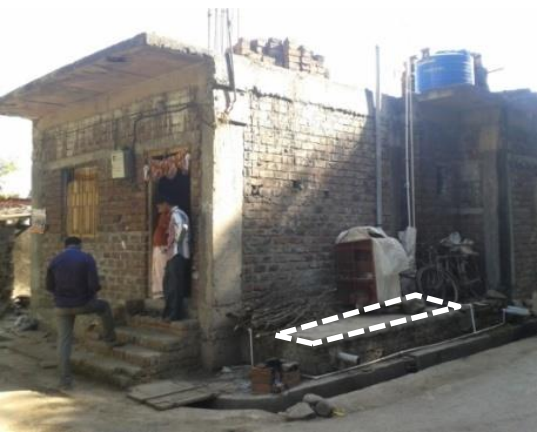
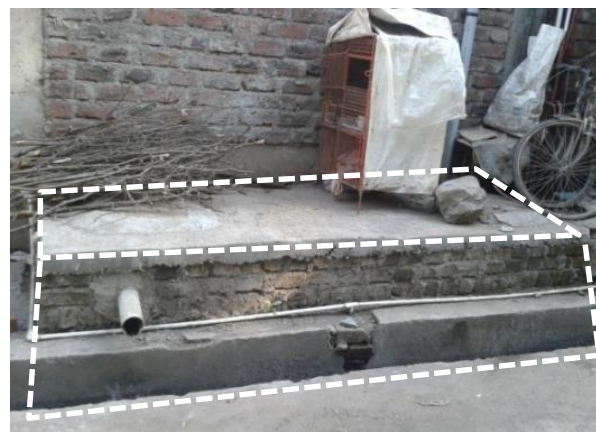
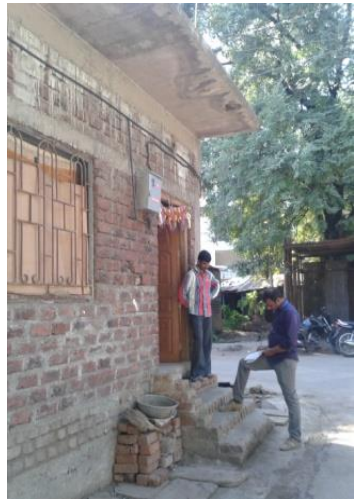
CASE 14: RAVIVAR PETH, INDIVIDUAL PLOT (PRABHAG NO 2)

Length (m)	Breadth (m)	Height (m) (300mm free board has been considered)		Volume of the tank (cu m)
			(Cleaning interval - 2 year)	(Cleaning interval - 3 year)	
Recommended Size of the Septic tank (5 Users) (CPHEEO)	1.50	0.75	1.3	1.35	1.42 (Two year Cleaning Interval) 1.52 (Three year cleaning interval)
	L	B	Height (m)		Volume of the tank (cu m)
Actual Size of the tank (4 Users)	2.7	0.8	1.5		3.24
Observations					Oversized (113% Bigger)

Sr No	Location, Area	Waste water	Parameters										
			BOD (mg/l)			COD (mg/l)			pH		TSS (mg/l)		
			Inlet	Outlet	% Reduction	Inlet	Outlet	% Reduction	Inlet	Outlet	Inlet	Outlet	% Reduction
1	Ravivar Peth	Grey Water	--	88.5	--	--	220	--	--	8.36	--	128	--
2	Ravivar Peth	Black Water	--	93	--	--	210	--	--	7.68	--	134	--

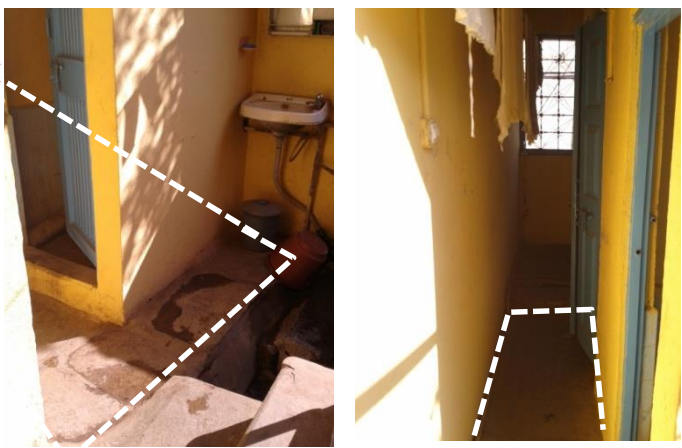
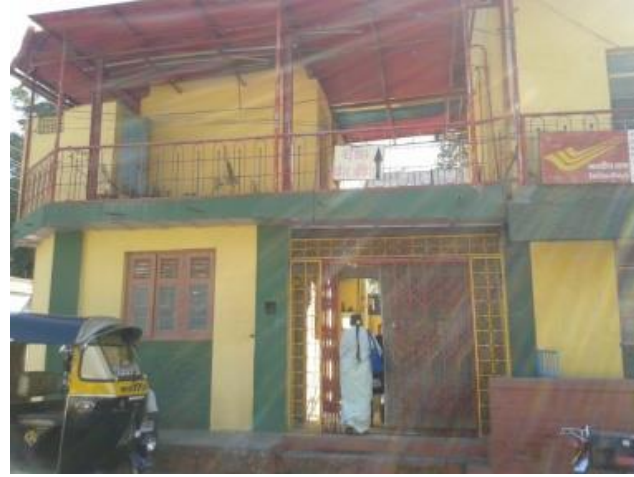
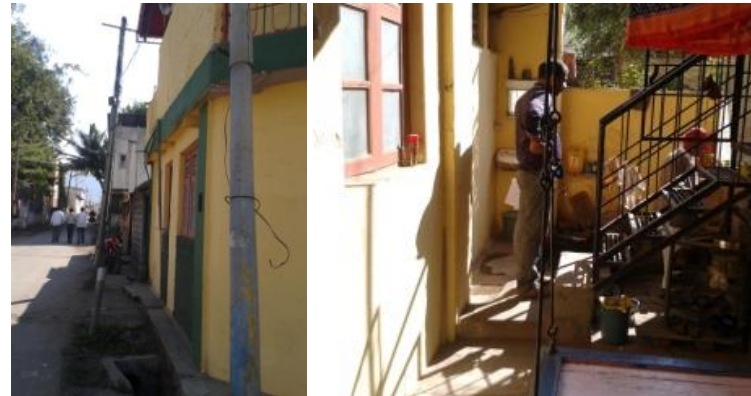
CASE 15: MADHALI ALI, INDIVIDUAL PLOT (PRABHAG NO 3)

<u>Users</u> 2	<u>Building type</u> G+1	<u>Inputs to septic tank</u> Black water	<u>Cleaning frequency of ST</u> One time	<u>When was the septic tank last emptied?</u> Not cleaned (Since year 2009)	<u>How toilet is cleaned?</u> Daily(Water) & Weekly (Harpic/ detergent)
--------------------------	------------------------------------	--	--	---	---

Length (m)	Breadth (m)	Height (m) (300mm free board has been considered)		Volume of the tank (cu m)
			(Cleaning interval - 2 year)	(Cleaning interval - 3 year)	
Recommended Size of the Septic tank (5 Users) (CPHEEO)	1.50	0.75	1.3	1.35	1.42(Two year Cleaning Interval) 1.52(Three year cleaning interval)

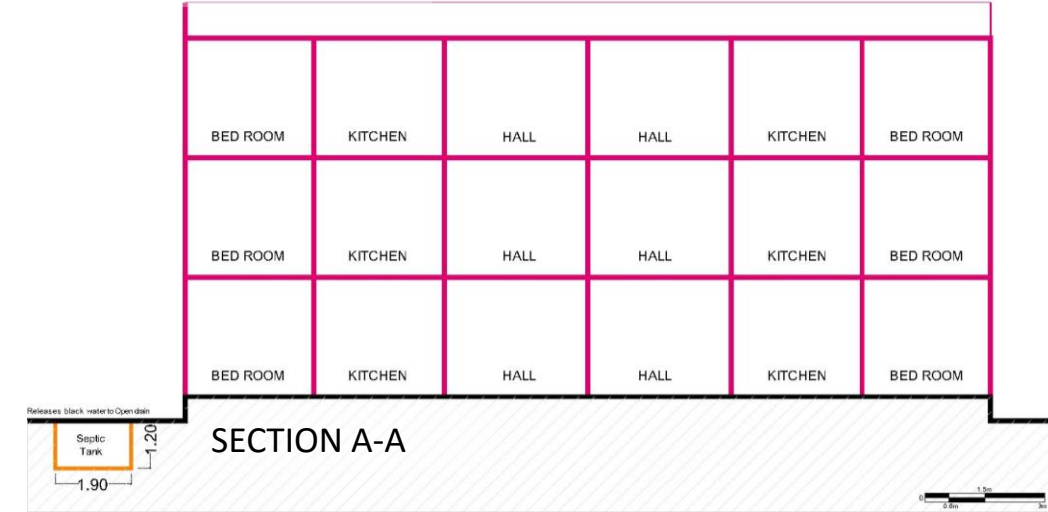
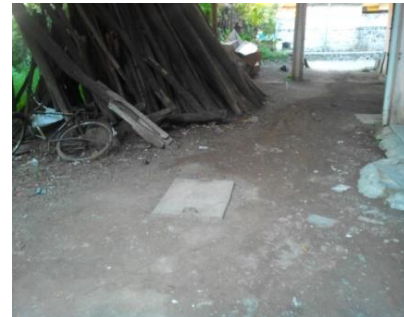
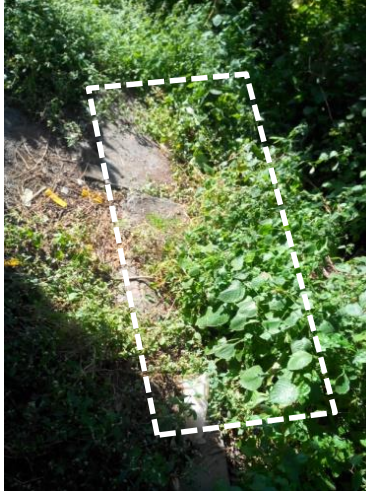
CASE 16: DWARKA ALI, APARTMENT (PRABHAG NO 3)

<u>Users</u> 80	<u>Building type</u> G+2	<u>Inputs to septic tank</u> Black water	<u>Cleaning frequency of ST</u> One time	<u>When was the septic tank last emptied?</u> Not cleaned (Three years ago -2011)	<u>How toilet is cleaned?</u> Daily(Water) & Weekly (Harpic/ detergent)	
		Length (m)	Breadth (m)	Height (m) (300mm free board has been considered)		Volume of the tank (cu m)
				(Cleaning interval - 2 year)	(Cleaning interval - 3 year)	
Recommended Size of the Septic tank (100 Users) (CPHEEO)		7.50	2.65	1.3	1.54	25.84 (Two year Cleaning Interval) 30.61 (Three year cleaning interval)
		L	B	Height (m)		Volume of the tank (cu m)
Actual Size of the tank (80 Users)		2.6	1.9	1.2		5.93
Observations						Undersized (81% Smaller)

Sr No	Location, Area	Waste water	Parameters										
			BOD (mg/l)			COD (mg/l)			pH		TSS (mg/l)		
			Inlet	Outlet	% Reduction	Inlet	Outlet	% Reduction	Inlet	Outlet	Inlet	Outlet	% Reduction
1	Dwarka Ali	Raw Swage	--	10.2	--	--	38.2	--	--	7.66	--	13	--
2	Dwarka Ali	Black Water	142	115	19	428	358	16	7.43	7.67	191	154	20

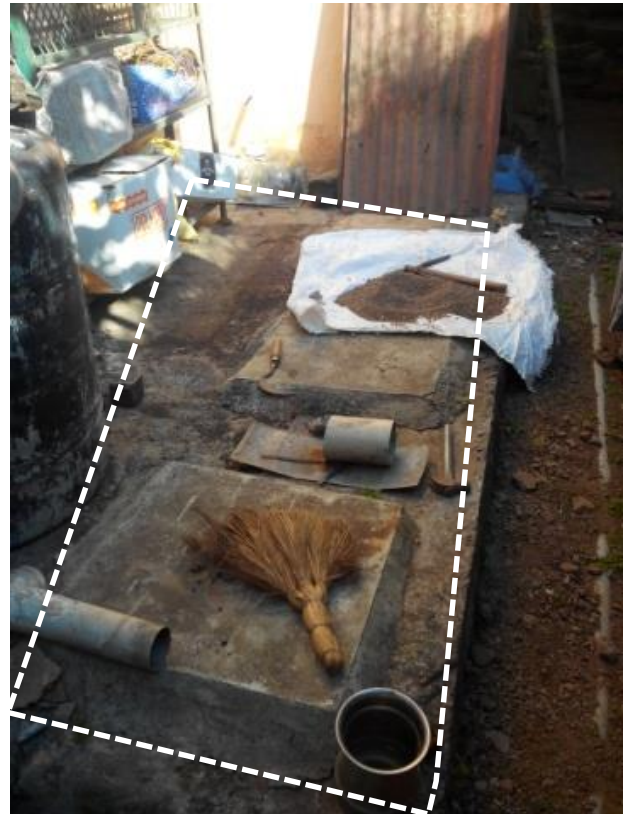
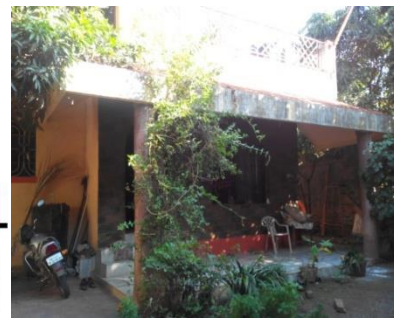
CASE 17: DWARKA ALI, BUNGLOW (PRABHAG NO 3)

<u>Users</u> 5	<u>Building type</u> Ground Floor	<u>Inputs to septic tank</u> Black water	<u>Cleaning frequency of ST</u> Nil	<u>When was the septic tank last emptied?</u> Not yet cleaned (Since construction year 2000)	<u>How toilet is cleaned?</u> Daily(Water) & Weekly (Harpic/ detergent)
	Length (m)	Breadth (m)	Height (m) (300mm free board has been considered)		Volume of the tank (cu m)
			(Cleaning interval - 2 year)	(Cleaning interval - 3 year)	
Recommended Size of the Septic tank (5 Users) (CPHEEO)	1.50	0.75	1.3	1.35	1.46(Two year Cleaning Interval) 1.52(Three year cleaning interval)
	L	B	Height (m)		Volume of the tank (cu m)
Actual Size of the tank (5 Users)	3.2	1.4	1.2		5.98
Observations					Oversized (293% Bigger)

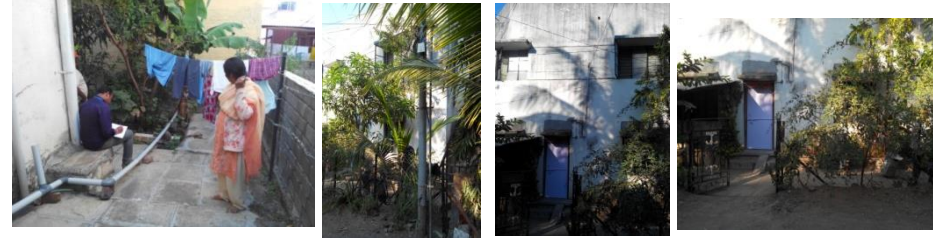
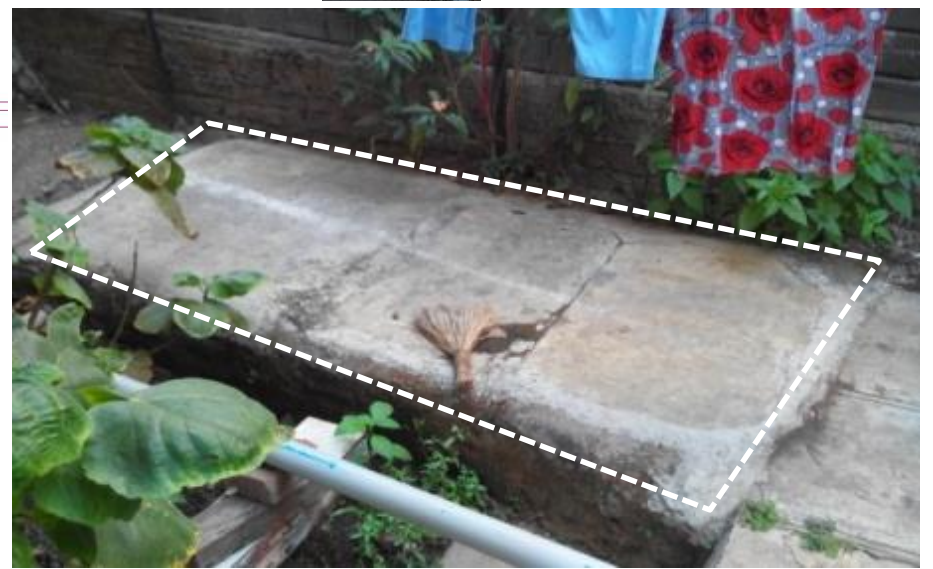
CASE 19: SIDHNATH WADI, BUNGLOW (PRABHAG NO 4)

<u>Users</u> 2	<u>Building type</u> G+1	<u>Inputs to septic tank</u> Black water	<u>Cleaning frequency of ST</u> More than two times	<u>When was the septic tank last emptied?</u> Two years ago-2012	<u>How toilet is cleaned?</u> Daily(Water) & Weekly (Harpic/ detergent)
			Height (m) (300mm free board has been considered)		Volume of the tank (cu m)
	Length (m)	Breadth (m)	(Cleaning interval - 2 year)	(Cleaning interval - 3 year)	
Recommended Size of the Septic tank (5 Users) (CPHEEO)	1.50	0.75	1.3	1.35	1.46(Two year Cleaning Interval) 1.52(Three year cleaning interval)
	L	B	Height (m)		Volume of the tank (cu m)
Actual Size of the tank (5 Users)	2.2	1.1	1.3		3.15
Observations					Oversized (107% Bigger)

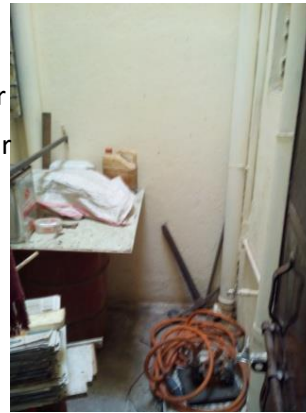
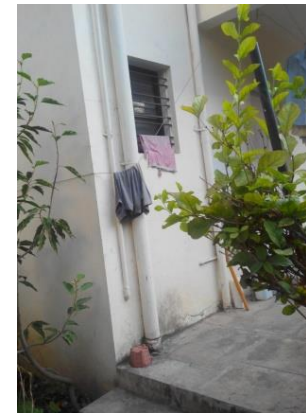
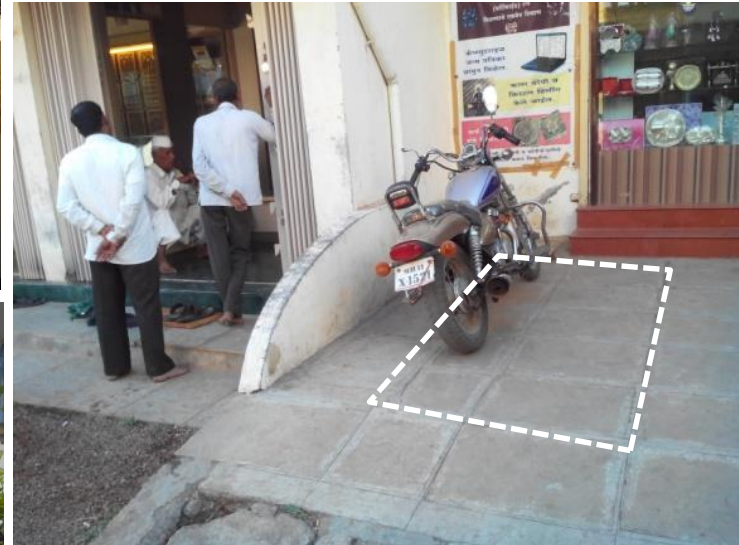
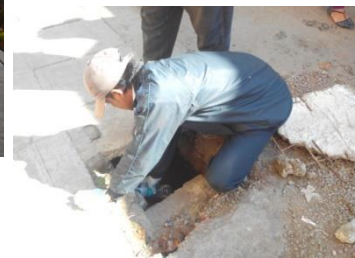
CASE 20: DHARMPURI, APARTMENT (PRABHAG NO 4)

<u>Users</u> 20	<u>Building type</u> G+2	<u>Inputs to septic tank</u> Black water	<u>Cleaning frequency of ST</u> One time	<u>When was the septic tank last emptied?</u> Two years ago-2012	<u>How toilet is cleaned?</u> Daily(Water) & Weekly (Harpic/ detergent)
---------------------------	------------------------------------	--	--	--	---

Length (m)	Breadth (m)	Height (m) (300mm free board has been considered)		Volume of the tank (cu m)
			(Cleaning interval - 2 year)	(Cleaning interval - 3 year)	
Recommended Size of the Septic tank (20 Users) (CPHEEO)	2.3	1.10	1.6	2.1	4.04 (Two year Cleaning Interval) 5.31 (Three year cleaning interval)
	L	B	Height (m)		Volume of the tank (cu m)
Actual Size of the tank (20 Users)	2.3	1.6	1.2		4.41
Observations					Undersized (17% Smaller)

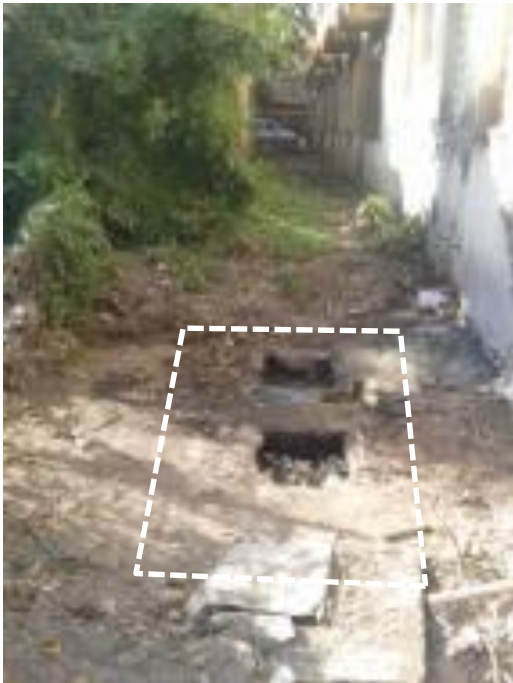
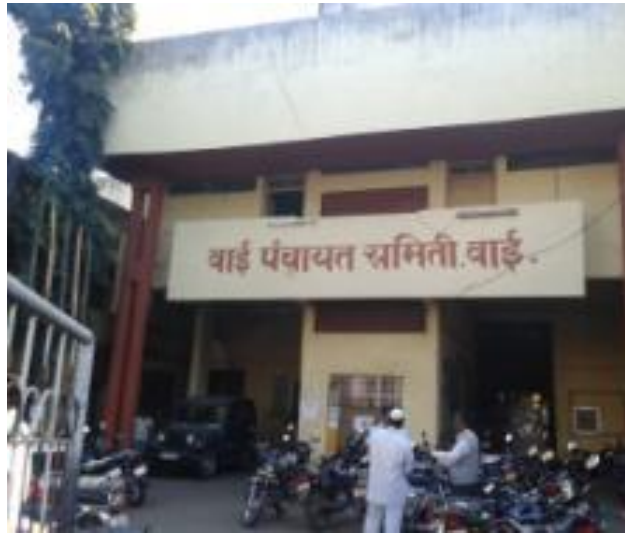
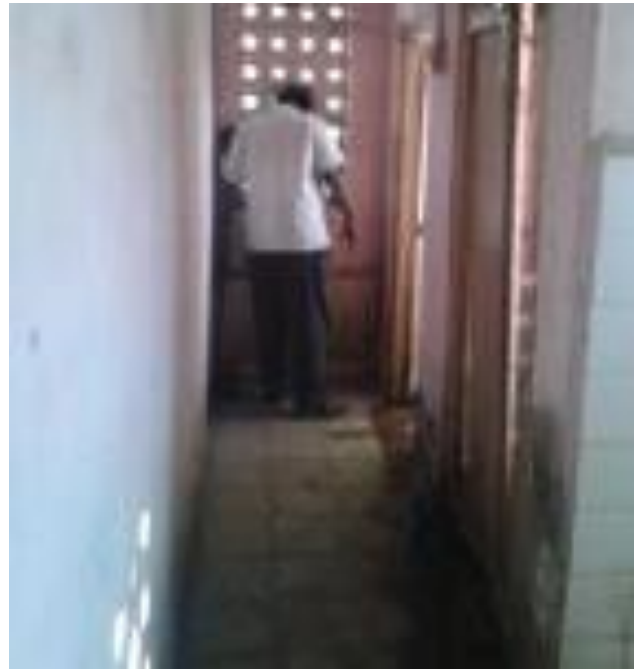
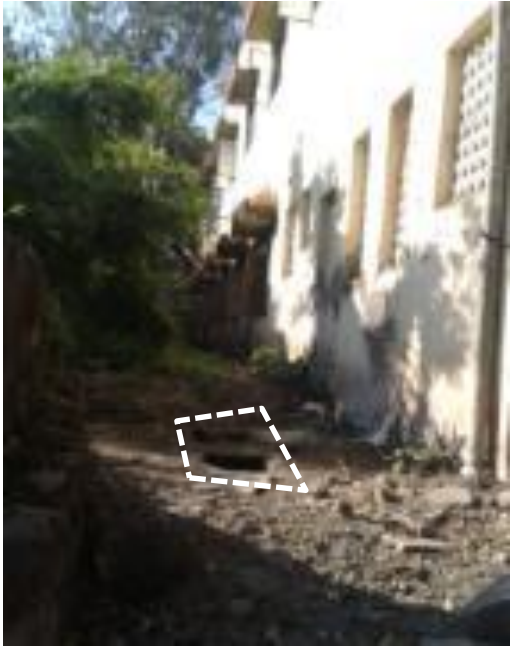
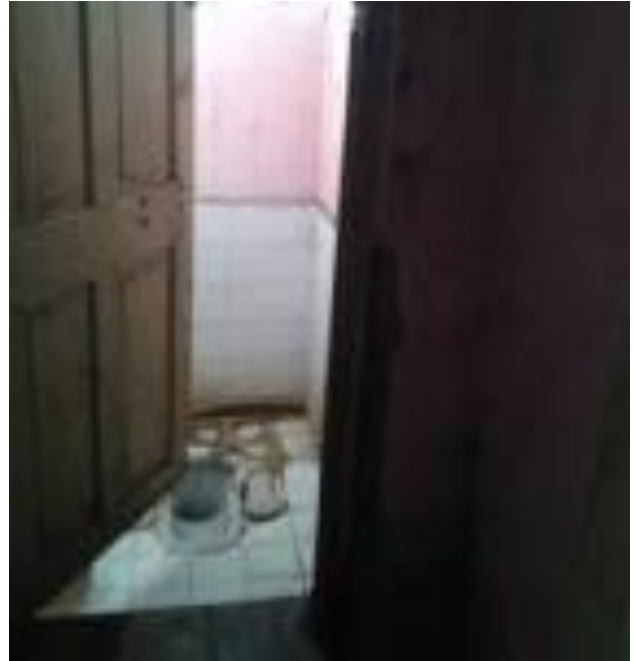
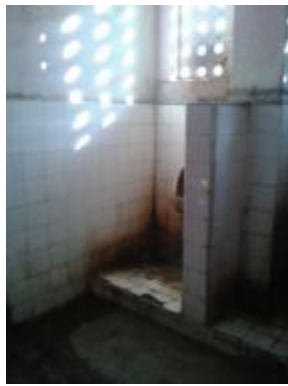
CASE 23: PANCHAYAT SAMITI (PRABHAG 5)

<i>Panchayat Samiti</i>					
<u>User s</u> 210	<u>Building type</u> G+1	<u>Inputs to septic tank</u> Black Water	<u>Cleaning Frequency of ST</u> Nil	<u>When was the septic tank last emptied?</u> Not Cleaned (More than 8 years)	<u>How toilet is cleaned?</u> Daily (Water) & Weekly (Harpic)
		Length (m)	Breadth (m)	Height (m) (300mm free board has been considered)	Volume of the tank (Cum)
Size of the Septic tank (200 Users) (<i>As per Expert/Consultant</i>)		5	1.6	1.3 (Cleaning interval of one year)	10.4 (Cleaning interval of one year)
Actual Size of the tank (121 Users)		3.4	2.22	1.5	11.32
Observation					Oversized (9 % bigger)

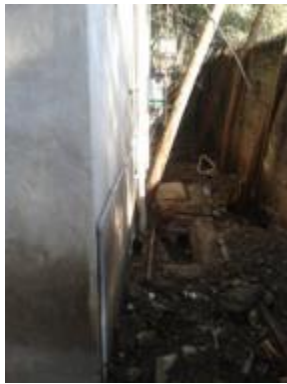
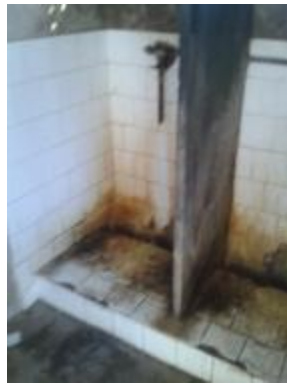
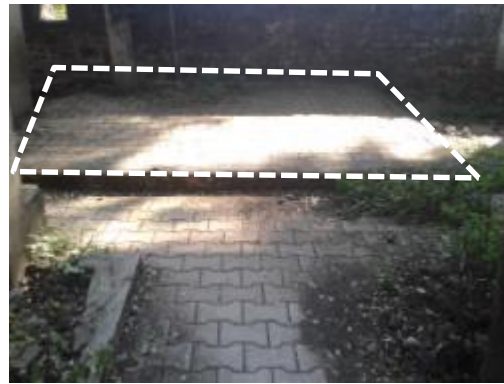
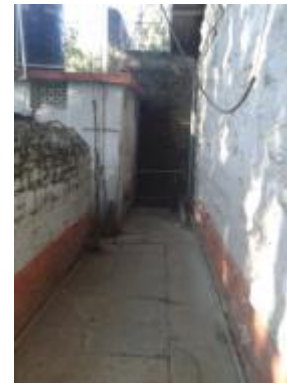
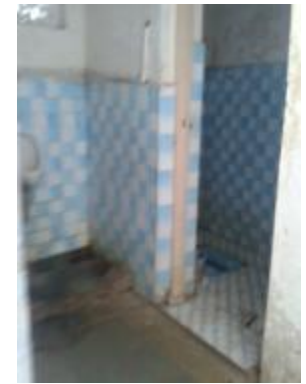
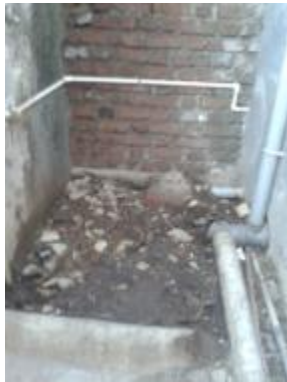
CASE 25: POLICE STATION, TEHSHIL OFFICE, COLLECTOR OFFICE (PRABHAG 5)

Police station, Tehshil office, Collector office													
<u>Users</u> 135	<u>Building type</u> Ground Floor	<u>Inputs to septic tank</u> Black Water	<u>Cleaning Frequency of ST</u> Nil			<u>When was the septic tank last emptied?</u> Not Cleaned (More than 5-10 years)				<u>How toilet is cleaned?</u> Daily (Water) & Weekly (Harpic)			
		Length (m)	Breadth (m)			Height (m) (300mm free board has been considered)				Volume of the tank (Cum)			
Size of the Septic tank (150 Users) (<i>As per Expert/Consultant</i>)		4.2	1.4			1.3 (Cleaning interval of one year)				7.64 (Cleaning interval of one year)			
Actual Size of the tank (135 Users)		2.5	1.1			1.5				4.125			
Observation										Undersized (46% Smaller)

Sr No	Location, Area	Waste water	Parameters										
			BOD (mg/l)			COD (mg/l)			pH		TSS (mg/l)		
			Inlet	Outlet	% Reduction	Inlet	Outlet	% Reduction	Inlet	Outlet	Inlet	Outlet	% Reduction
1	<i>Police station</i>	Black water	420	330	21	1120	895	20	--	7.46	625	588	5

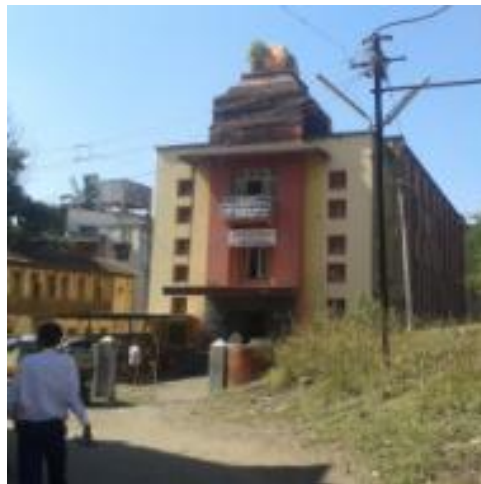
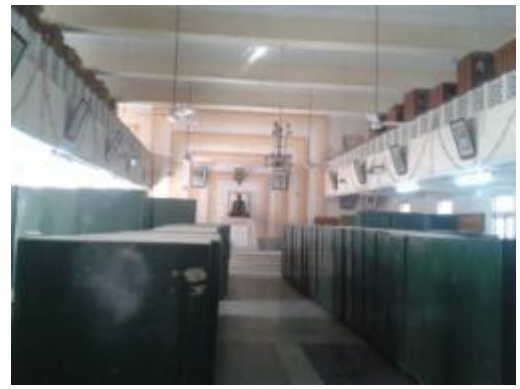
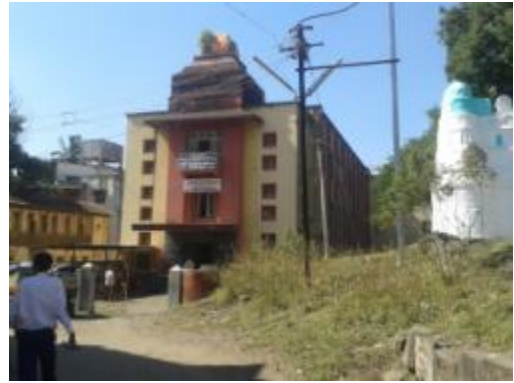
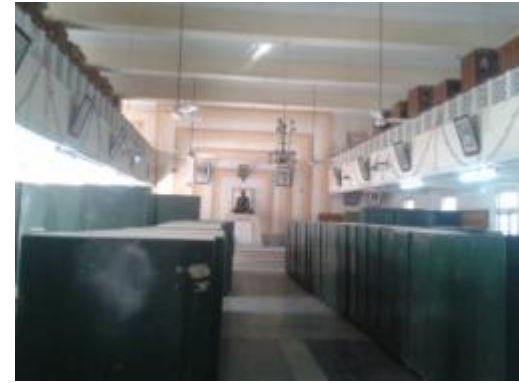
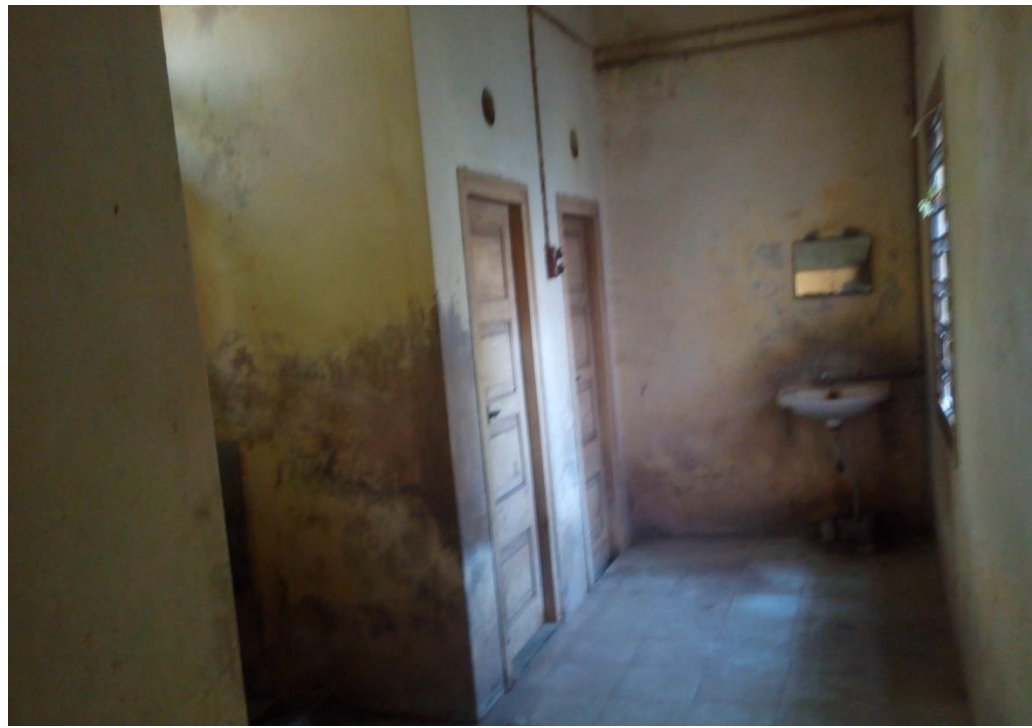
CASE 26: VISHWAKOSH EDUCATION CENTER (PRABHAG 1)

Sr No	Location, Area	Waste water	Parameters										
			BOD (mg/l)			COD (mg/l)			pH		TSS (mg/l)		
			Inlet	Outlet	% Reduction	Inlet	Outlet	% Reduction	Inlet	Outlet	Inlet	Outlet	% Reduction
1	<i>Vishwakosh</i>	Black water	--	156	--	--	205	--	--	7.45	--	128	--

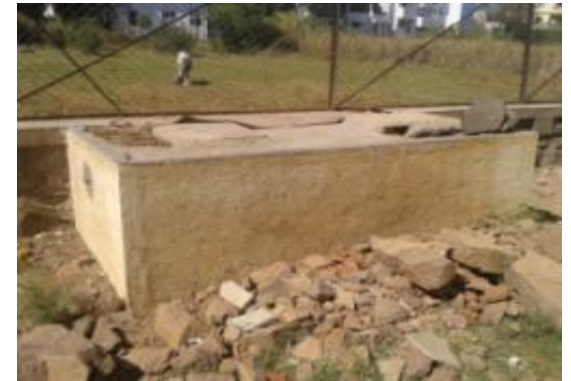
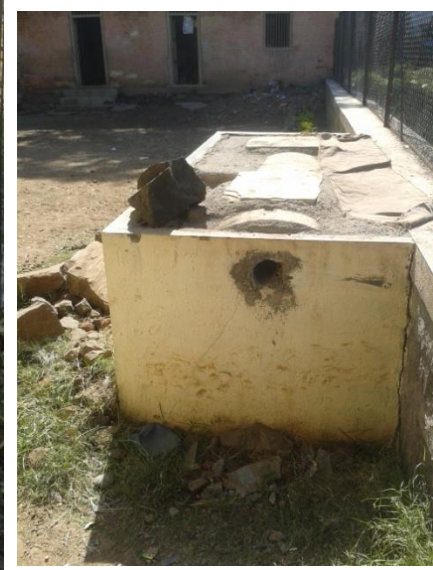
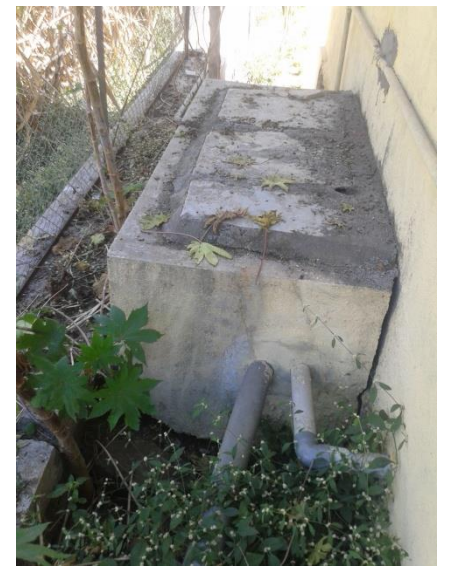
CASE 27: SCHOOL (MARATHI) (PRABHAG 1)

Police station, Tehshil office, Collector office					
<u>Users</u> 264	<u>Building type</u> G	<u>Inputs to septic tank</u> Black Water	<u>Cleaning Frequency of ST</u> Nil	<u>Cleaning frequency of the tank</u> Not Cleaned (More than 5 years)	<u>How toilet is cleaned?</u> Daily (Water) & Weekly (Harpic)
	Length (m)	Breadth (m)	Height (m) (300mm free board has been considered)	Volume of the tank (Cum)	
Size of the Septic tank (300 Users) (As per Expert/Consultant)	6.0	2.06	1.3 (Cleaning interval of one year)	15.6 (Cleaning interval of one year)	
Actual Size of the tank (264 Users)	2.1	0.94	1.2	2.41	
				Observation	Undersized (85% Smaller)

Sr No	Location, Area	Waste water	Parameters										
			BOD (mg/l)			COD (mg/l)			pH		TSS (mg/l)		
			Inlet	Outlet	% Reduction	Inlet	Outlet	% Reduction	Inlet	Outlet	Inlet	Outlet	% Reduction
1	<i>School</i>	Black water	354	307.5	13	935	865	7	8.85	8.21	456	288	36

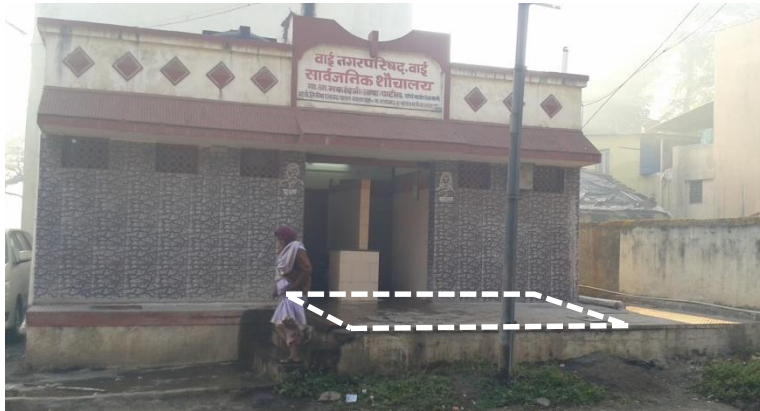
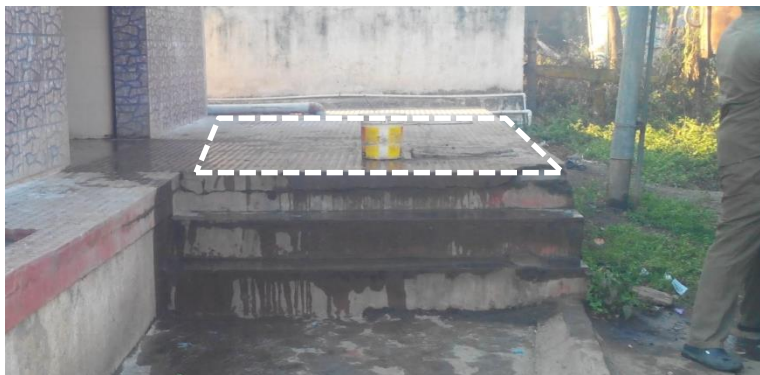
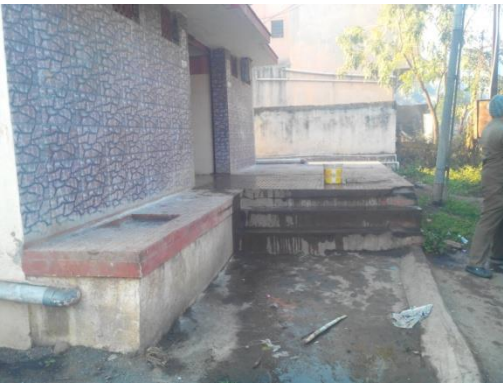
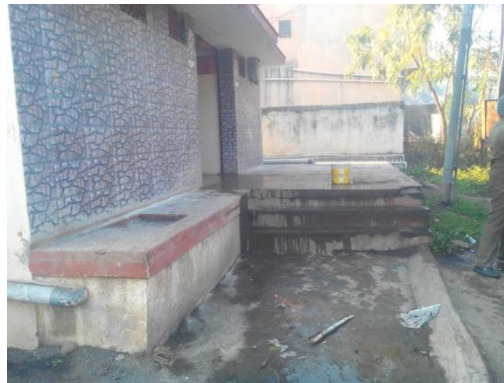
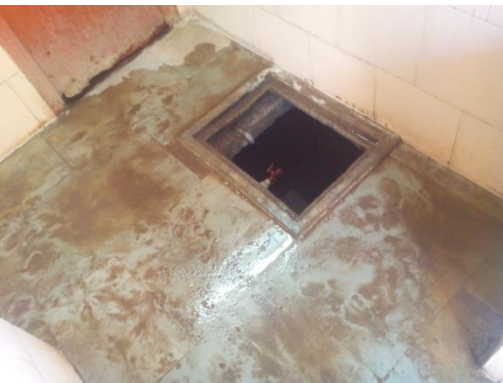
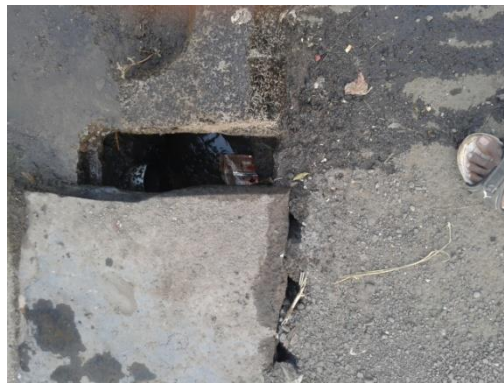
CASE 2: COMMUNITY TOILET (Opposite Bus Stand) (PRABHAG 5)

Users 210	Building type Community toilet	Inputs to septic tank Black water	Cleaning frequency of the tank Once in a every 8-10 days	How toilet is cleaned? Weekly	
		Length (m)	Breadth (m)	Height(m) (300 mm free board has been considered)	Volume of the septic tank (Cu m)
Actual Size of the tank	4.5	2.0	1.8	16.2	
Size of the Septic tank (210 Users) (Calculated based on certain assumption for same has been mentioned in previous slide)	7.37	2.29	1.34	24.25 (One year cleaning interval)	
<p>References: Indian Standards (2470 (PART 1) -1958), " Code of practices for installation of septic tanks", Design criteria and construction (Second revision) CPHEEO manual 2013 (Chapter 9) The capacities are recommended on the assumption that the discharges from only WC will be treated in the septic tank.</p>				Undersized (33% Smaller)

•In both cases the size of septic tank is not sufficient, the local body have to clean this tank once in a every month because the tank is fill in very short period of time. After that suspended solids come along with outlet and creates unhygienic condition.

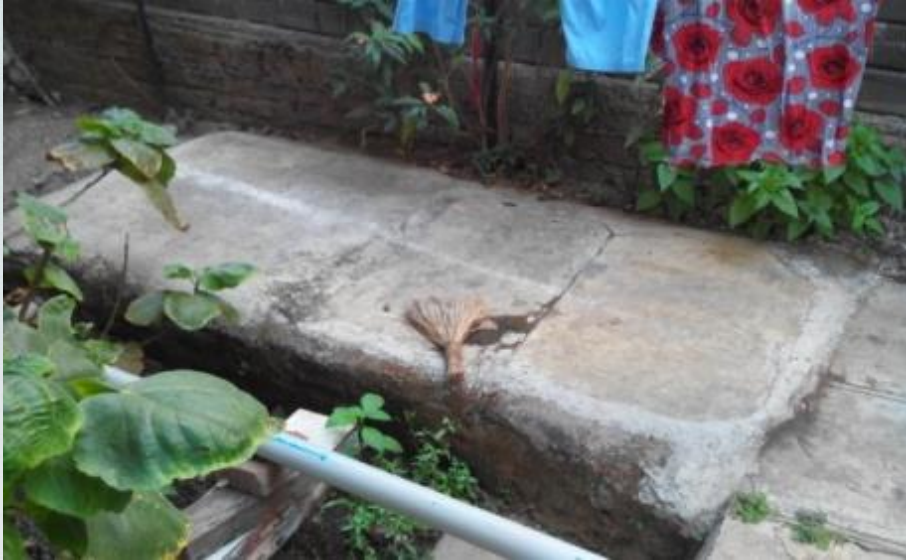
GENERAL OBSERVATION-SEPTIC TANKS

In some of the cases no ventilation pipes have been provided to the septic tanks. This is leading to significant odour problems in the vicinity

In few cases the septic tanks are not accessible for maintenance and repairs. This is probably due to location of them below the toilet blocks

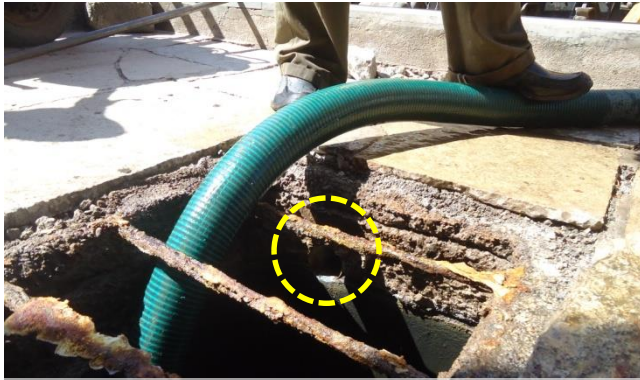
Case 4: Fulenagar, No proper design for inlet pipe

1.) Inlet/ Outlet Pipe: As per best practices for construction of a septic tank, it is advisable to use a T-junction pipe joint at both the inlet and outlet of the septic tank. Usually 100 mm diameter PVC pipes are used for the purpose.

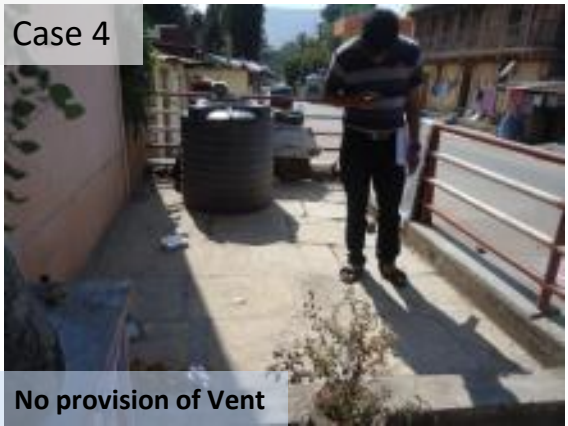
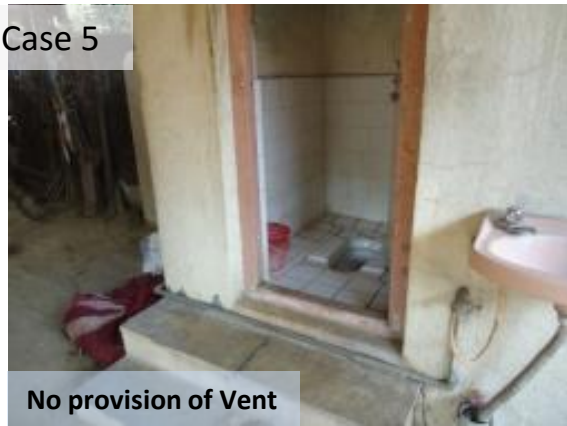
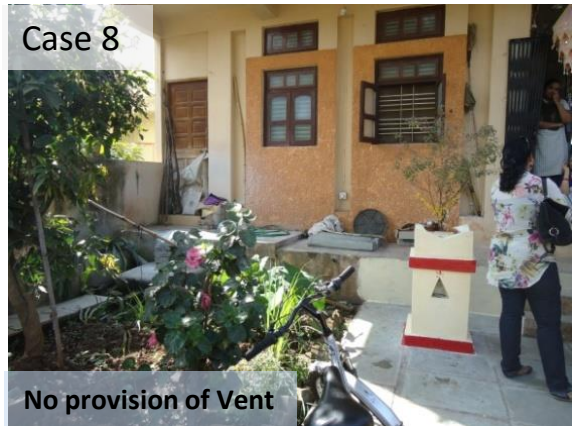
2.) Ventilation Pipes: In the cases studied, in several cases the ventilation pipes required for the septic tanks is absent. In a few cases ventilation pipes have been provided above the inspection chambers only.

2.) Ventilation Pipes: (contd)

For efficient working of the septic tanks the methods adopted for constructing a Septic tank must be as shown in the adjacent diagram.

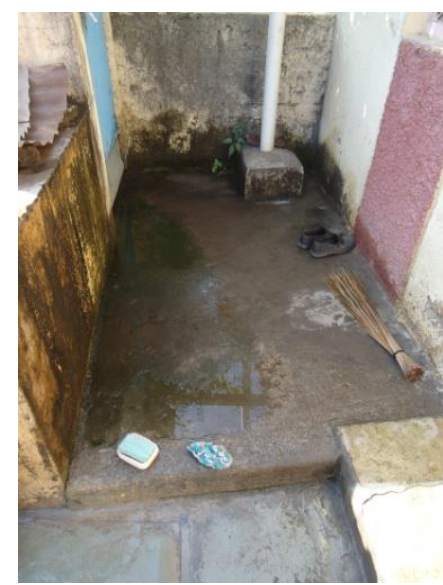
In few cases the septic tanks had no accessibility due to the location of septic tanks below the toilet block.

Case no 7: *Nhavi Ali*
No provision of lid/
openings

Ideally a septic tank must have atleast two manholes of adequate size and must be covered properly with a concrete lid. This opening help for keeping the maintenance of the septic tanks and the lids prevent odour problems as well as any mishaps/ accidents.

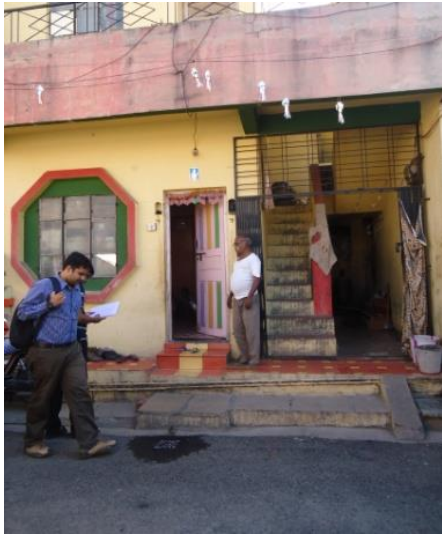
Proposed T Junction:
Two number of T Junction required

4. CONSTRUCTION OF T JUNCTION AND NECESSARY PIPE CONNECTIONS

Installation of ventilation pipe	Criteria (IS CODE:2470)	Amount (INR)
PVC pipe (1 m)	100 mm dia (Not less than 50 mm dia)	178
2 T Joint	100 mm dia	240
Total (INR)		418

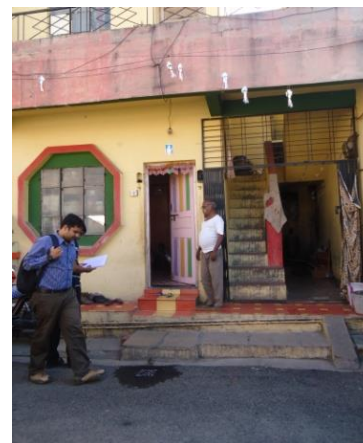
Case no 3: Damle Ali

- No provision of lid/ openings
- Volume of septic tank: Oversized
- Inlet: Only Black water
