Sanitation Service Delivery in West Africa: Report to PSI on Product Scan Findings

Benin

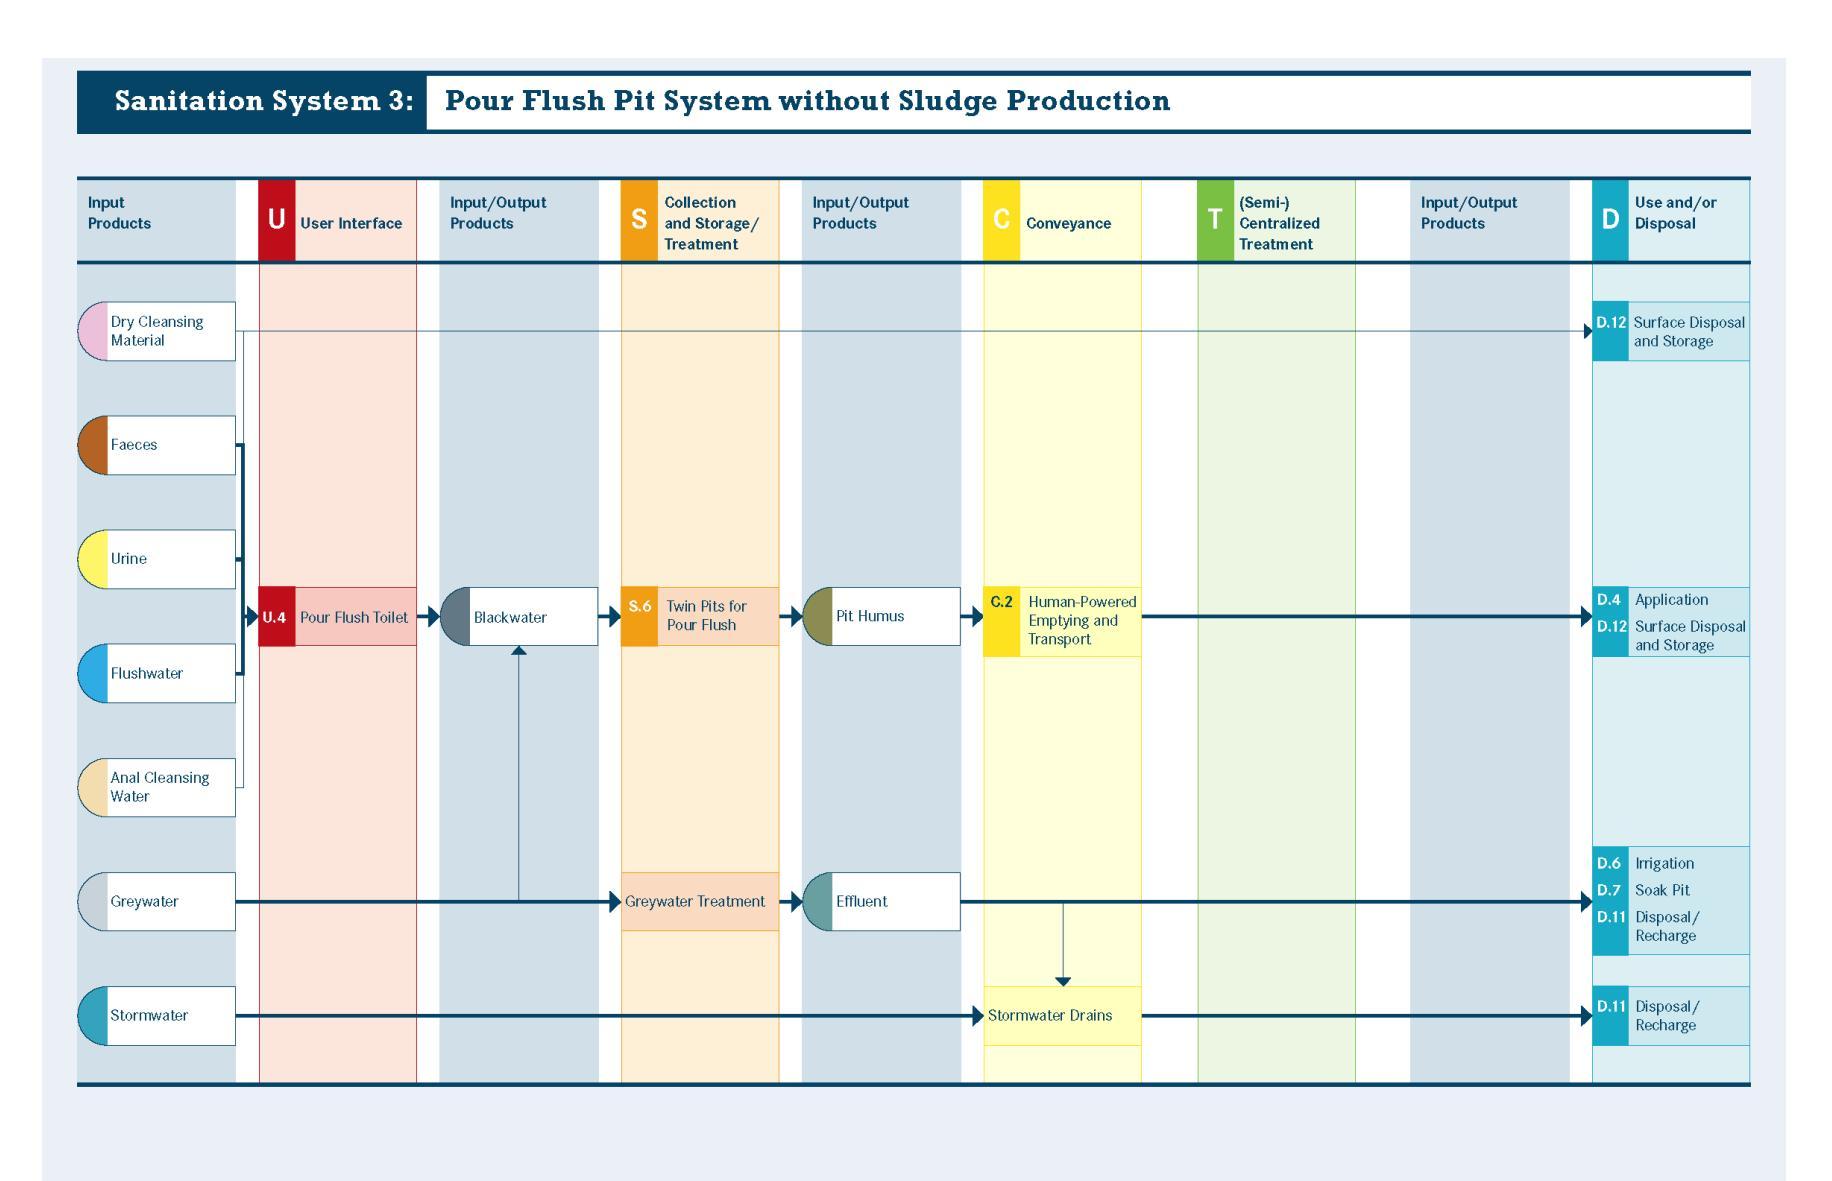
Figure 1. Eawag Sanitation System 3.

According to this model, the sanitation system consists of input and output "products" (such as feces and blackwater, urine, flush and washing water) which move through "functional groups" (such as "user interface") within the system via technologies (such as "pour-flush toilet"). Eawag's model provides a holistic framework for considering the logical combination of technologies within the sanitation system as well as the impact of technologies on the movement of "products" through the system (see Figure 1 below). Eawag identifies nine sanitation system templates in their compendium, although they note that other combinations of technologies may be configured.

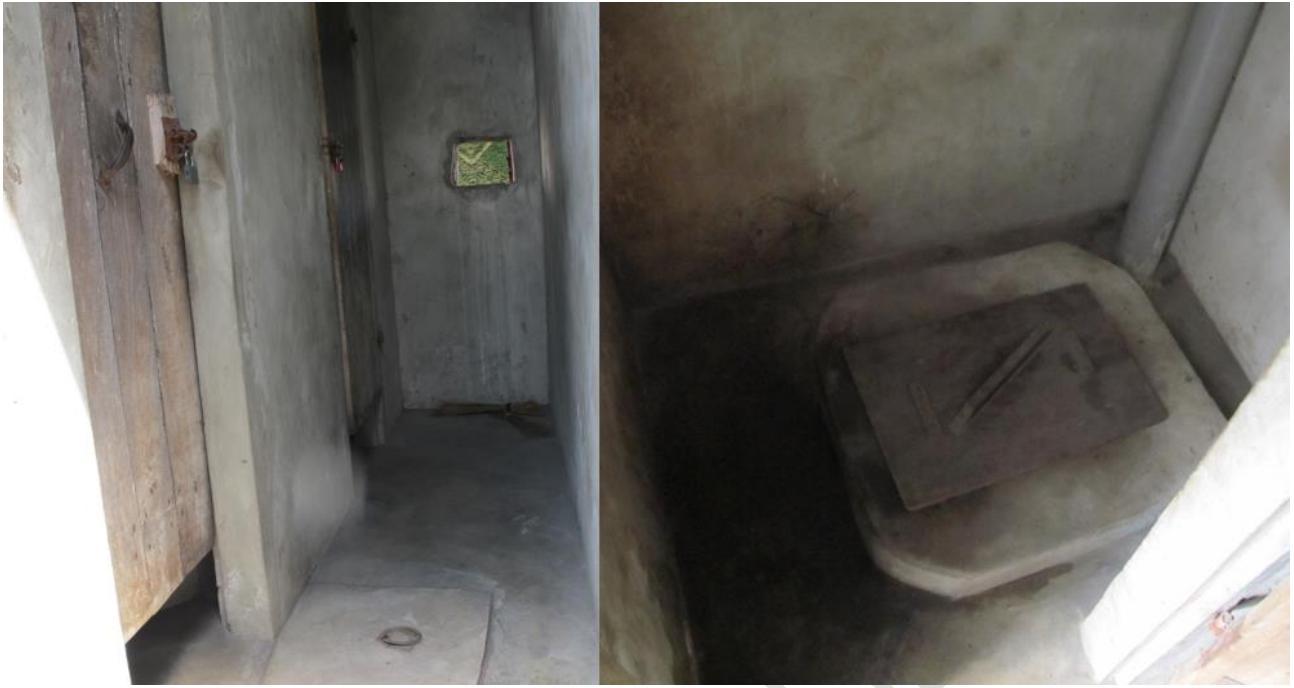
Figure 2. This compound latrine includes two stalls for users from three households and illustrates a clean, well-maintained latrine. The image on the left shows a clean, dry cement structure with locking doors. Note also the access window for emptying the tank. The image on the right depicts a clean stall with a lid over the squat plate and a ventilation pipe to limit pests and odors.

In general, the density of users per latrine is lower than was found in the product scan research in Côte d'Ivoire. Private, single households (n = 5) reported between 1 and 15 users with one or two toilets available on the household property. Landlords and respondents with compound (or shared) latrines (n = 12) reported between 3 to 15 households sharing the latrines. Two respondents did not report the number of households in their compound. Both tenants and landlords counted the number of doors within a compound to determine the number of households. Reported household size for households using shared latrines ranged from 1 to 12 people with two to four toilets per compound. Researchers at Eawag have found that when compound latrines are used, fewer than four households sharing one improved latrine is acceptable for maintaining the latrine such that it continues to provide improved, shared sanitation.8 Among the compounds we visited, only two had more than four households per latrine, while the average was less than three. See Figure 2 for an example of a well-maintained latrine.

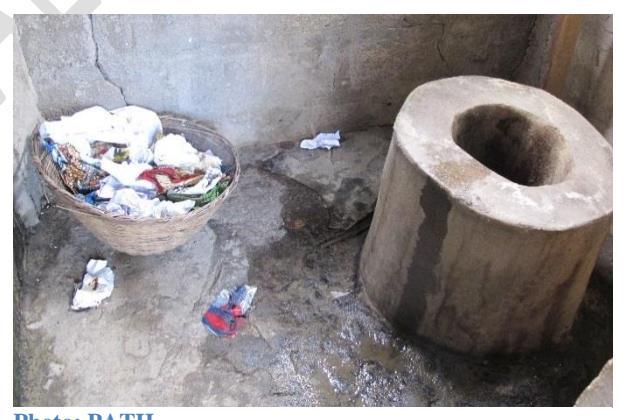
Photo: PATH Figure 3. Burn bin to collect cleansing paper.

According to all landlords, the latrines in their compounds are cleaned on a weekly basis. Many end users also said that their latrines are cleaned weekly. Cleaning may be done using water, soap, and bleach. Some respondents mentioned also using deodorizers and/or pesticides when they could afford them. For compounds and households practicing dry cleansing, paper is often collected in a bin in each stall and may be burned as part of the cleaning duties (Figure 3).

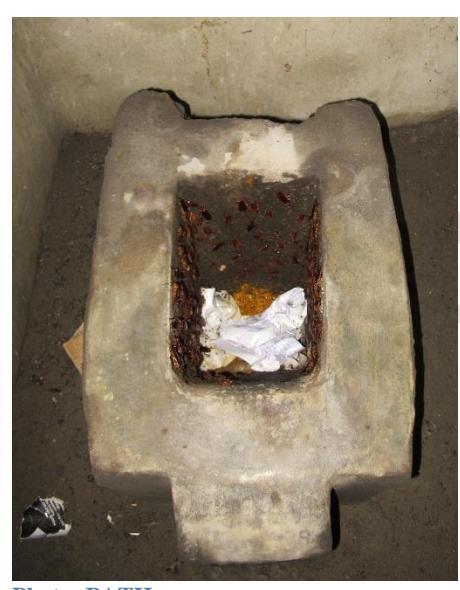
Photo: PATH Figure 4. The presence of feces, flies, maggots, cockroaches, urine, and a general lack of cleaning and maintenance are a major concern among end users and landlords.

When asked what they do not like about their current sanitation facilities, a major shared dislike of end users and landlords is a lack of cleanliness, including the presence of feces, flies, maggots, cockroaches, urine, and a general lack of cleaning and maintenance (see Figure 4). Another significant and related dislike is odor. This is reflected in our facility assessments in which we recorded medium to high odor in 12 of 18 latrines.

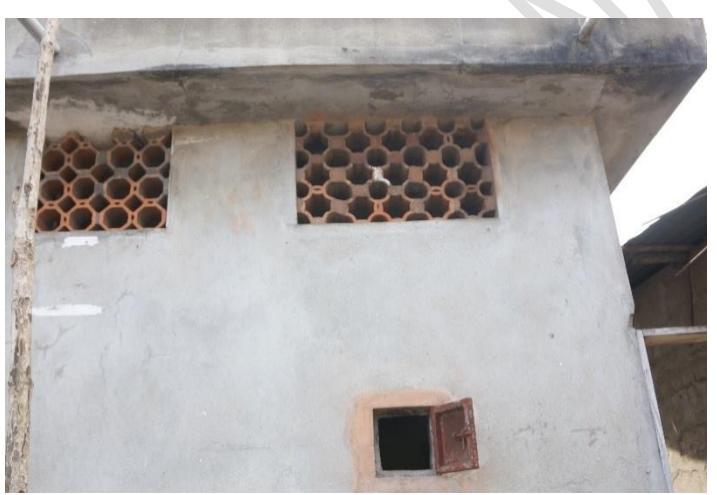
Photo: PATH Figure 6. A small window with a latching door enables vidange trucks easy access to tanks for emptying.

located on a very rough, deeply rutted road, and the respondent reported that the vidange truck had no difficulty traveling on this road. We observed that several latrines have small windows built into the wall of the latrine facing the street to enable hoses from vidange trucks easy access to tanks for emptying (Figure 6).

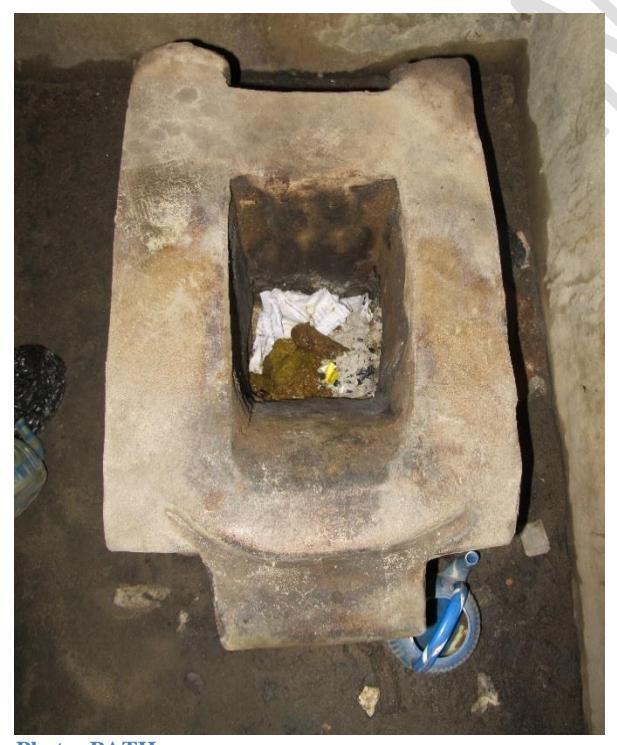
Photo: PATH Figure 7. Several users reported very full tanks in their latrines, suggesting landlords may delay emptying.

The reported cost for vidange services varied. While tenants and private homeowners reported the cost for emptying services to be 45,000 CFA, landlords reported much higher emptying costs, ranging between 95,000 and 120,000 CFA. This discrepancy may be because the vidange association sets the cost for emptying at 45,000 CFA for a 6m³ tank. This value is widely known, and tenants, who may not actually have to pay the bill, have been sensitized to this publicized amount while landlords may be quoting the actual cost they pay, and they may be paying to empty larger tanks that exceed the 6m³ capacity. Regardless, the costs for emptying services reported are much higher than in Côte d'Ivoire, where respondents reported emptying costs ranging between 12,500 and 26,000 CFA per trip. In fact, one landlord responded that his motivation for renting units was to help pay for the high cost of emptying services. Several tenants also noted that the tanks in their latrines were very full. One complained that liquid would splash up when they used the latrine, suggesting that landlords may delay emptying, possibly due to high costs (see Figure 7).

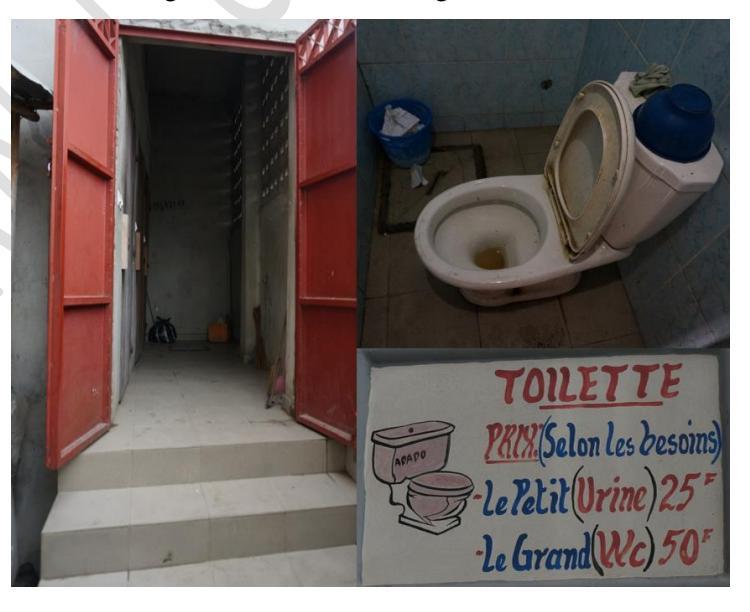
Photo: PATH Figure 8. Public, pay-per-use latrine with three pour-flush toilets.

draw water from the well and fill large, portable tanks outside the latrines so users can fill small buckets to manually flush the toilets. Due to the high volume of use, drawing such a large amount of water from the well becomes a burdensome task. She also suggested that additional toilets should be added to accommodate the high number of users during peak times and that showers could be installed, as she is often asked whether showers are available at the facility.

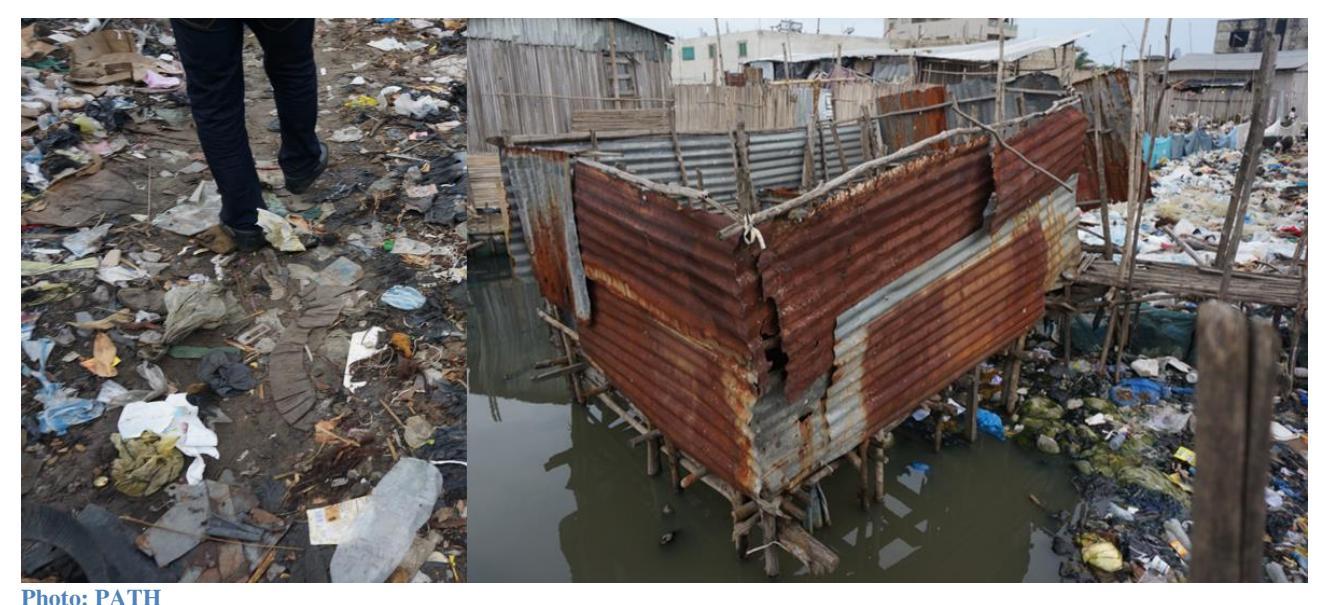
Figure 9. Public pay-per-use latrine over the lagoon. In the left image, users must walk along a path through a garbage dump, along which children defecate, to reach the latrines. In the image on the right, the women's latrine is collapsing into the lagoon; plans are in place to replace it by December 2015.

The PLB hanging over the lagoon was constructed 20 years ago by a local entrepreneur in response to the public need and has separate facilities for men and for women. These latrines are accessed by walking through a garbage dump and then crossing an unstable wooden bridge. Because of the danger of falling into the water, children younger than eight or nine years of age defecate along the path to the latrines. The latrines are poorly constructed and made out of wood and sheet metal, which degrade quickly in the wet environment of the lagoon. At the time of the interview, the women's latrine had fallen into such disrepair that it was collapsing into the lagoon (Figure 9).

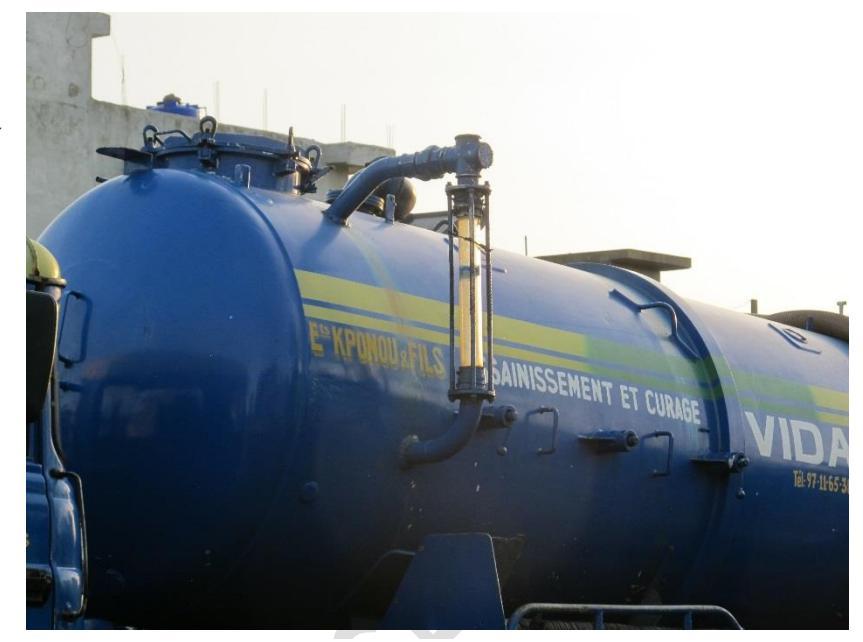
Photo: PATH Figure 11. Many of the vacuum trucks had a translucent visual level attached to their tanks.

During the site visits and interviews, the study team observed that many of the vacuum trucks had a translucent visual level attached to their tanks (Figure 11). This was something unique to Benin and was not seen in Côte d'Ivoire. The site manager noted that these levels are common in Benin and that the majority of secondhand trucks come with these levels already installed.

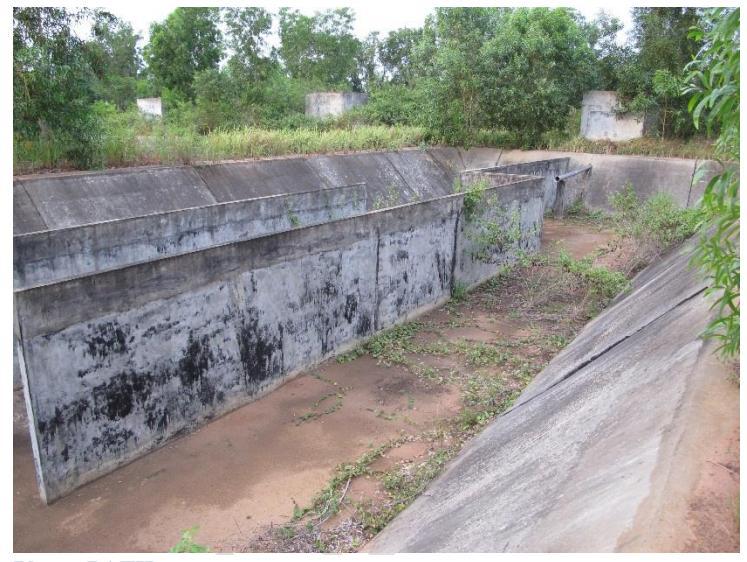
Photo: PATH Figure 12. The Takon Waste Management site was completed in 2005 and has never been used.

sludge treatment facility: four parallel systems of three ponds or lagoons (anaerobic, facultative, and maturation) each. The four systems end at a large drving bed for the sludge. While the treatment facility was completed in 2005, it has never been used (Figure 12). The respondent noted that the mayor's office in Porto Novo was originally expected to pay for the ongoing operational costs, which the mayor's office subsequently refused to do. The Ministry of the Environment oversaw the project and has the baseline assessment and technical documents; however, about ten years ago Benin underwent a shift to commune governance (decentralized from national to 77 communes) and documents were not transferred over. Since the Porto Novo commune does not have the technical documents for the Takon lagoon system, the

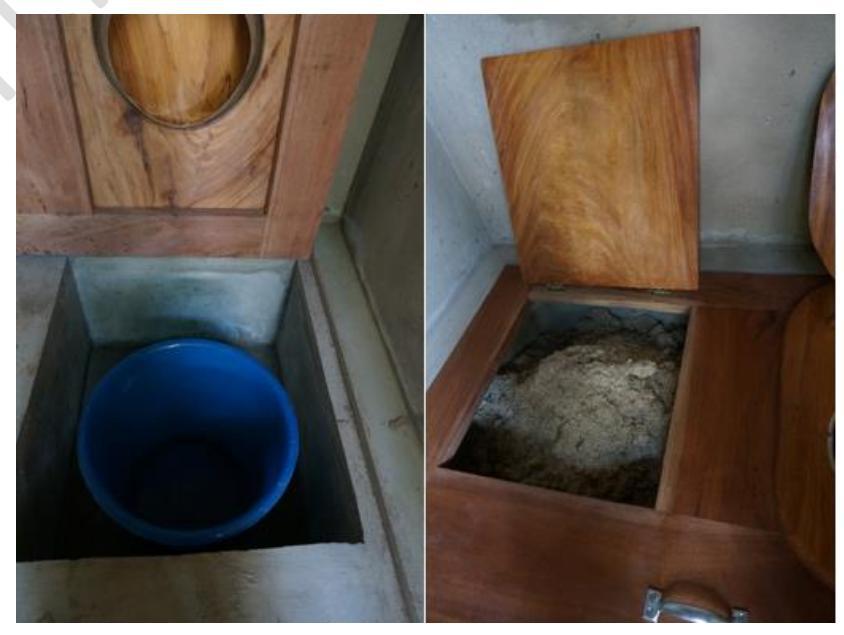
Photo: PATH Figure 14. Ecological sanitation toilets at Songhai.

The ecological sanitation toilets at Songhai (Figure 14) are intended to be used and self-managed by approximately 300 students. Instructions for use include adding sawdust after each use (a common

amendment for ecological sanitation toilets) and applying a chemical disinfectant (using a spray bottle) that accelerates decomposition. When the material is removed from the toilets, it is placed on the ground outside the facility: the material then needs to be turned over after three weeks. After a total of six weeks, the waste is reportedly safe to apply to crops. This process is of much shorter duration than that usually found with ecological sanitation systems, and the project would need to follow up with the technical director to get additional information about this technology. The study team did not have the opportunity to see the spray, which is the primary driver of the enhanced decomposition performance. The

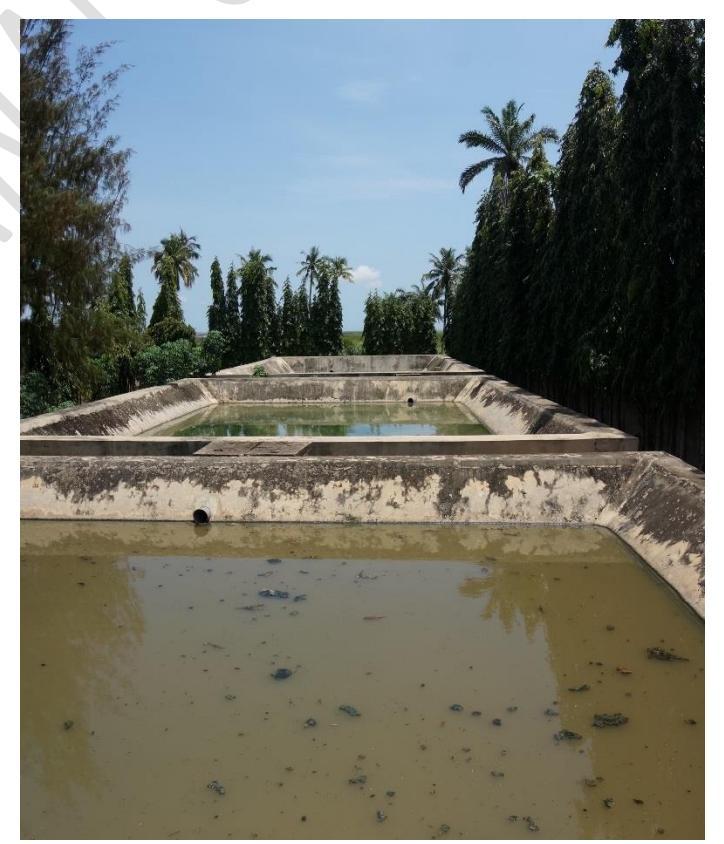
Photo: PATH Figure 15. DCAM Bethesda's graywater treatment pilot site.

In addition to meeting personnel from DCAM Bethesda, the study team visited a graywater treatment site (Figure 15) that is overseen by the NGO and is operated by a graduate and parttime teacher of construction of the technical secondary school. While graywater treatment does not address FS management directly, it provides a potential model for decentralized treatment of FS that could be similarly implemented. Furthermore, because DCAM Bethesda is operating a FS treatment pilot site in Parakou (a location too far away for the study team to visit during the product scan), visiting the graywater treatment site provided the study team with an opportunity to gain insights into DCAM Bethesda's capabilities. The graywater treatment facility began operations in 2012 and treats graywater (laundry water, shower water) through a three-pond system (anaerobic, facultative, and maturation) of elevated cement basins. Presently, there are only 22 households (~120 persons) connected to the system that has a capacity for approximately 700 persons, which means that the facility is only operating at 17% of its capacity. Each household is only required to pay an installation fee of 15,000 CFA (~US\$25); households do not contribute to the

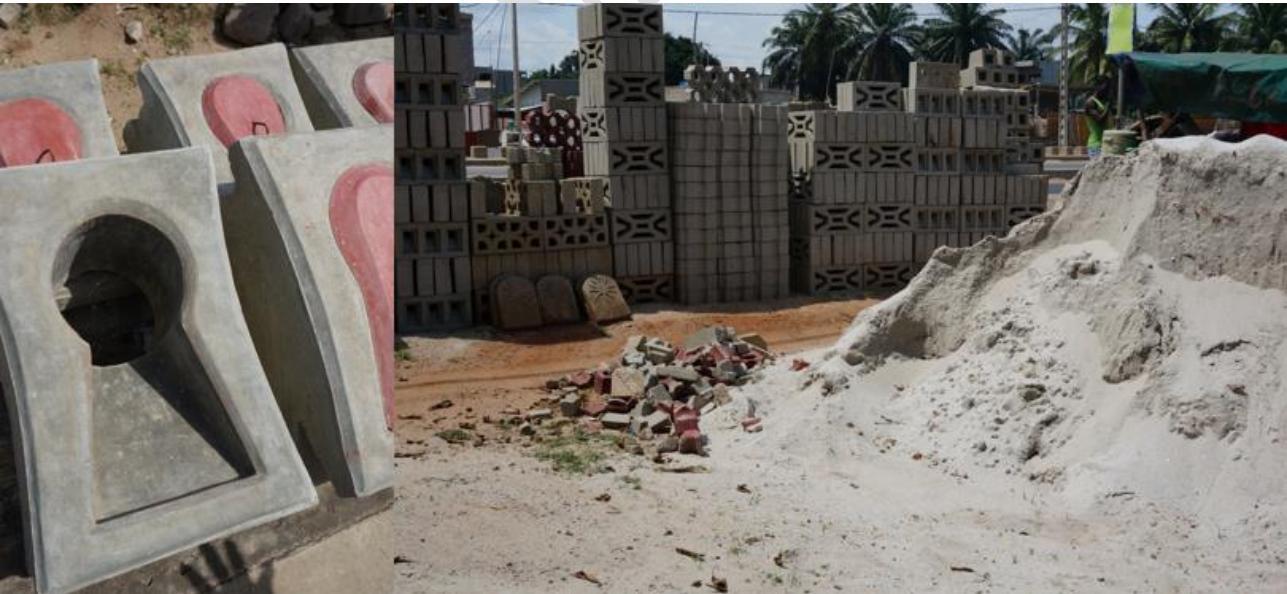
Figure 16. Cement artisans produce squat toilets with lids (left) and a variety of other sanitation products, including ventilation blocks, large washing basins, and hand-washing sinks.

Cement artisans: The cement artisans typically located themselves road-side on the outskirts of the city. Both artisans fabricated a variety of sanitation-related products, such as squat toilets, ventilation blocks for ventilation of latrines, large washing basins for laundry, and hand-washing sinks (Figure 16).

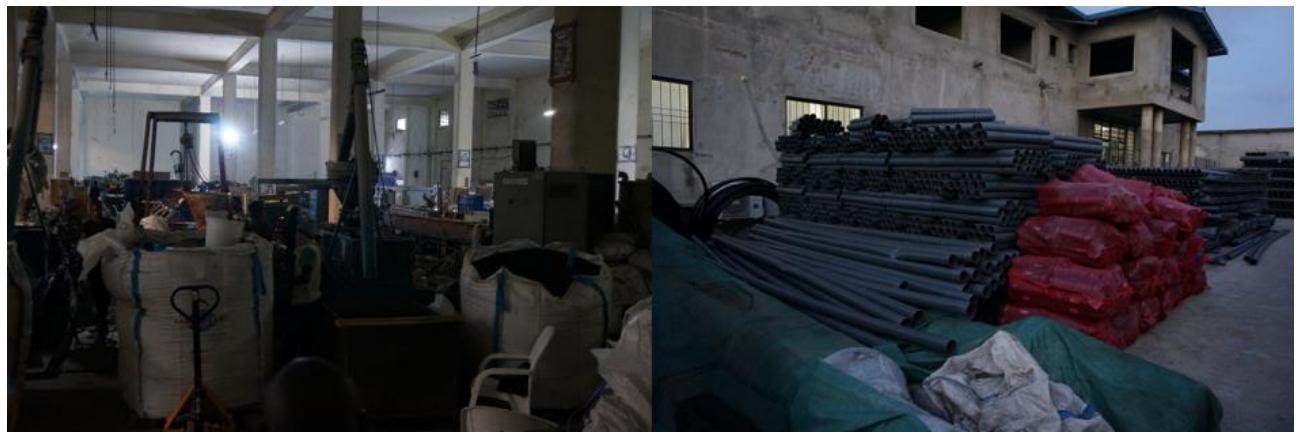
Photo: PATH Figure 20. IBP uses injection molding and extrusion molding (left) for the production of pipes, joints, and tables (right).

molding for the production of pipes and injection molding for the manufacturing of joints and tables (Figure 20). The company owns three types of injection molding machinery: 750 ton, 1,000 ton, and 1,500 ton. The company works with two levels of distributors: 30 large distributors and more than 50 retailers. Their biggest client is SONEB, which purchases approximately 90% of their joints from IBP.
