# Search Continues For Answers On Health Impact Of Ecosan

*While the mass rollout of urine diversion (UD) toilets continues on the outskirts of Durban in the municipality's quest to provide all its constituents with decent sanitation by 2010, questions remain regarding the environmental impact of these systems and the possible reuse of the accumulating waste. A joint research effort between the Pollution Research Group of the University of KwaZulu-Natal and the Water and Sanitation Department of eThekweni Municipality is hoping to come up with some answers. Lani Holtzhausen reports.*

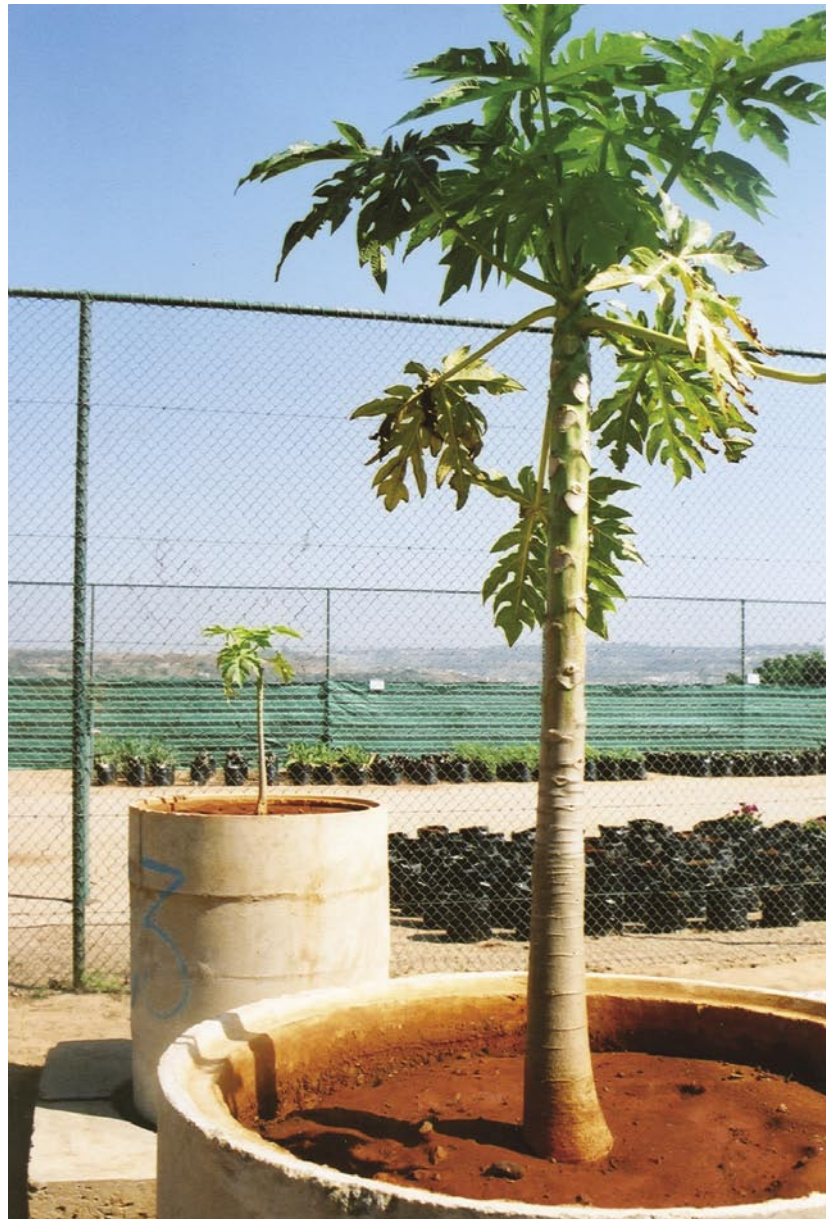
*A dwarf paw-paw tree grown on waste (front) compared with a tree grown in conventional soil (behind).*

An extremely positive aspect of the project is that growth of the spinach plants was boosted markedly when growing above the buried UD waste. While the paw-paw trees took longer to show as marked a difference, the same trend was evident after eight weeks' growth and, particularly by ten weeks' growth. “Our research showed that even the UD sanitation-only approach adopted by eThekweni Municipality, which does not specifically provide for agricultural reuse, may boost food production from crops grown in a relatively small area immediately above the burial site,” says Guness.

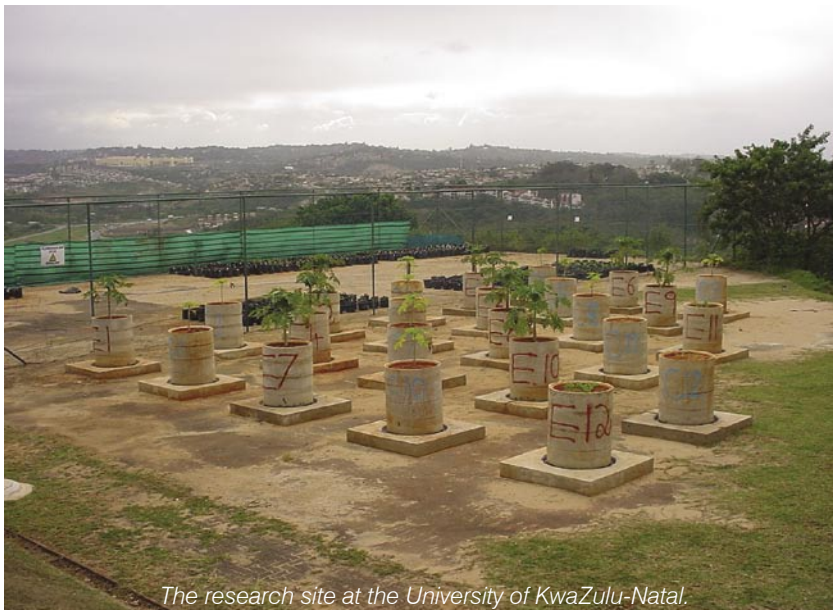
The research site at the University of KwaZulu-Natal.

To answer some of these questions a study site was selected at the university grounds. The project, funded by National Research Foundation, started in August 2004. A total of 24 concrete columns were constructed from conventional manhole pipe rings with a diameter of 75 m and a height of

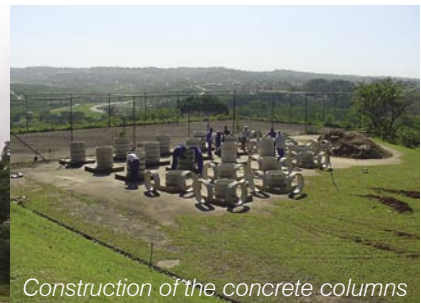
Construction of the concrete columns

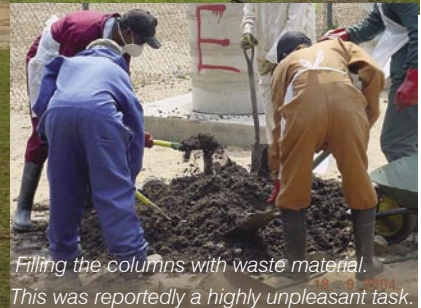
Filling the columns with waste material. This was reportedly a highly unpleasant task.

The columns were filled with combinations of soil and urine diversion solid waste collected from toilets nearing filling of the second toilet vault. Berea red soil, a relatively nutrient-poor soil typically found in the area, was used as covering soil and as substitute for the UD wastes

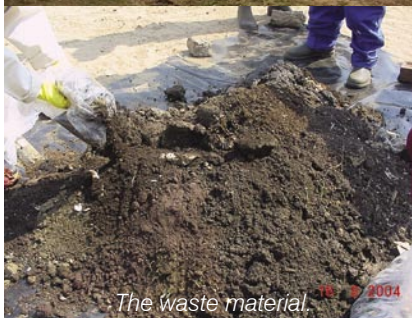
The waste material.

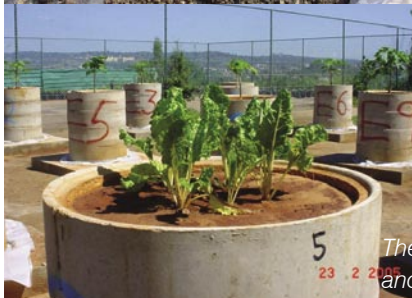
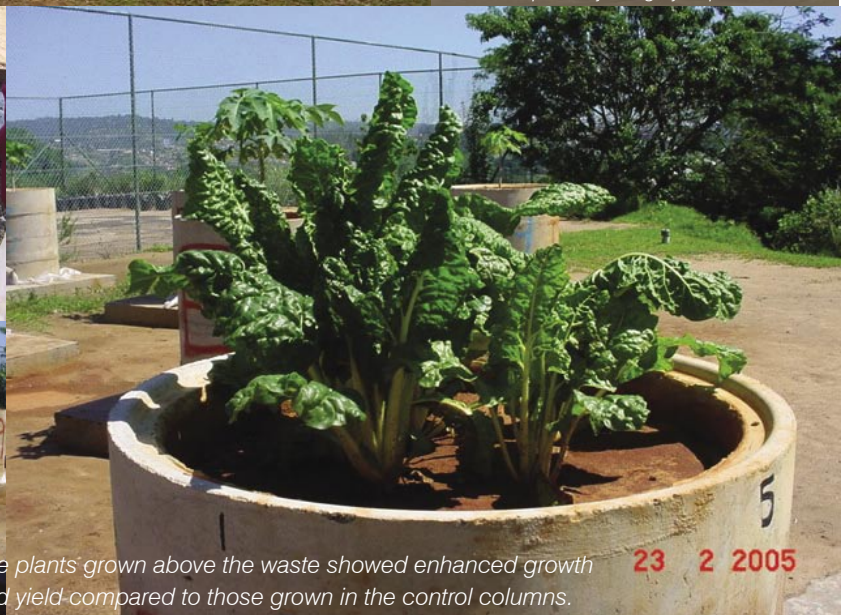
The plants grown above the waste showed enhanced growth and yield compared to those grown in the control columns. 23 2 2005
